# **Craigie High School Site Local Structure Plan**

## **STRUCTURE PLAN NO. 13**

This Structure Plan is prepared under the provisions of Part 9 of the City of Joondalup District  
Planning Scheme No. 2.

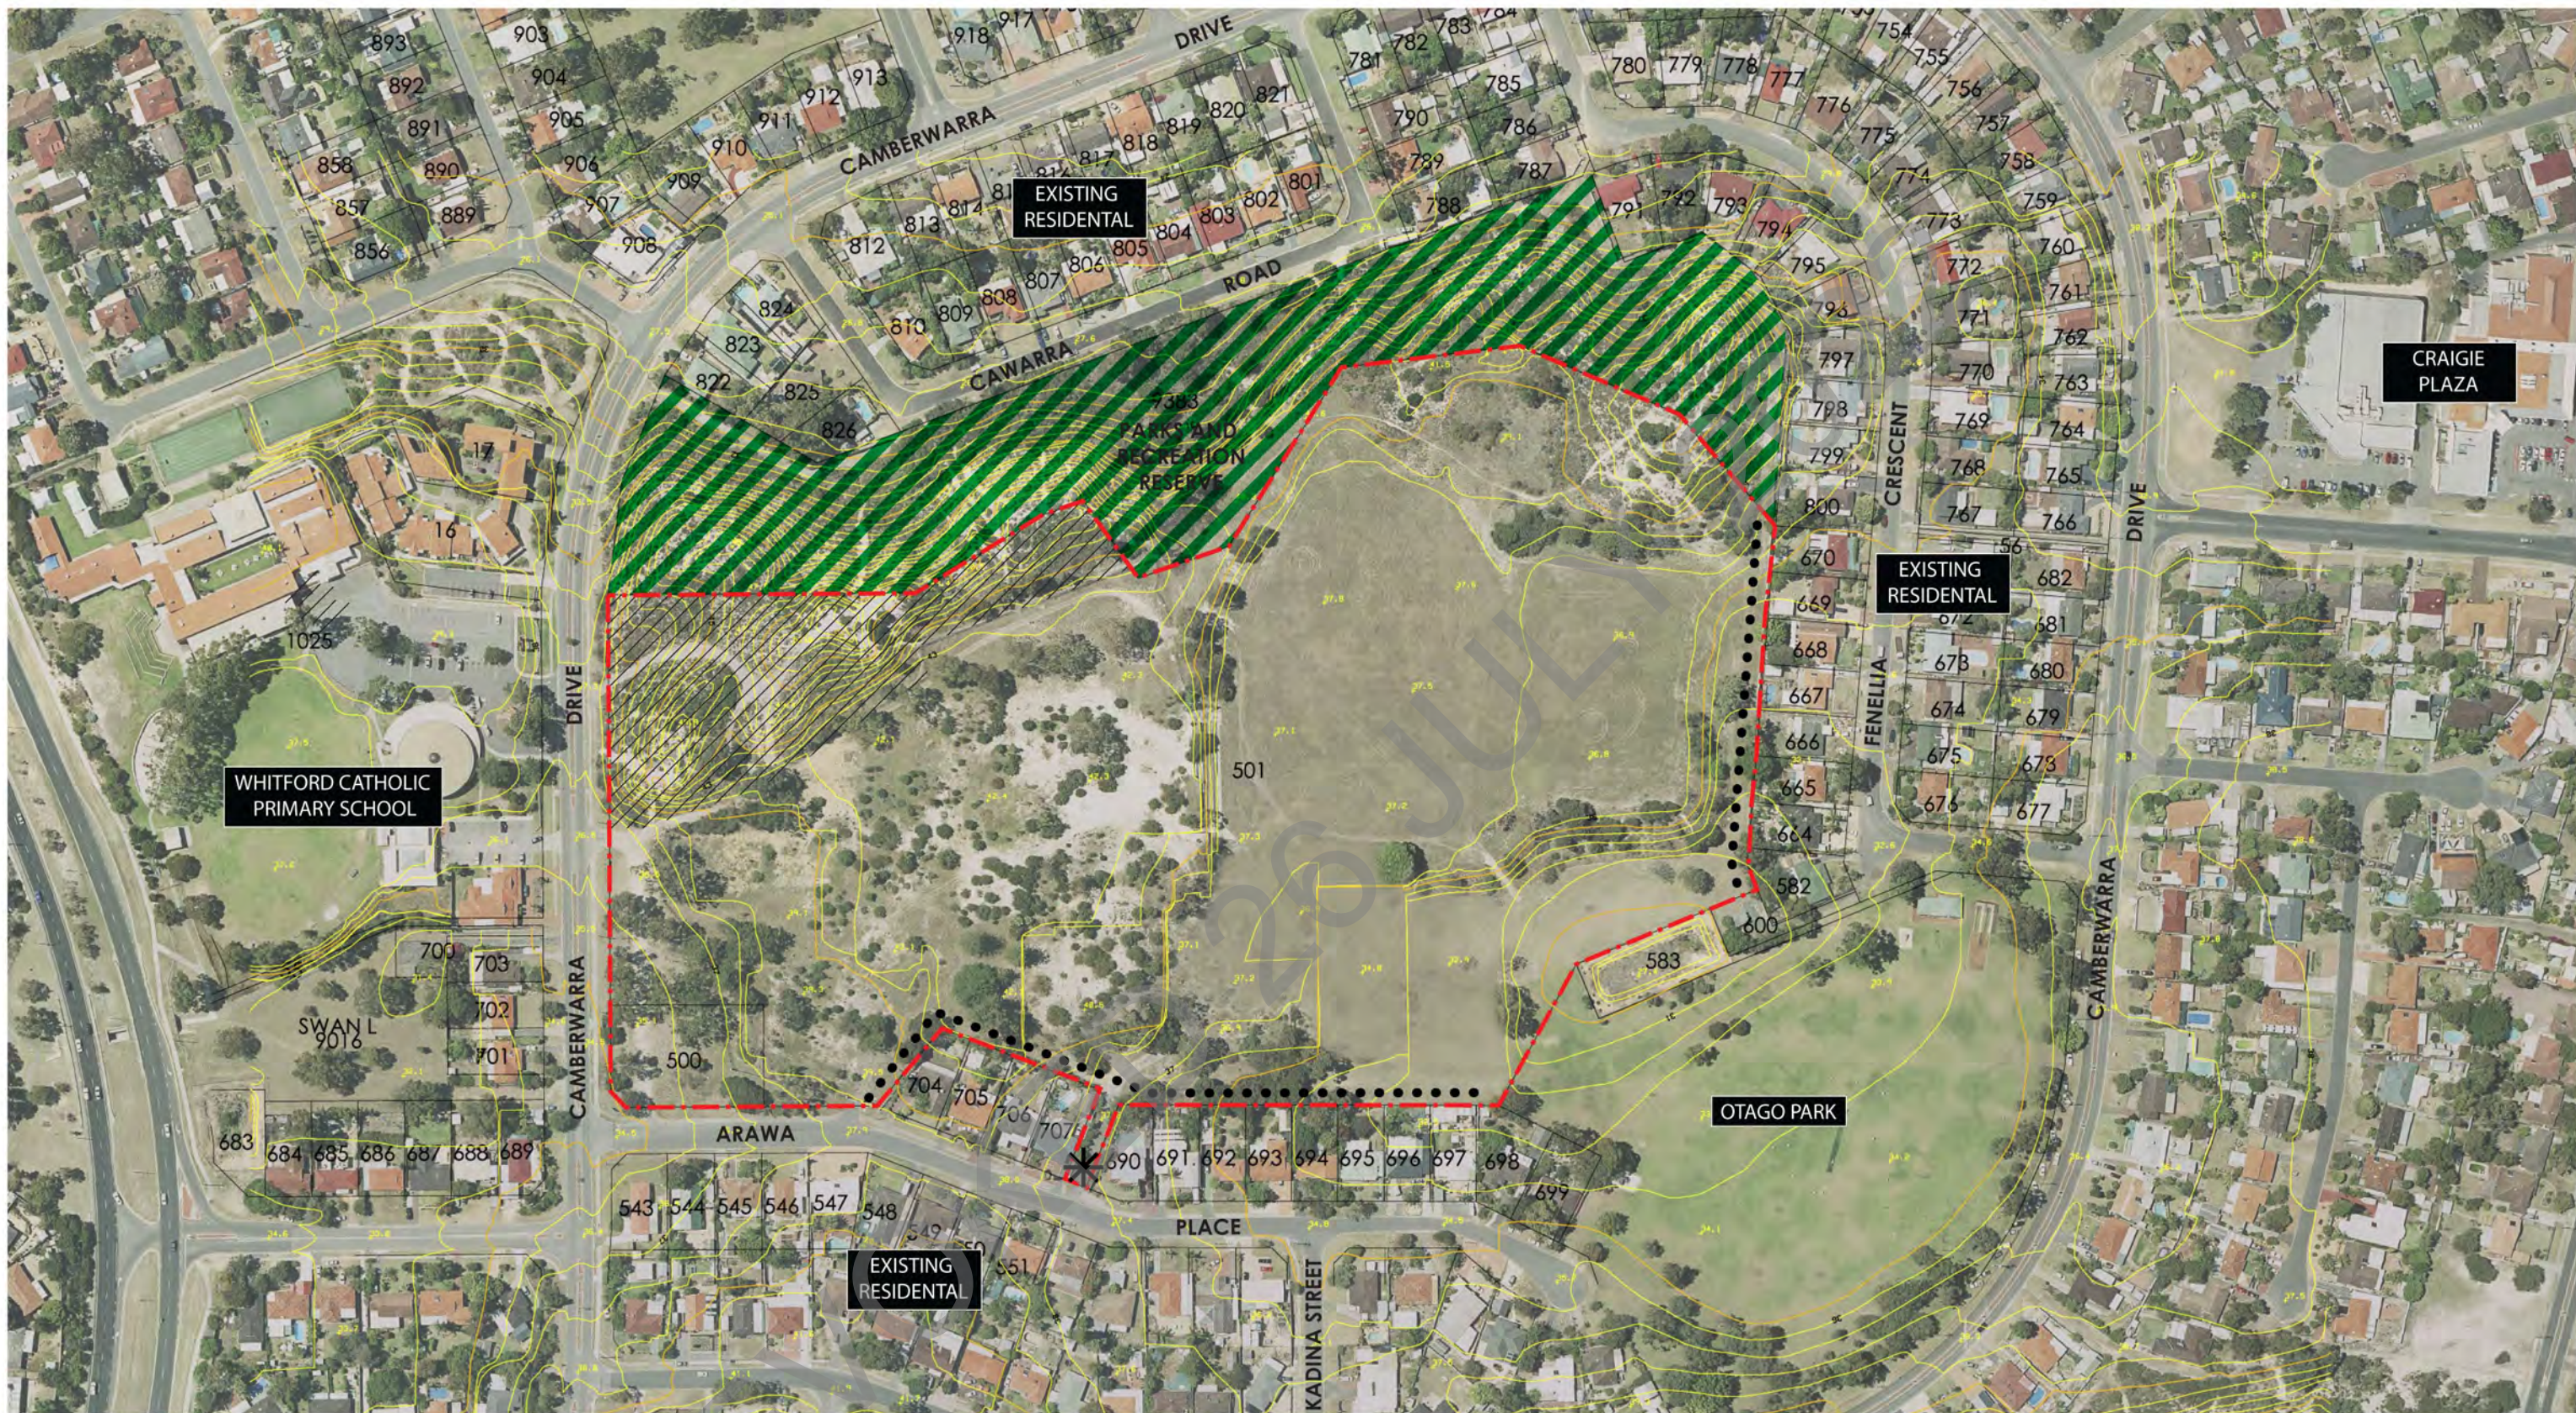
03

More specifically, the subject land extends from Camberwarra Drive to the west to the rear of the existing residential to the east; and from the Parks and Recreation Reserve (R33739) to the north to the rear of the existing residential to the south (refer **Figure 4** – Local Context).

The subject land is bounded by Whitfords Catholic Primary School to the west, Parks and Recreation Reserve (R33739) to the north, existing residential to the east and south, Otago Park to the south-east and Arawa Place to the south-west. The direct interfaces with the Dunes to the north, existing residential lots to the east and south and Otago Park to the south-east (inclusive of drainage sump) are all important interfaces requiring careful consideration during the formulation of the Structure Plan.

Whitfords Catholic Primary School is situated over Camberwarra Crescent to the west and Craigie Plaza, a local centre, is situated approximately 300m north-east of the site (refer **Figure 4** – Local Context).

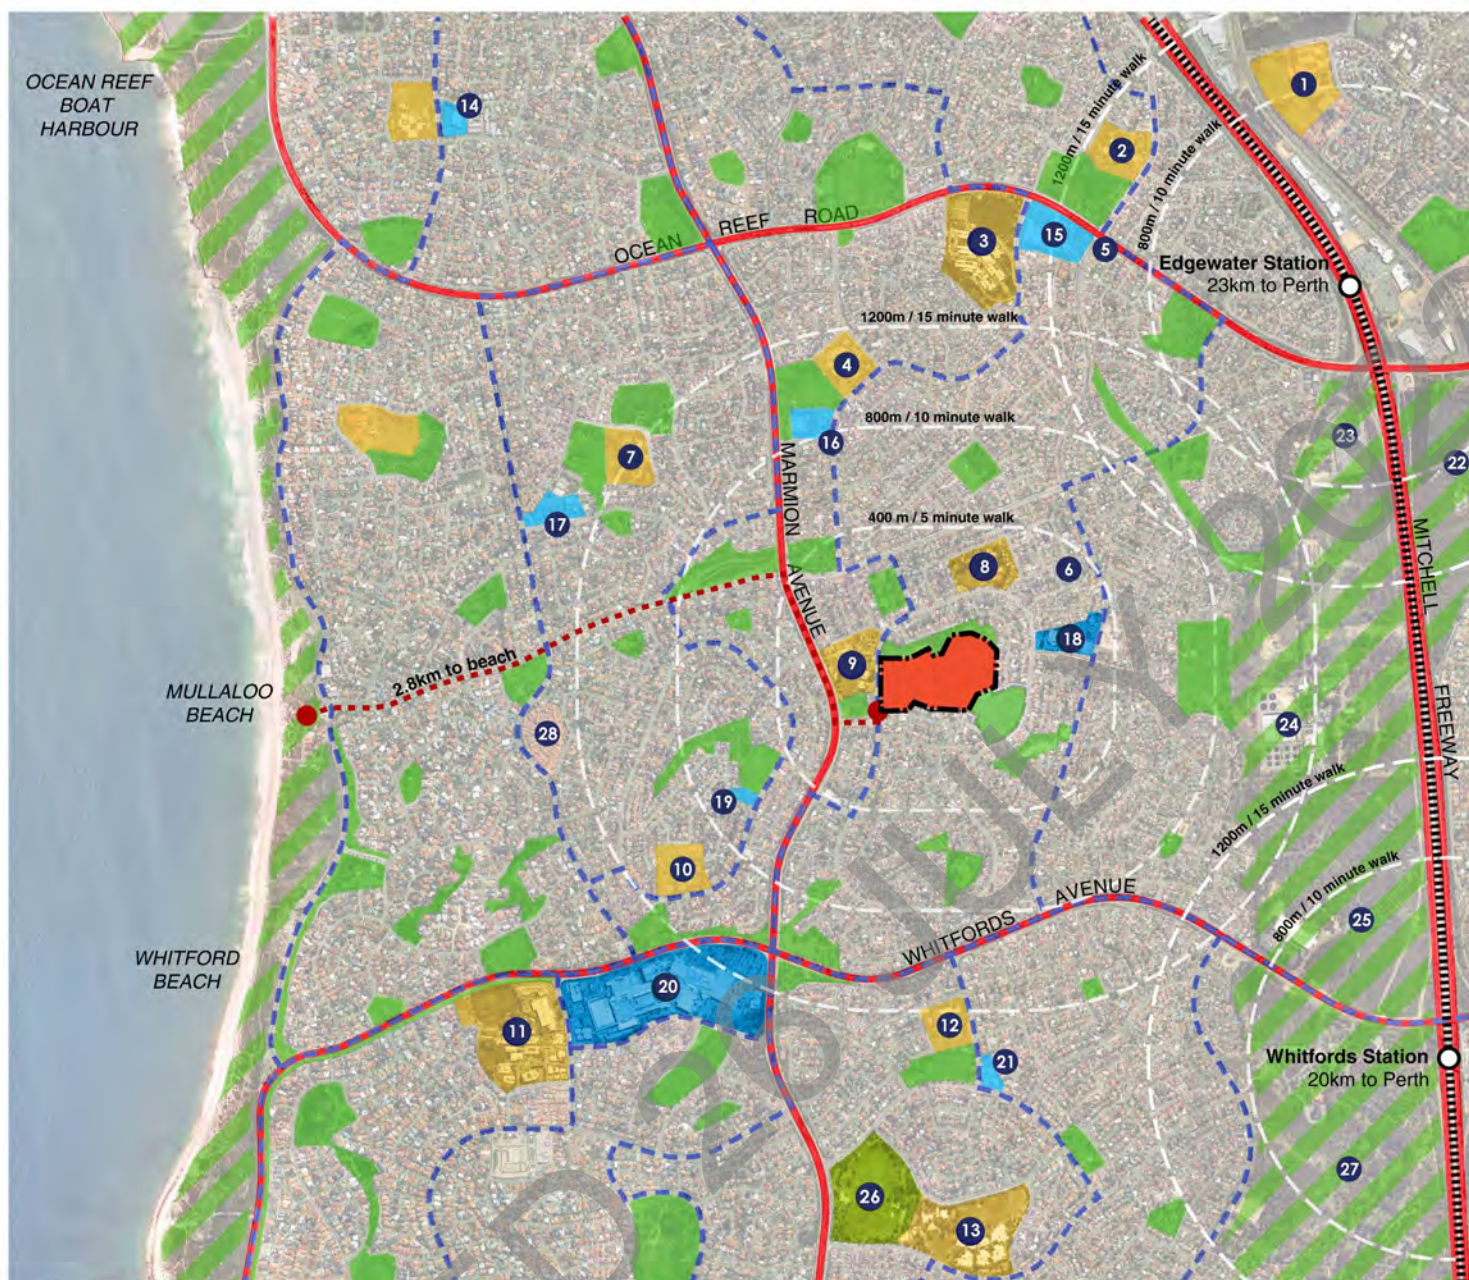
At a greater context, Whitfords Shopping Centre, a regional Centre, is located 1km south-west of the site. Marmion Avenue, a major north-south District Distributor Type A, is located approximately 200m west of the subject site with the Mitchell Freeway leading into the CBD, located approximately 1.5km east of the site. Various Primary Schools, 3 High Schools, a Retirement Village and a mixture of public open spaces are all found within a 2km radius of the site (refer **Figure 5** – Greater Context).

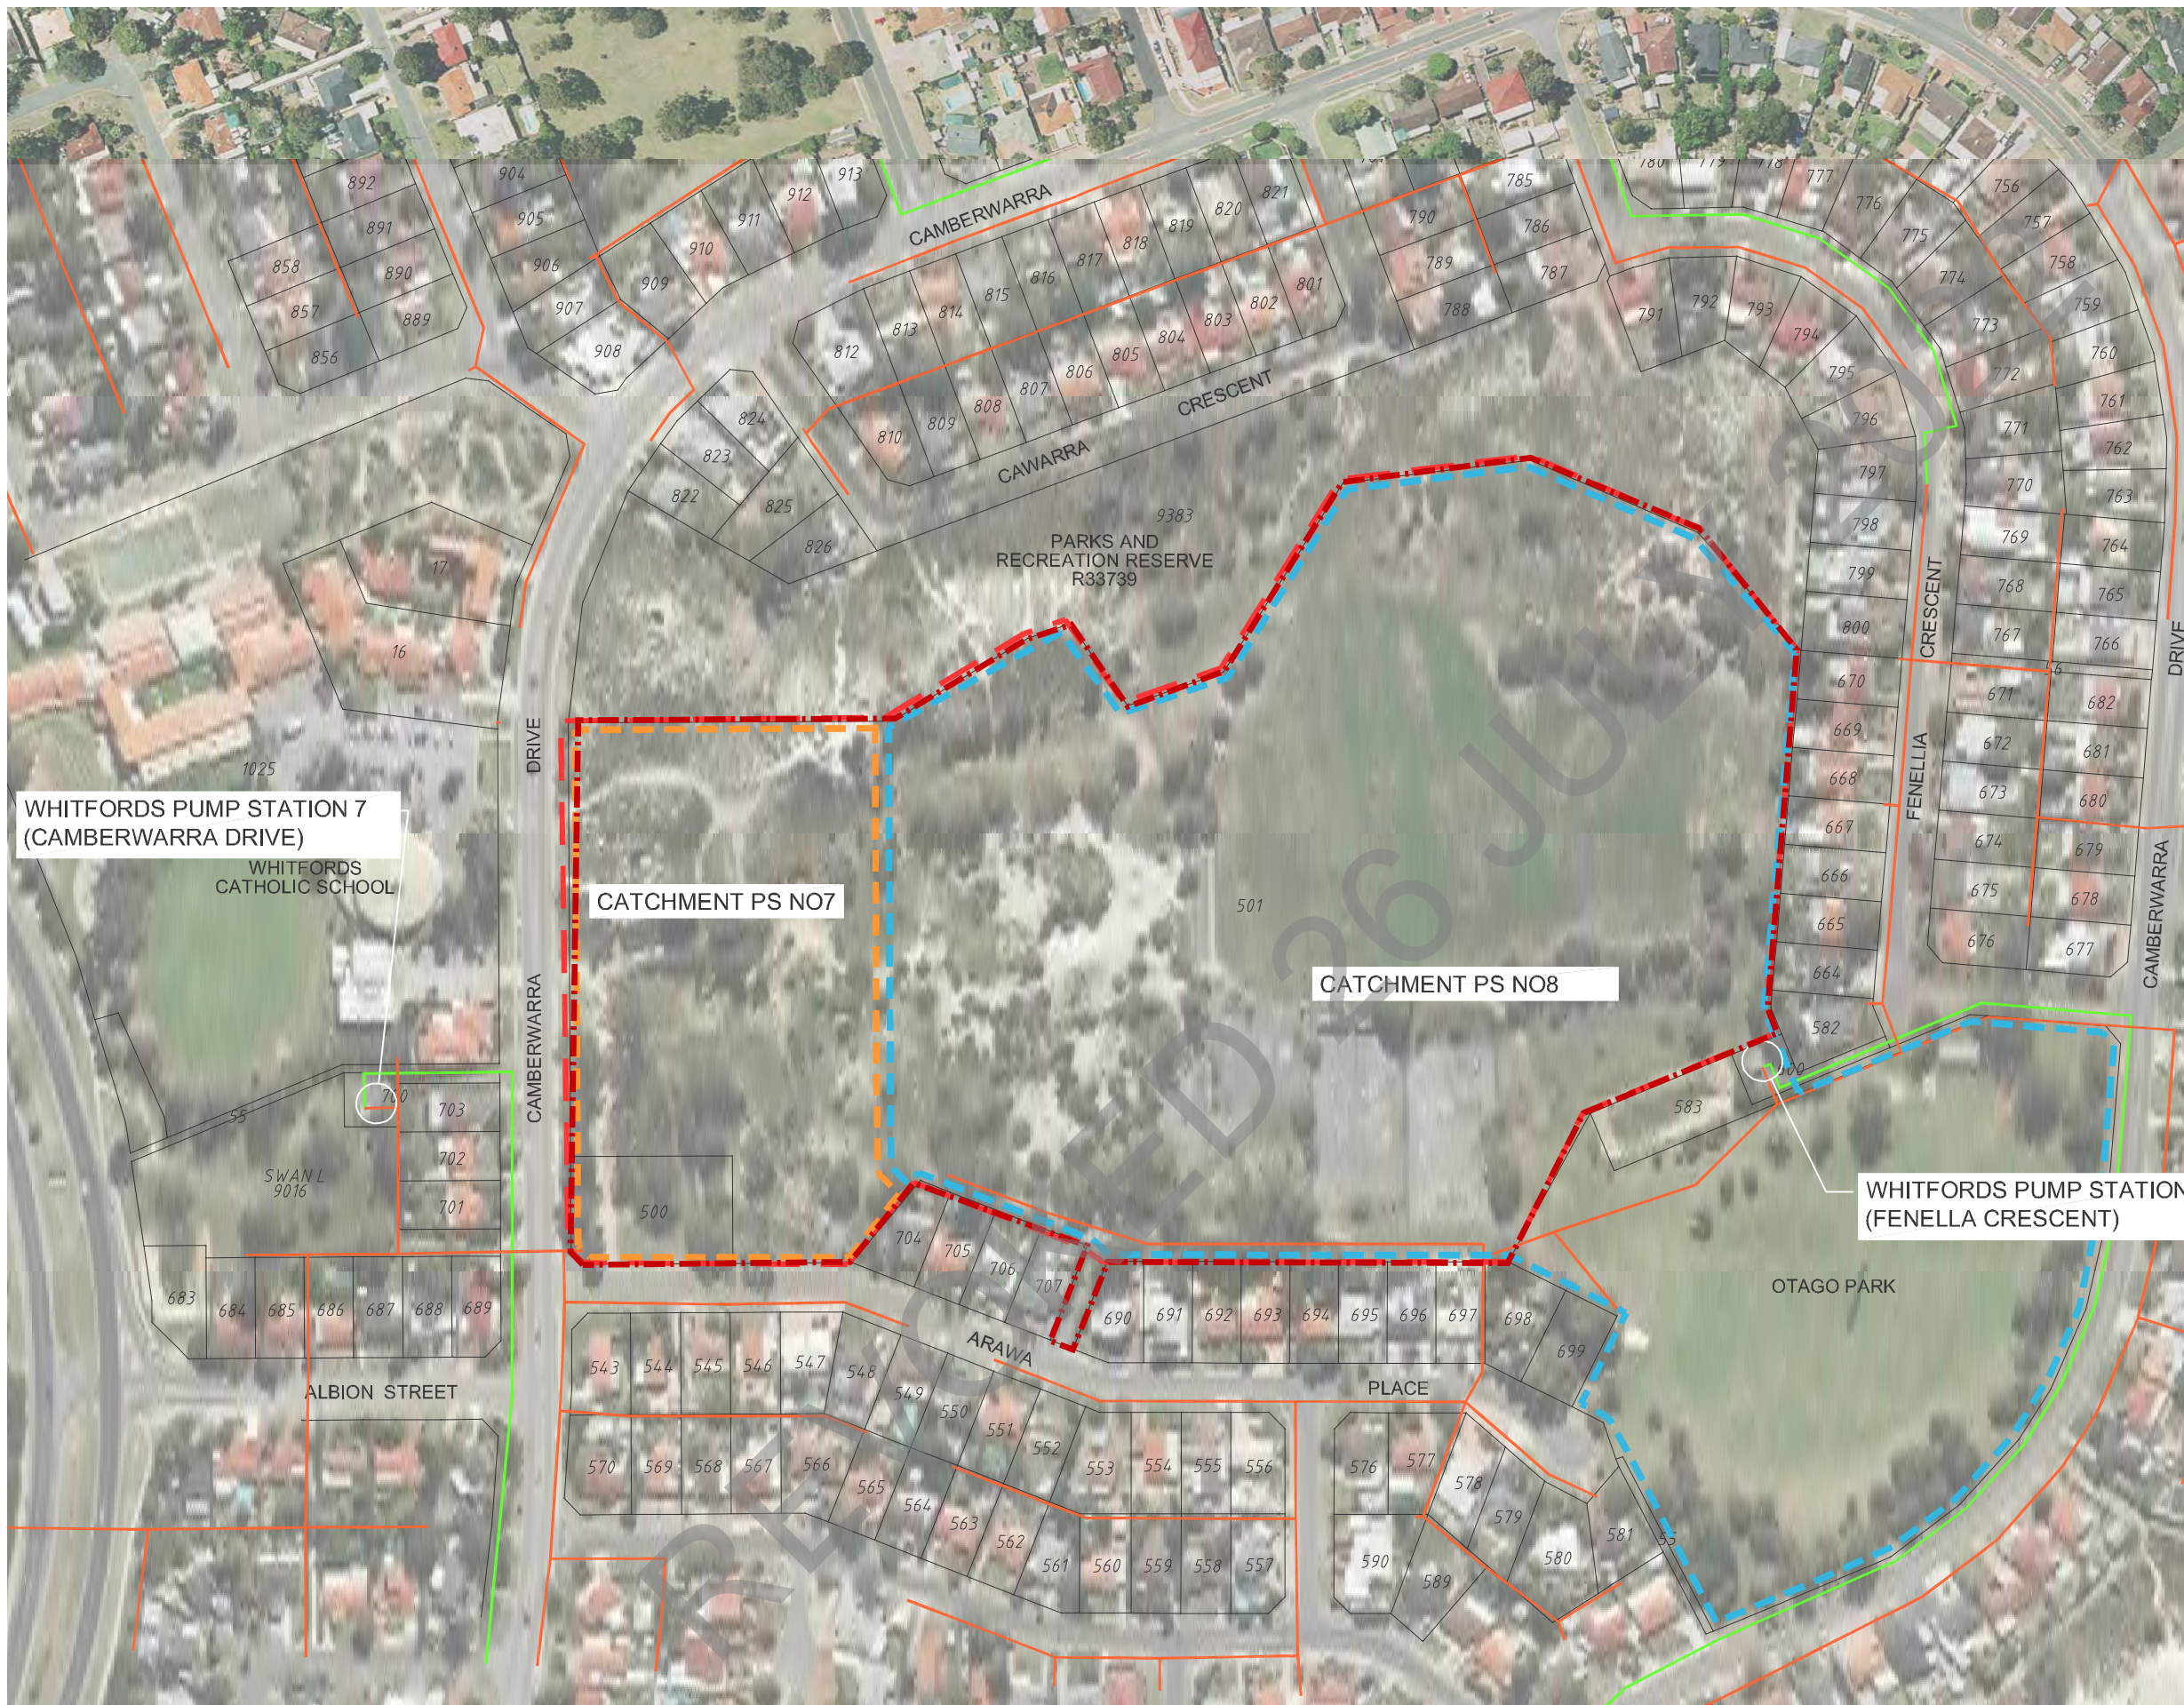
**EXISTING AND PROPOSED SEWER**  
 Craigie High School Structure Plan

- EXISTING SEWER
- EXISTING PRESSURE MAIN
- DEVELOPMENT CATCHMENT BOUNDARY
- DEVELOPMENT CATCHMENT BOUNDARY
- SUBJECT LAND BOUNDARY

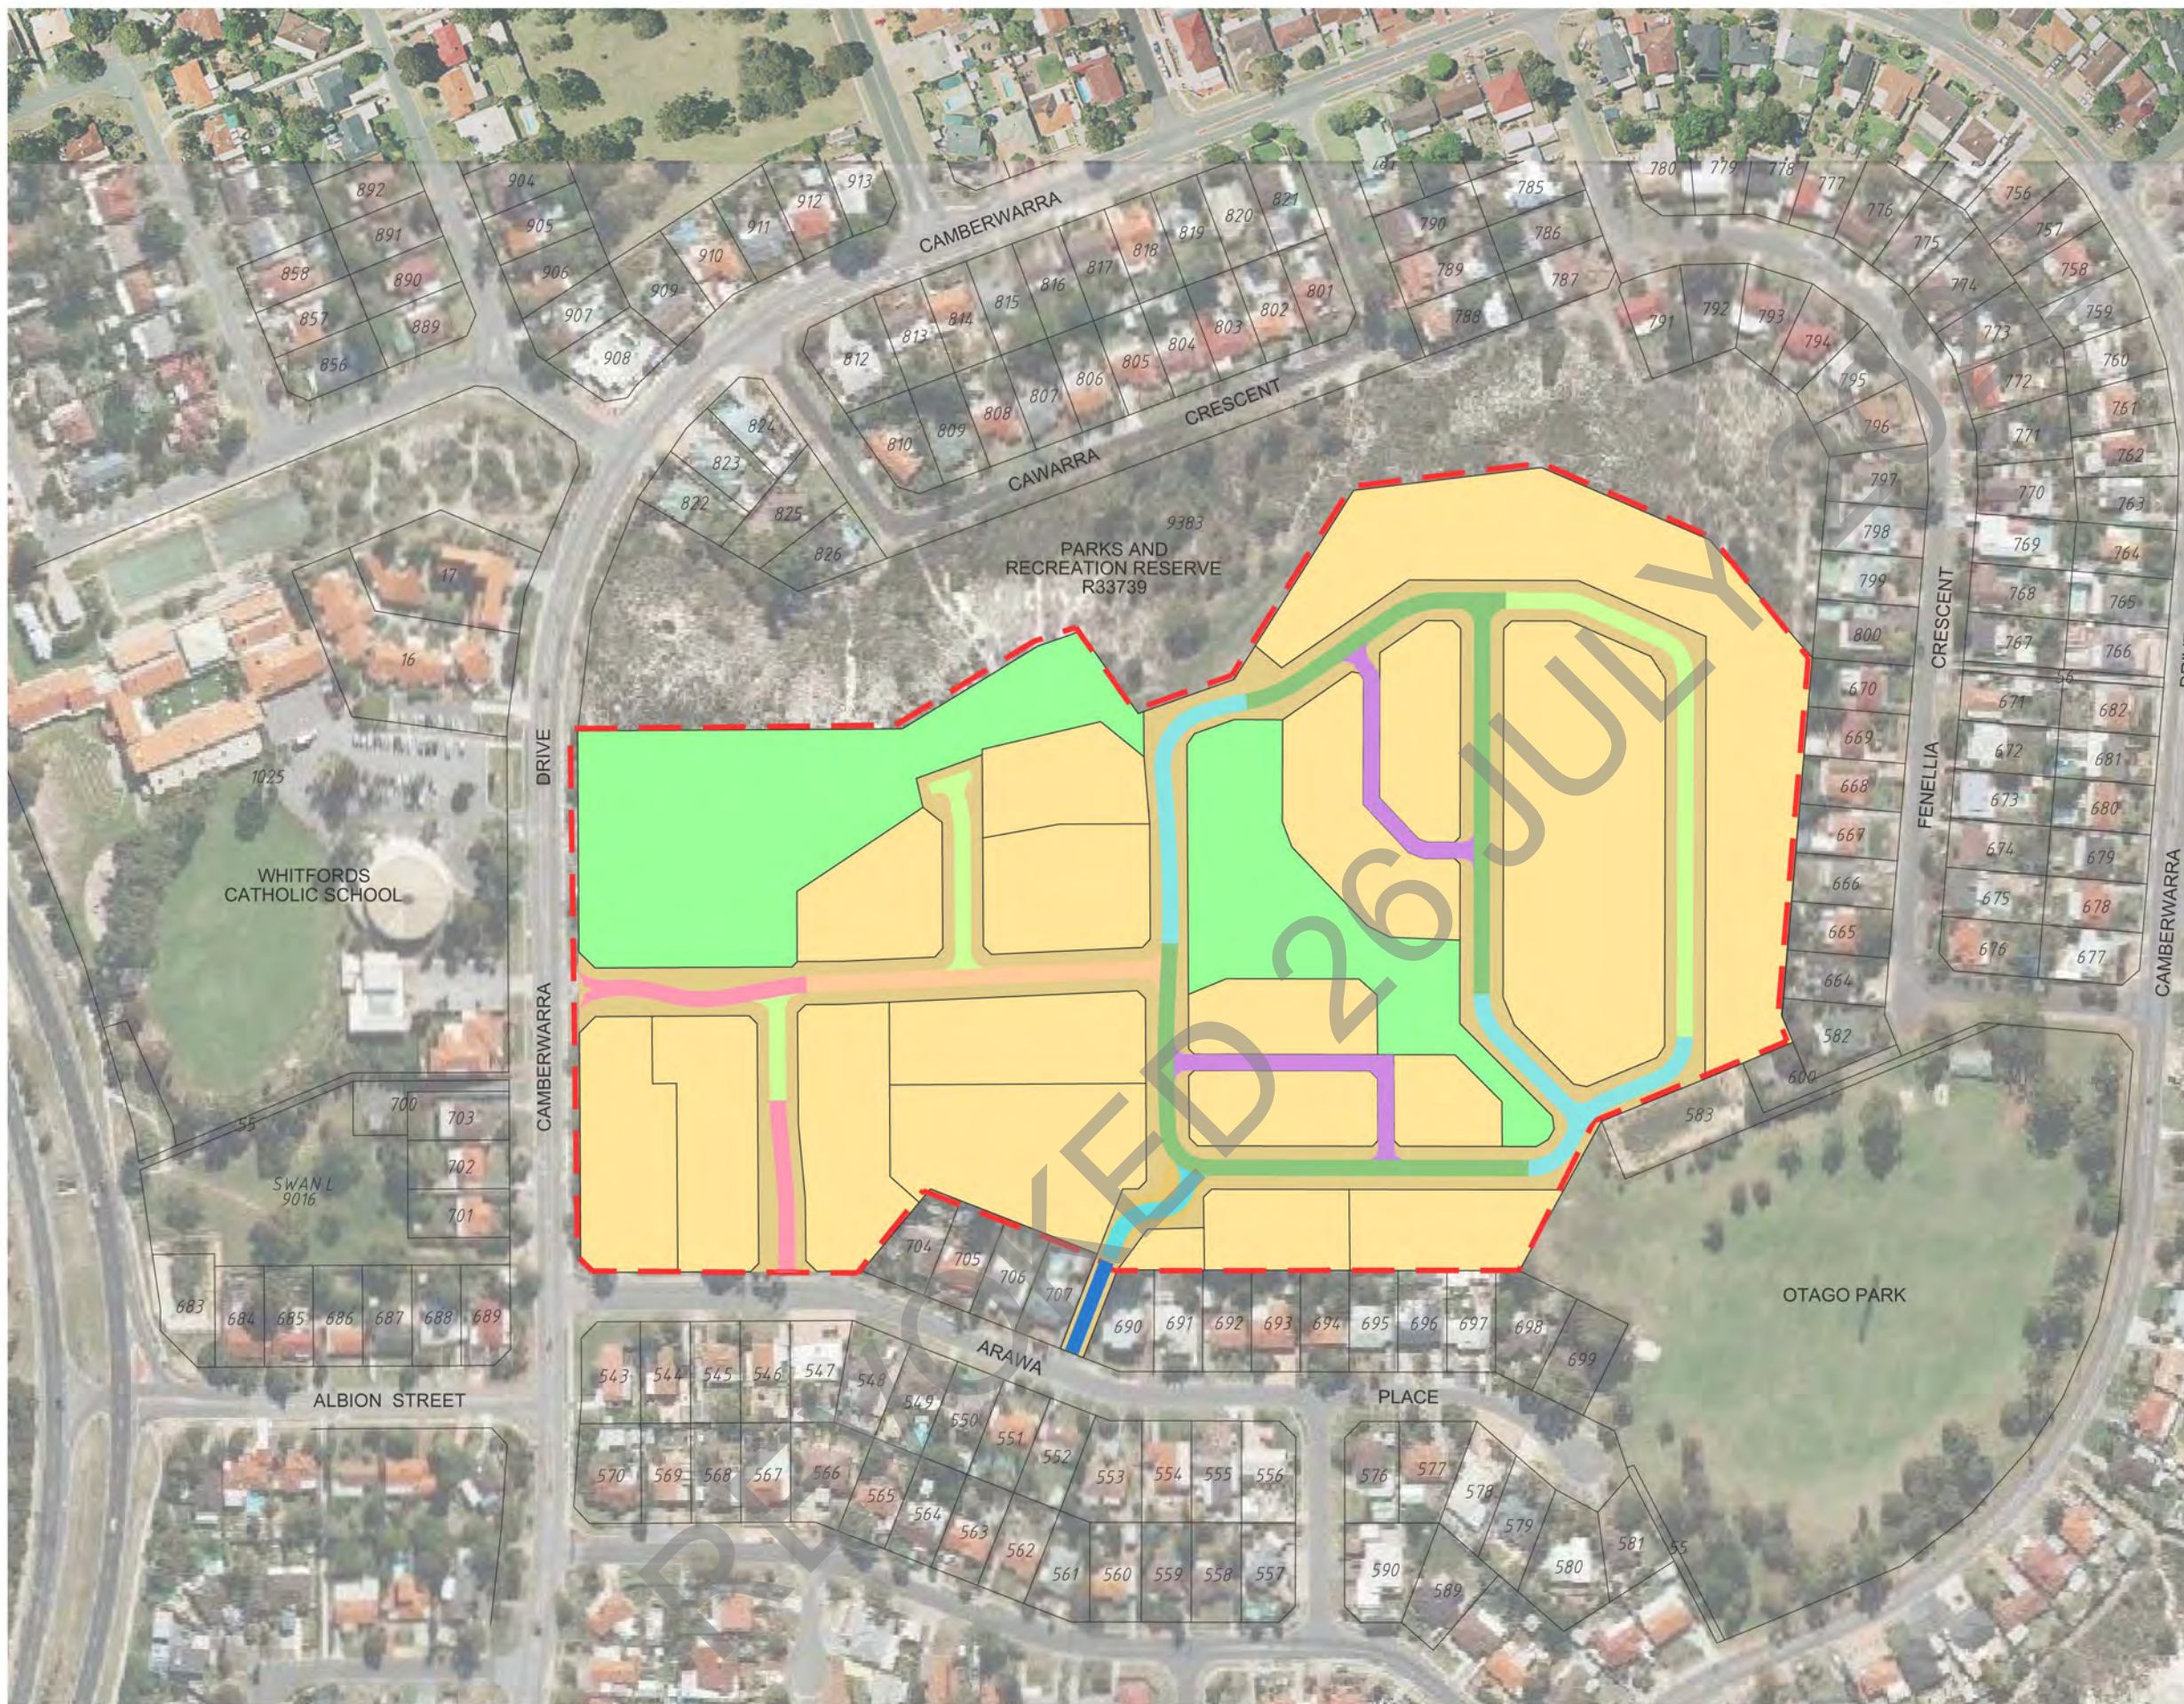
- 6m RIGHT OF WAY
- 9m PUBLIC ACCESS WAY/RIGHT OF WAY
- 14m ROAD RESERVE
- 15m ROAD RESERVE
- 16m ROAD RESERVE
- 16m ROAD RESERVE (ENTRY ROAD)
- 18m ROAD RESERVE (MEANDERING ROAD)
- PROPOSED RESIDENTIAL ZONING
- PROPOSED POS AREA
- SUBJECT LAND BOUNDARY

A second local road access to the development is proposed on Arawa Place, west of existing north side residential properties. This access will help spread site traffic and more importantly offer an alternative route to the Camberwarra Drive access point during busy school opening/closing times.

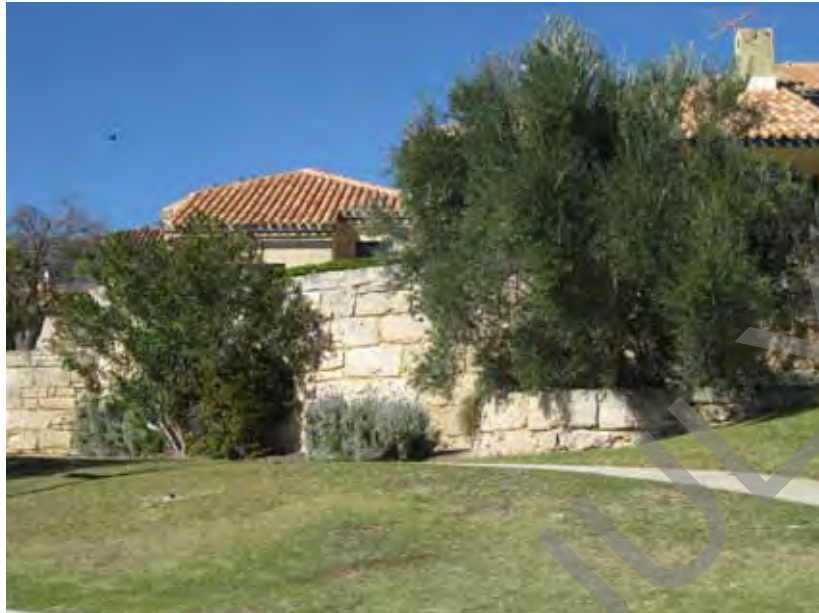
Indicative photo of a retaining wall screened by landscaped planting

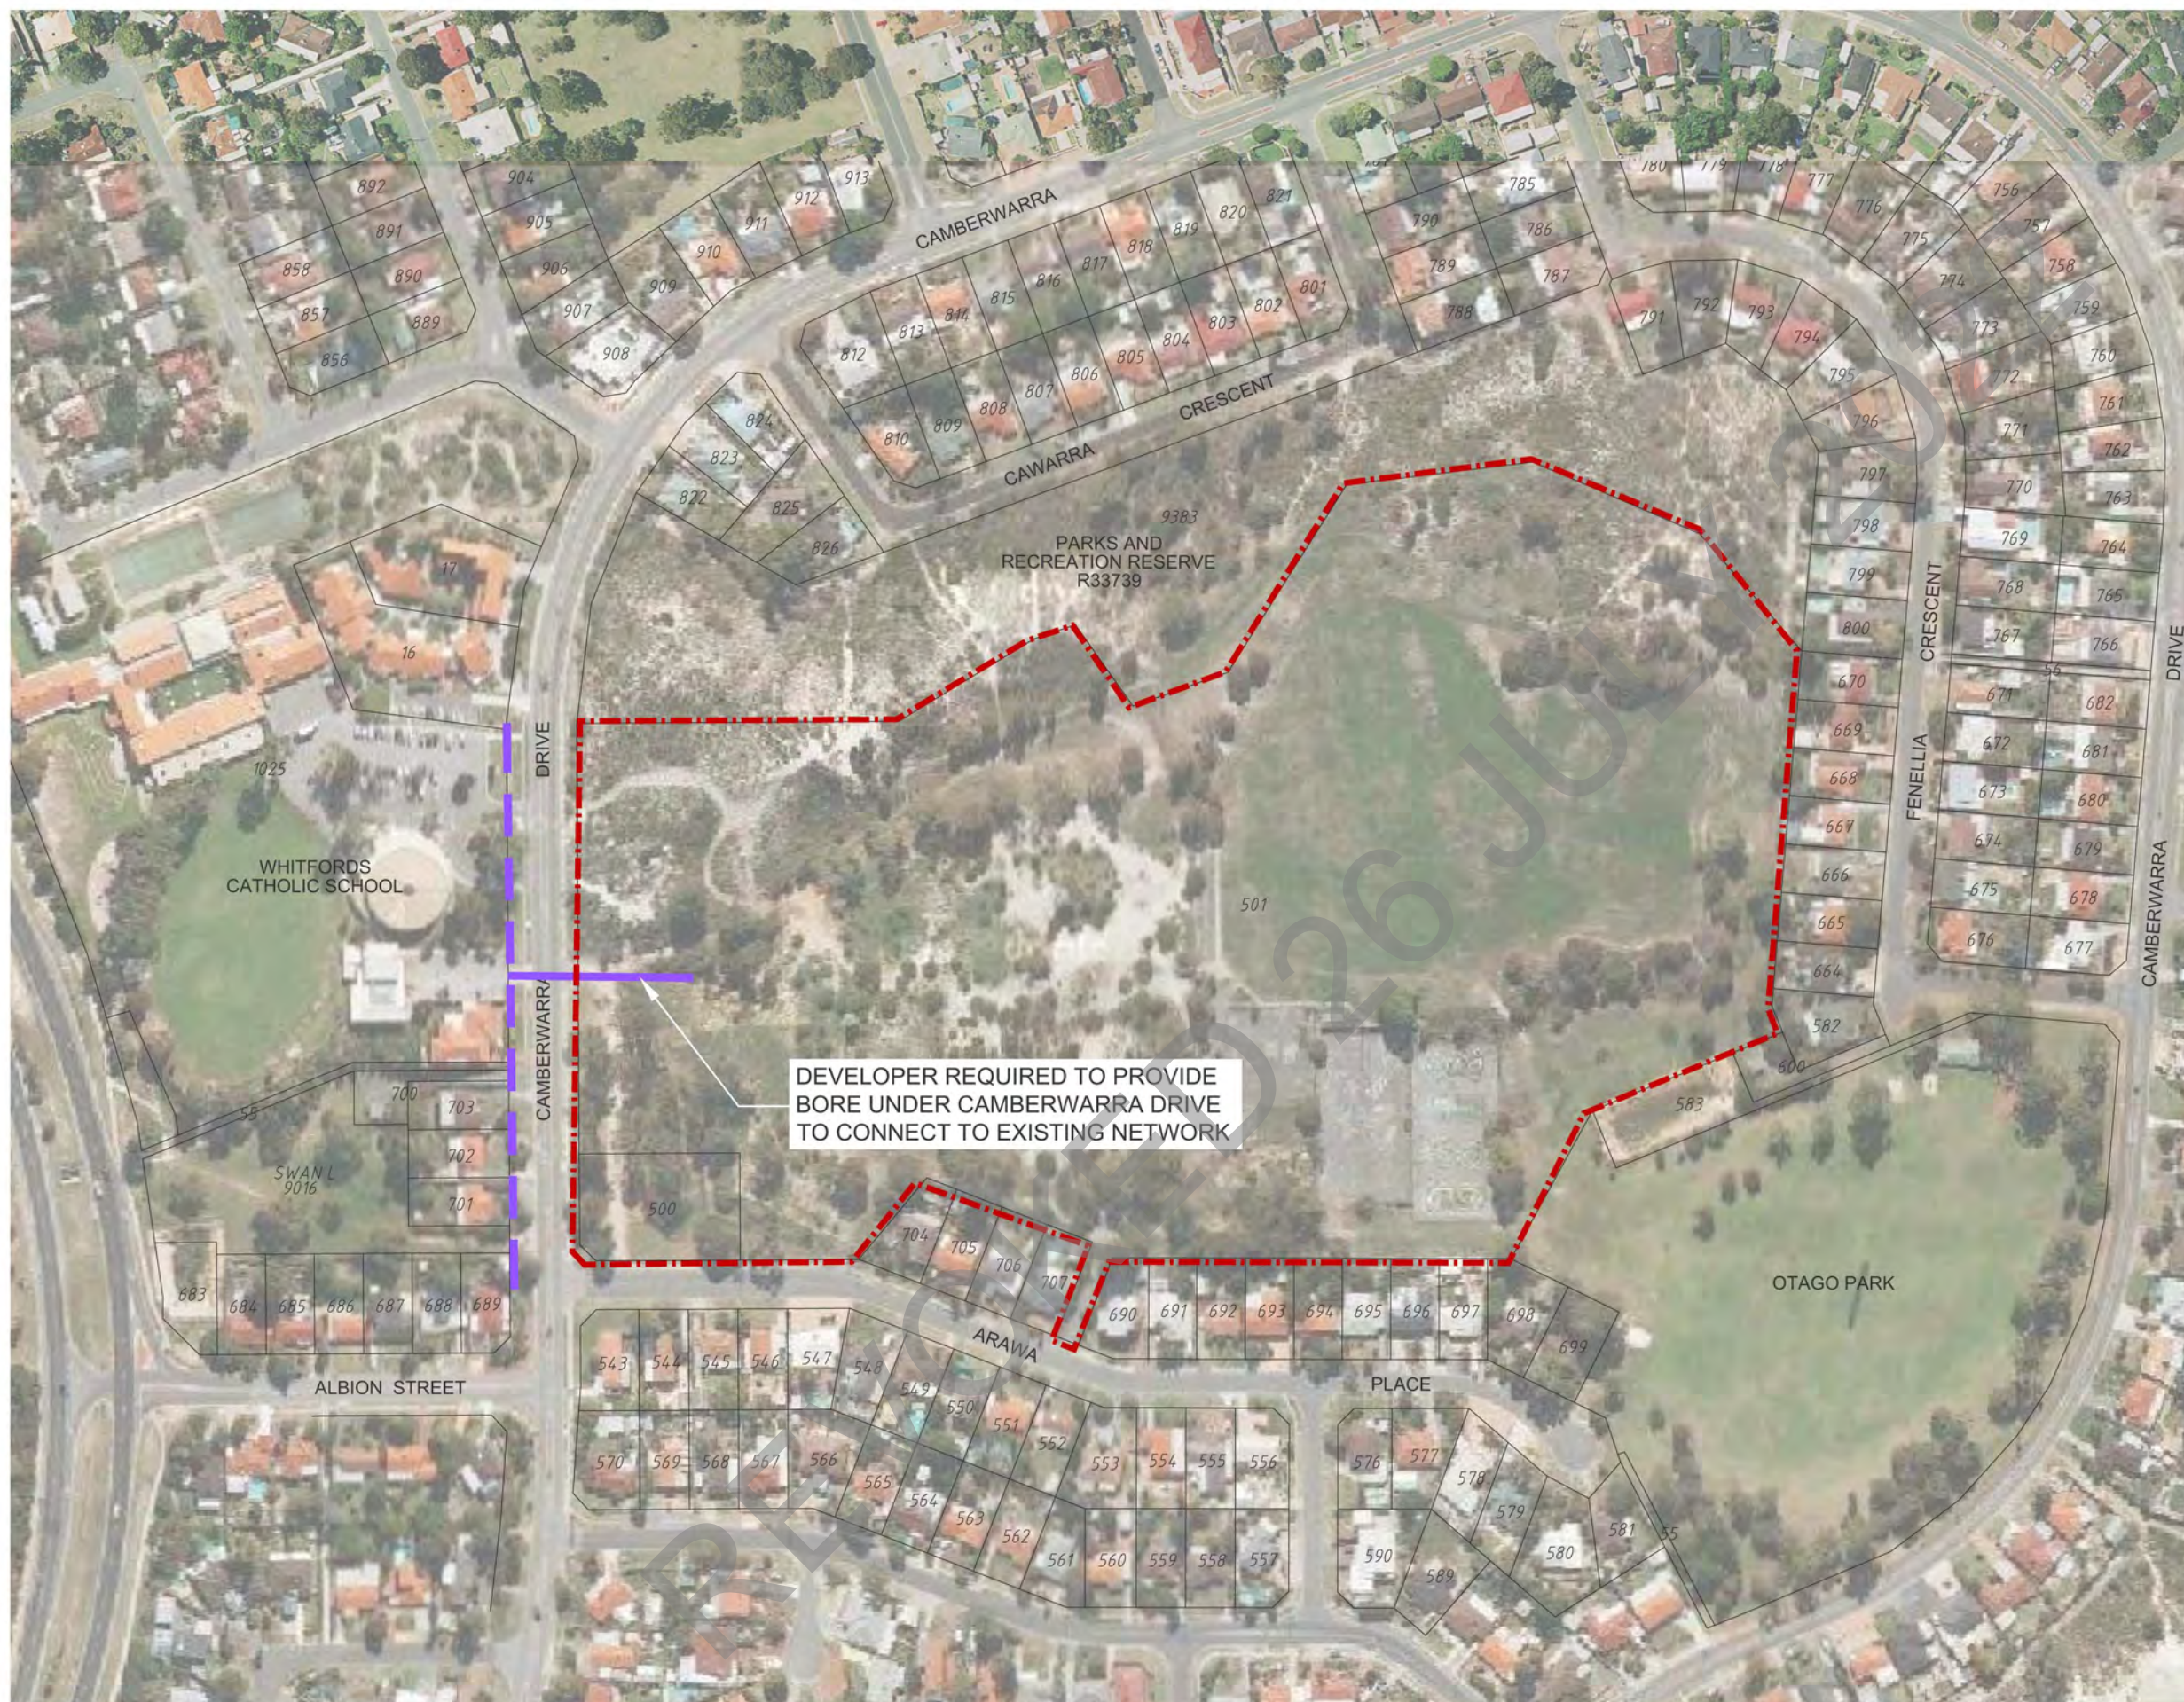
- LEGEND**
- EXISTING GAS NETWORK
  - PROPOSED GAS NETWORK
  - - - SUBJECT LAND BOUNDARY

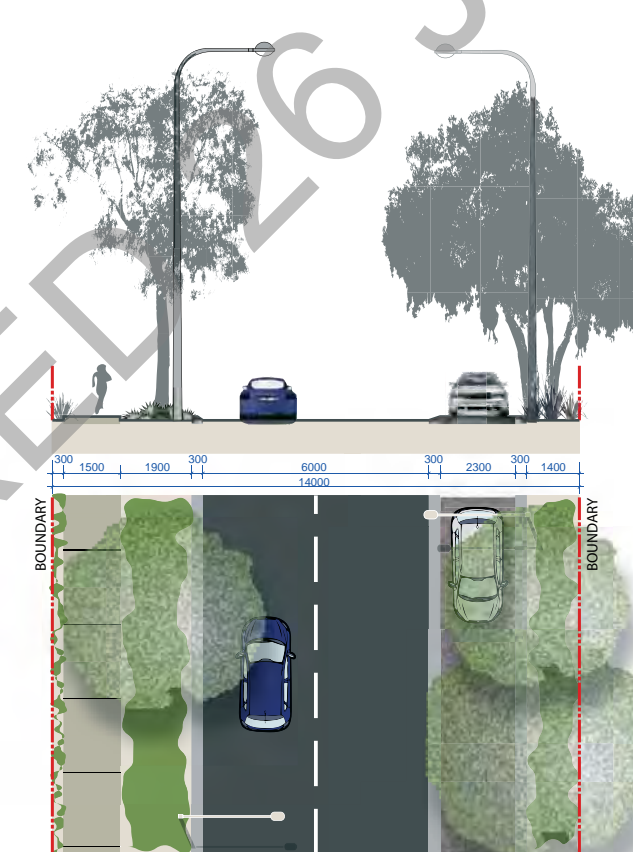
14m Road Reserve

**NOTE:**  
LANDSCAPING ADJACENT TO ON-STREET PARKING EMBAYMENTS IS NOT TO INCLUDE SHRUBS. APPROPRIATE LANDSCAPE TREATMENTS INCLUDE PAVING, GROUNDCOVER AND FORMAL TREE WELLS. A 1.8 METER STREET WELL DIAMETER IS REQUIRED FOR STREET TREE PLANTING.

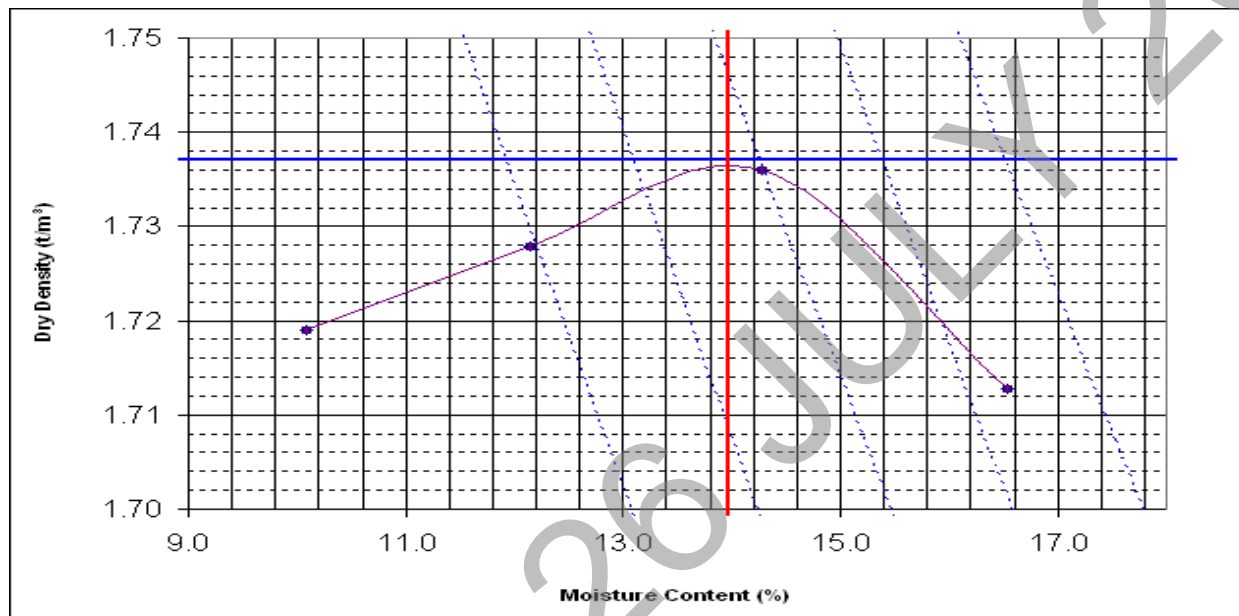
### DRY DENSITY/MOISTURE CONTENT RELATIONSHIP OF A SOIL

AS 1289.5.1.1 (Standard Compactive Effort)

Maximum Dry Density (t/m³): **1.74**

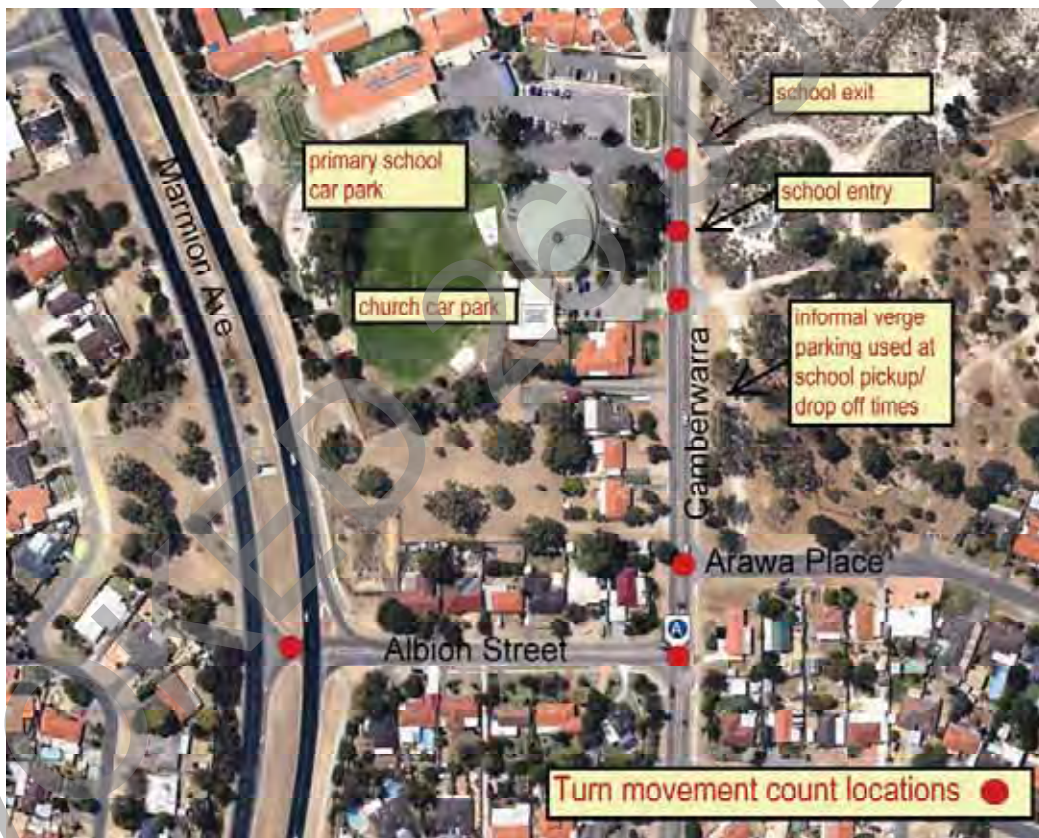
The counts covered the 7:30-9:00am period at the intersections shown in Figure 2 and listed below:

- Marmion Ave/ Albion Street
- Albion Street/ Camberwarra Crescent
- Camberwarra Crescent/ Arawa Place
- Camberwarra Crescent/ Catholic Church & Primary School.

Figure 2. February 2010 AM Peak Traffic Count Locations (photo by NearMap)

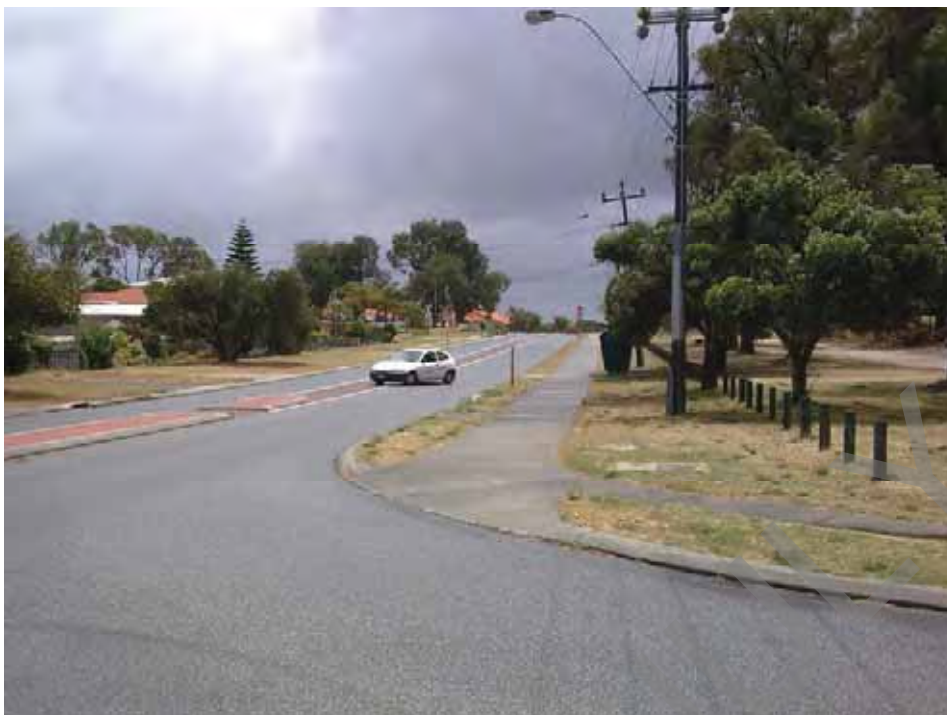
The Route 463 bus stop and shelter on Camberwarra Crescent just north of Arawa Place intersection are shown in *Figure 7*.

Figure 7 Route 463 bus stop & shelter on Camberwarra Crescent.

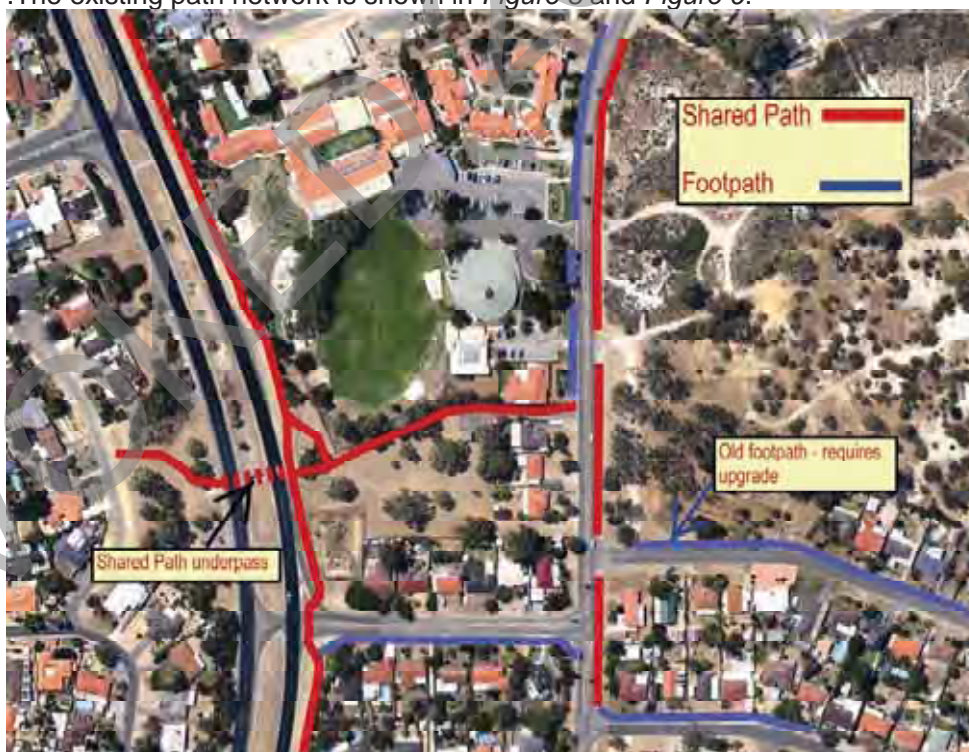
Figure 9. Path Network West Side (photo by NearMap).

The existing path network is well established at the perimeter of the Lot 500 & 501 development site.

The paths are generally in good condition, but the path on the north side of Arawa Place, near Camberwarra Crescent (west loop) is in a state of poor repair and should be replaced as part of the Lot 500 & 501 development works.

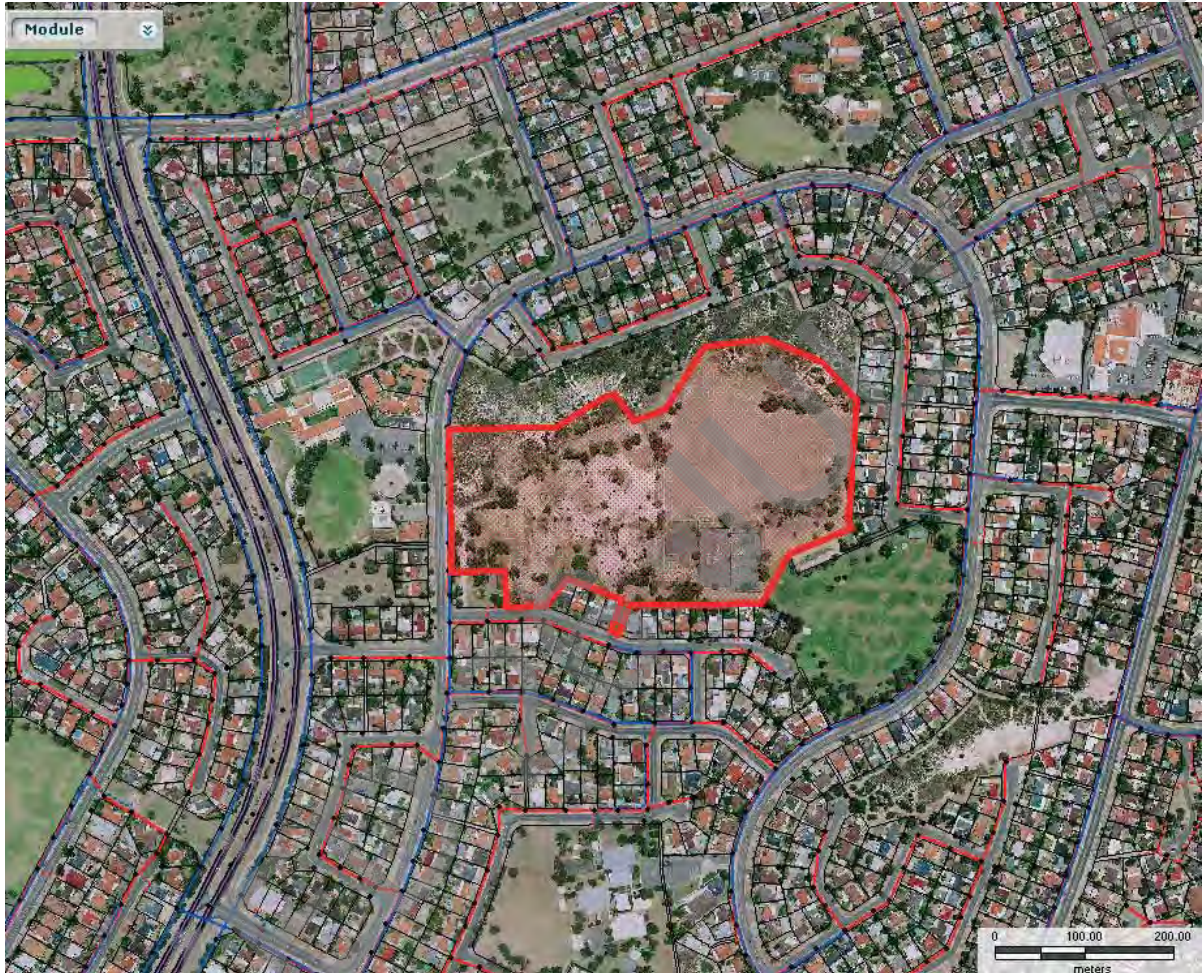
Western Power has been requested to conduct a feasibility study to connect 130 residential lots at Lot 501 Camberwarra Dr, Craigie High School Development. It is assumed that the start of construction for this project is December 2009.

*Figure 1: Photo Overview of Lot Location*
