# **Craigie High School Site Local Structure Plan**

## **STRUCTURE PLAN NO. 13**

This Structure Plan is prepared under the provisions of Part 9 of the City of Joondalup District  
Planning Scheme No. 2.

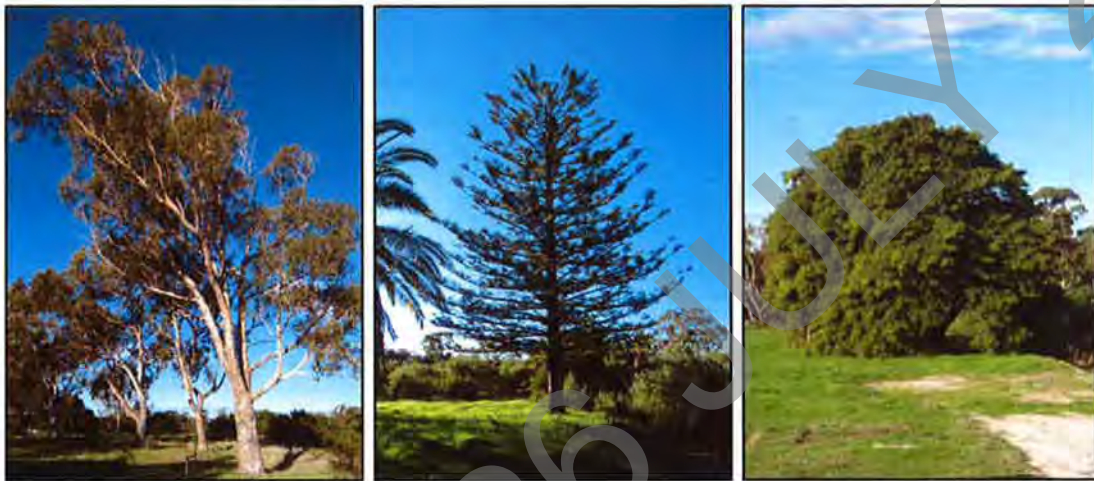
A few very good mature specimens were noted, including a number of *Ficus* specimens, Tuart, Norfolk Island Pine, and River Red Gum.

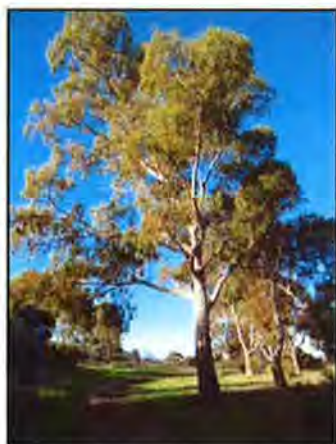
As with any large tree population the trees on Site showed varying degrees of health and vitality in their canopy mass; examples of which can be seen in the images below taken on Site.

*Tree showing to be in good health*

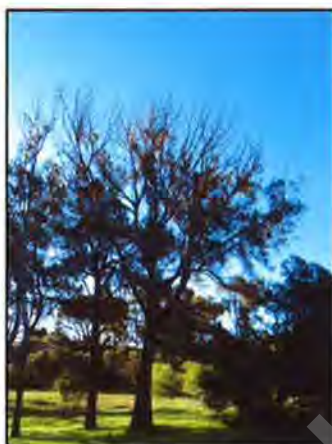
*Tree showing to be declining in health*

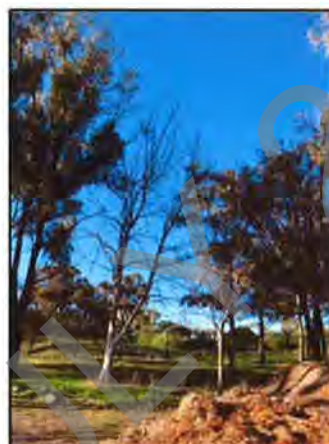
*Dead Tree*

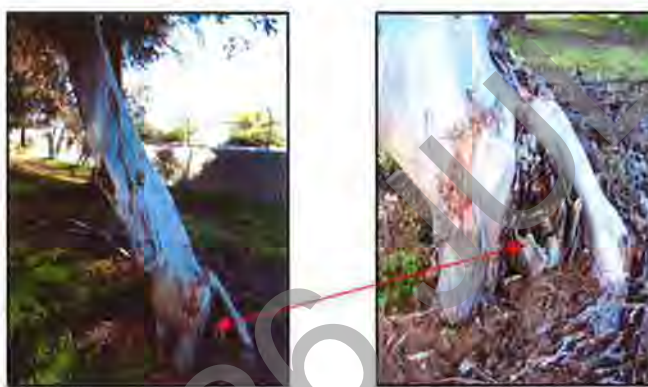
*Tree 120; Coastal Moort (Eucalyptus platypus var heterophylla)*

A number however showed to have poor (or even hazardous) structural forms with a history of major stem failures, basal cavities and/or decay in their main stems, or presence of poor unions within their stem structures. A few also showed some evidence of termite activity within their main stem structure.

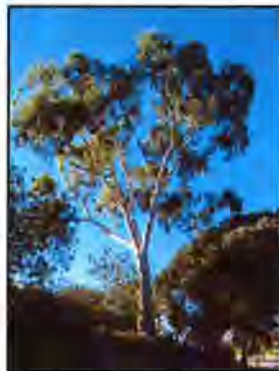
Northern River Red Gum  
(*Eucalyptus camaldulensis* 'Obtusa')

There are however a number of species found on this Site that would not be considered suitable for inclusion into an urban development; primarily due to the species having a propensity for unpredictable stem failure, or known to cause issues with high volumes of leaf, bark and nut litter.

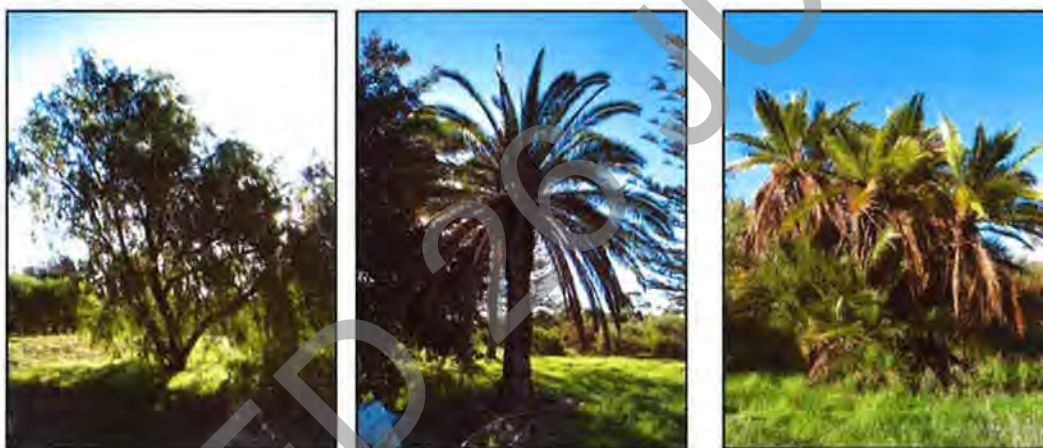
A number of the trees on the Site were noted to be of a size and species that would be suitable for transplanting if time frames and any budget constraints allow.

This included 21 semi-mature West Australian Peppermint (example seen in the image below left), and the two Palm specimens (seen in the images below right and centre).

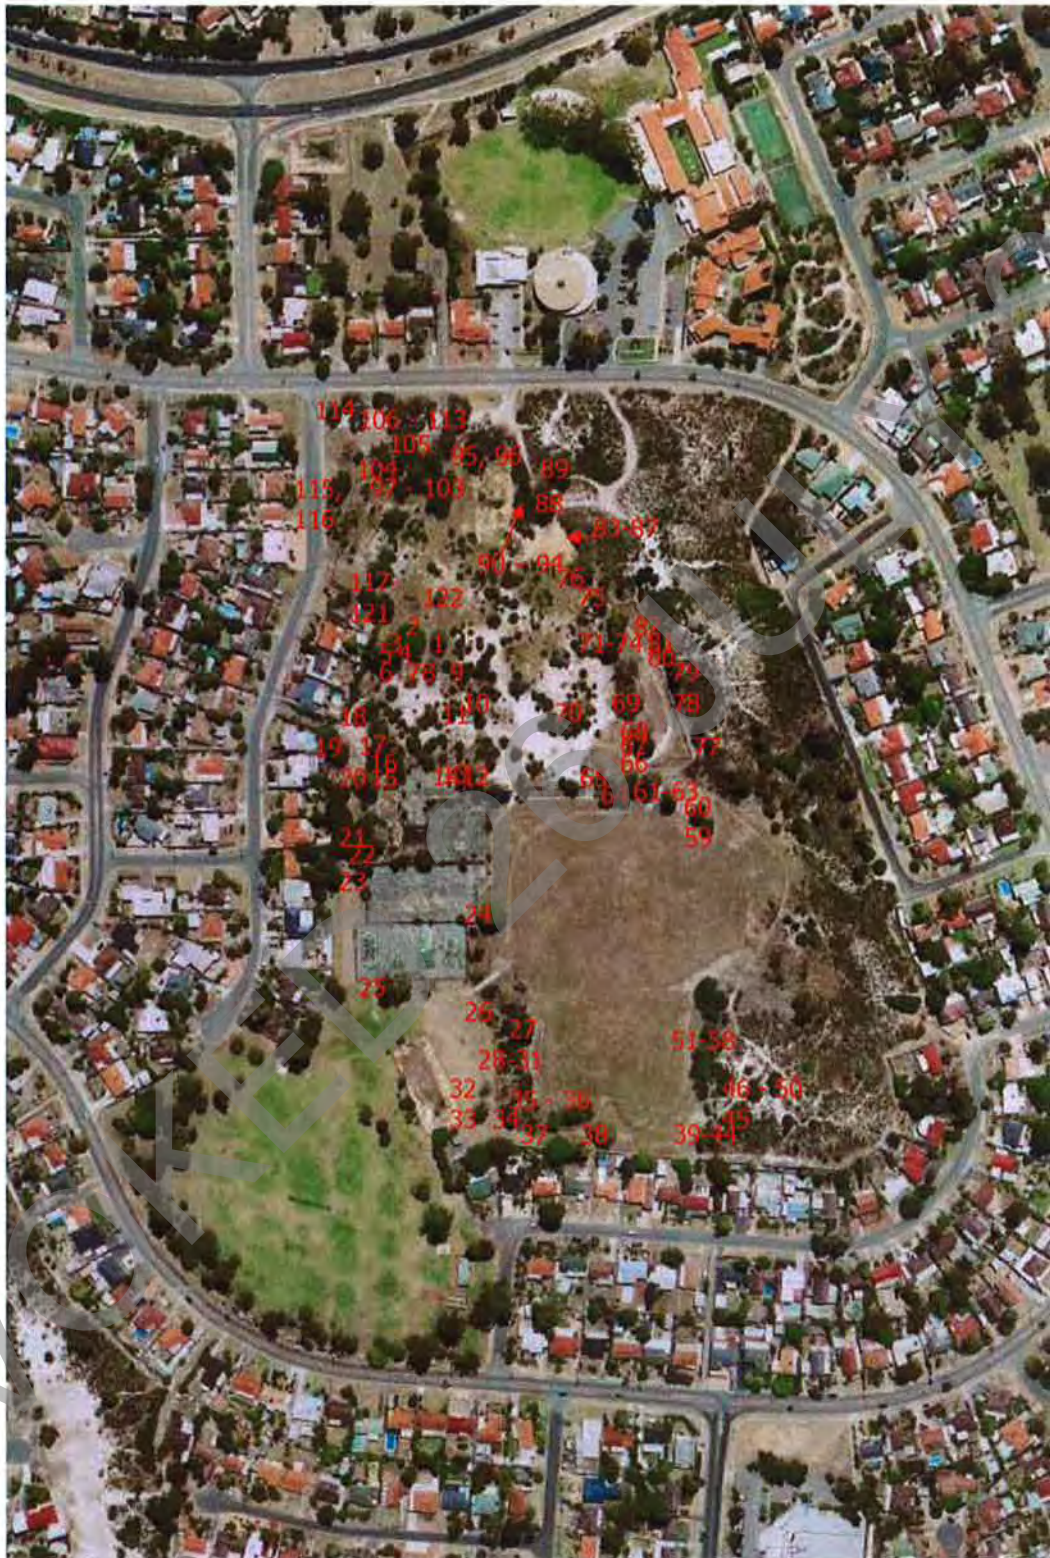
**Tree Location Guide**

Please note the above is a guide to the location of the trees only; they have not been surveyed or marked using GPS equipment.
