R733 Rev 1

May 2016

City of Joondalup

**Joondalup Coastal Monitoring
Baseline Monitoring Report**

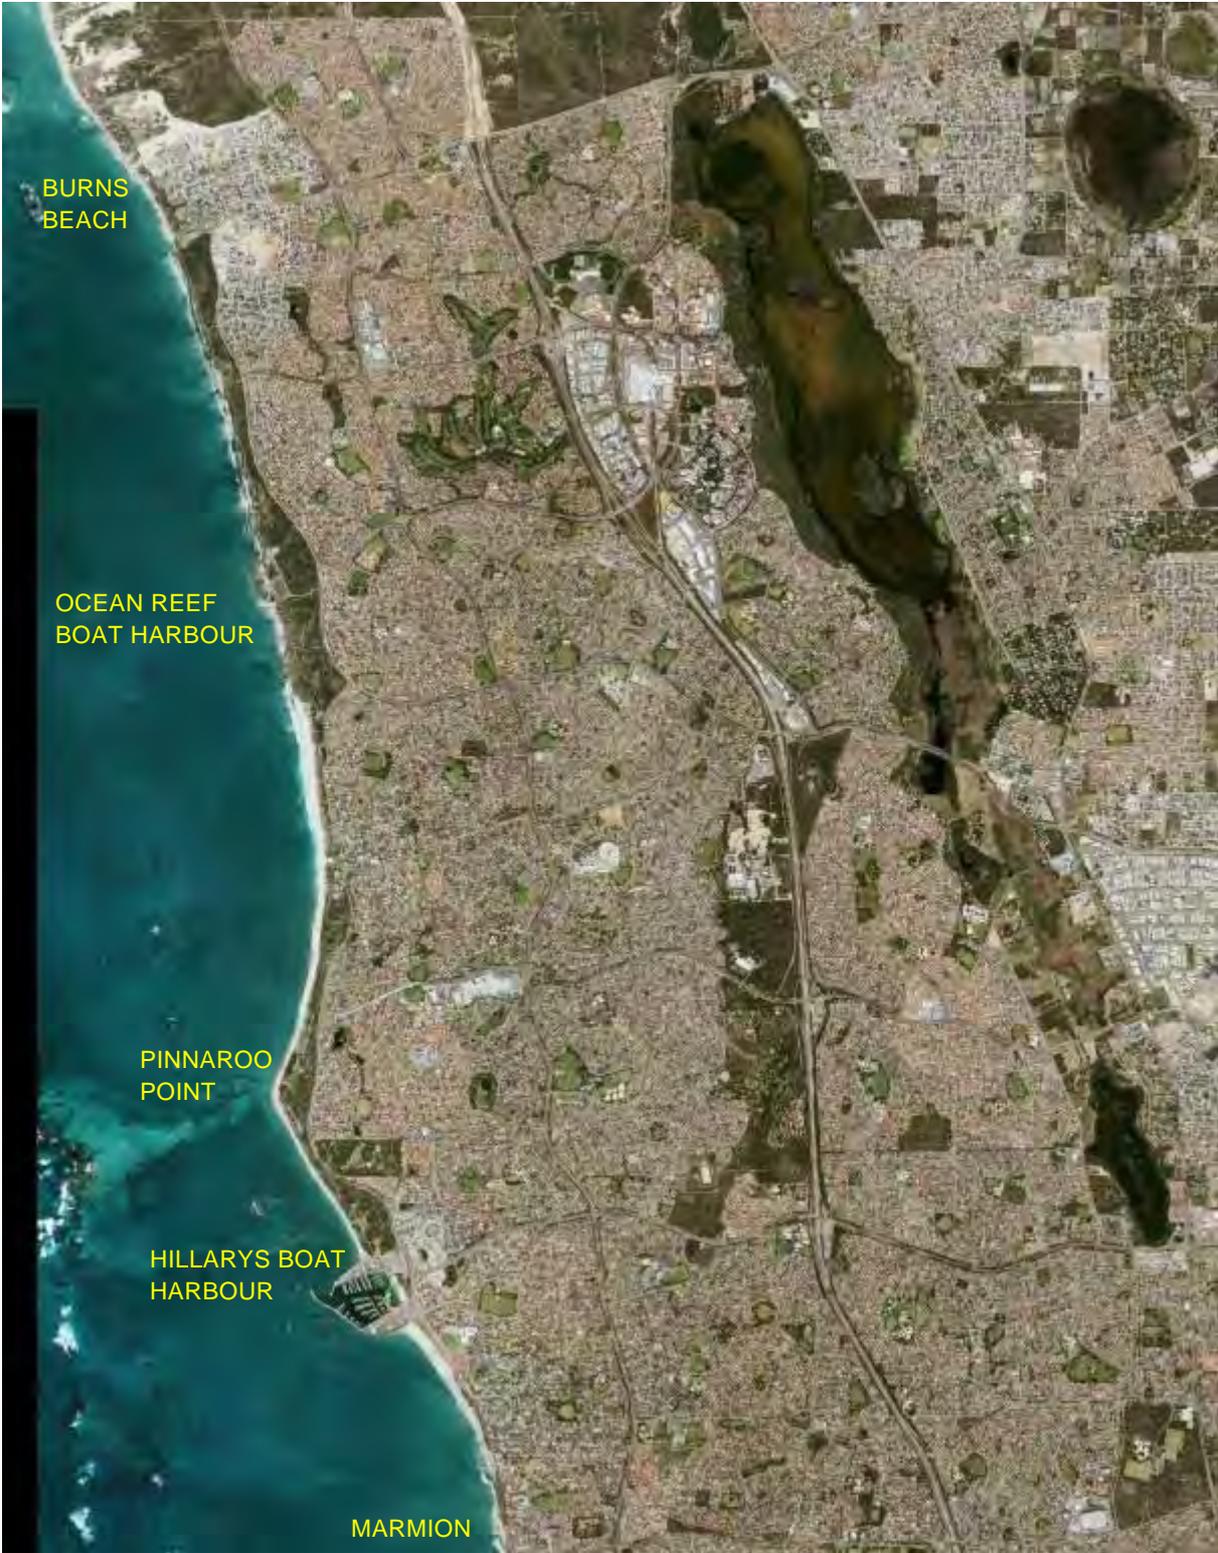
Figure 1.1 Joondalup Monitoring Study Area

The City of Joondalup (City) has established a coastal monitoring program for the shoreline within its boundaries. The City's shoreline extends from Marmion in the south, to Burns Beach in the north (Figure 1.1).

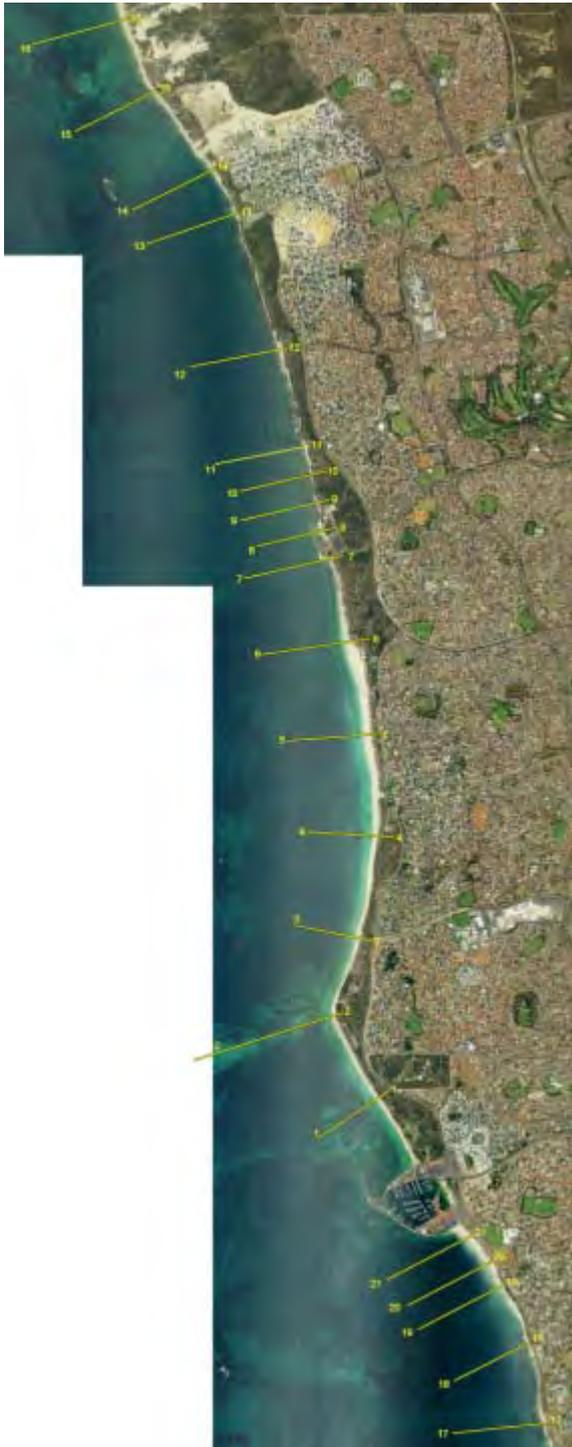
Figure 3.1 Location of Beach Monitoring Surveys

The beach monitoring program consists of 21 profiles across the full extent of the City's coastline, approximately 15 km. The location of the beach monitoring profiles are shown in Figure 3.1.

The locations of the profiles are shown along with the beach profiles on the survey plans in Appendix B.

Profiles 1 to 10 have previously been surveyed for works on the proposed Ocean Reef Marina development. These profiles were therefore retained in the same locations to allow comparison with the existing surveys from 2010 and 2013.

The 11 new beach surveys were located to represent the relevant shoreline sectors around them. They were generally located some distance from coastal structures to minimise the seasonal influences of structures on the results.

All of the surveyed profiles extend from behind the coastal dune to approximately 1 km offshore. This is important to capture the extent of sediment movement and accurately assess the shoreline changes and coastal processes.

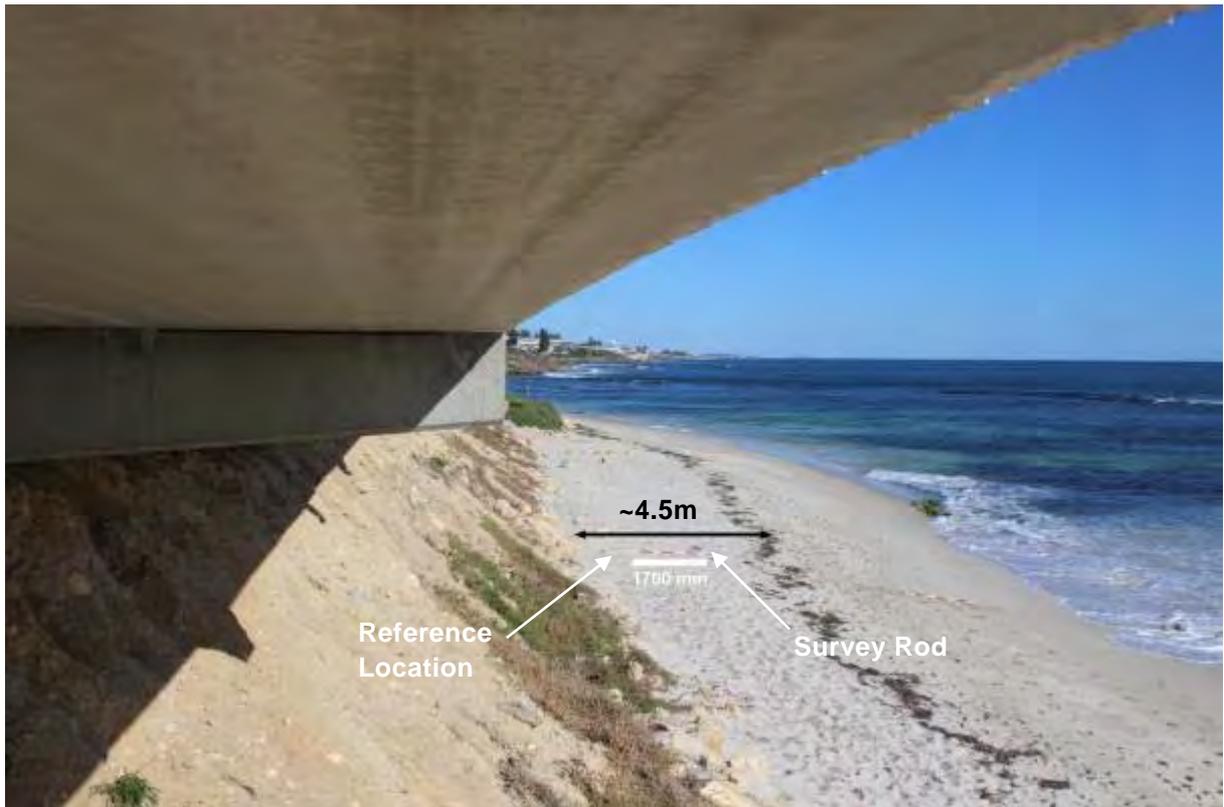
Figure 6.2 Spatially Calibrated Photo (21 April 2016)

Through the use of spatial calibration, the time lapsed photos can be used to estimate the seasonal movement and storm erosion in this section of shoreline. To spatially calibrate a photo, ImageJ (a Java based image processing programme) was used to scale the image pixel against a known distance (a 1,700 mm survey staff placed on the beach) on the image. The location of the known distance on the image is referred to as the reference location. As the field of view is consistent over time, once the calibration is completed, photography taken at different times can be imported into ImageJ for direct comparison. Spatially calibrated photos are presented below in Figures 6.2 and 6.3.

From Figures 6.2 and 6.3, it is noted that there is negligible change to the width of the beach berm since the installation of the camera in February 2016. The beach berm width at the reference location as measured by Image J is in the order of about 4.5 m. Using this methodology, future monitoring analysis and reports will be able to estimate the beach movement at the reference location. It is noted that distance estimated is most accurate near the reference location, where it is calibrated. Distances estimated at other locations will be affected by distortion as a result of the depth of field.

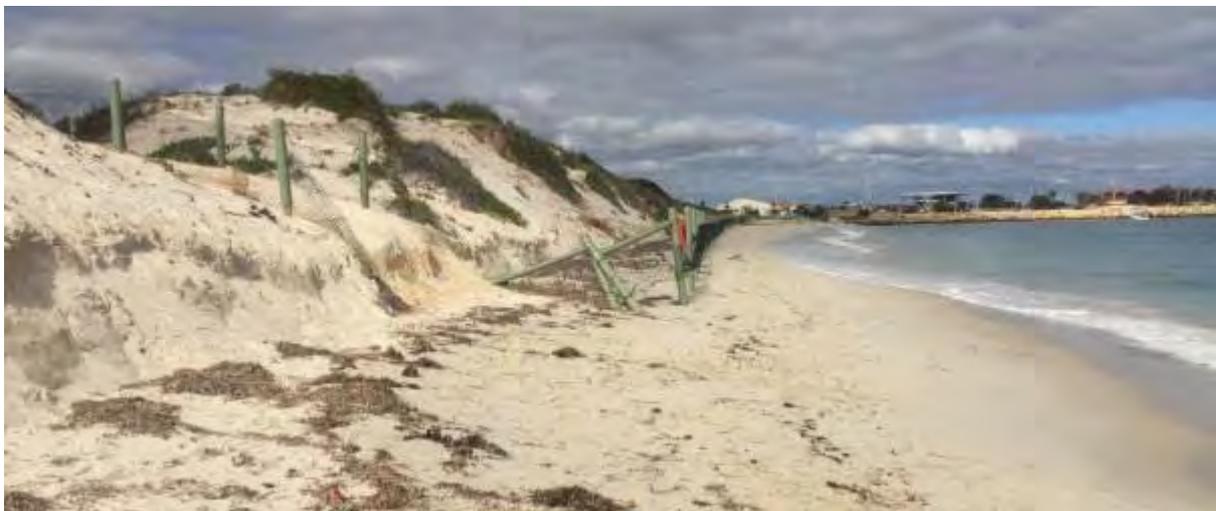
Figure 7.2 Eroded Dune & Damaged Fencing at Whitfords Nodes (May 2016)

It is also noted that there is a considerable accretion trend south of Hillarys Boat Harbour and erosion trend to the north. While the accretion on Sorrento Beach to the south has been occurring since construction, the erosion of the shoreline to the north of the harbour has not previously been a concern. However the beach widths in the area are now decreasing, the dune is eroding and the shoreline retreating. Figure 7.2 shows a recent photograph of storm damage, narrow beach and loss of dune fencing in the area.

The construction of Hillarys Boat Harbour has obviously interrupted the longshore sediment transport in the area and altered the coastal dynamics. Should this erosion trend continue north of the Harbour, the City may wish to consider movement of sediment from south to north of the Harbour.
