Aerial Photo Date : 23th April 2016

Coastal Hazard Assessment Map 2

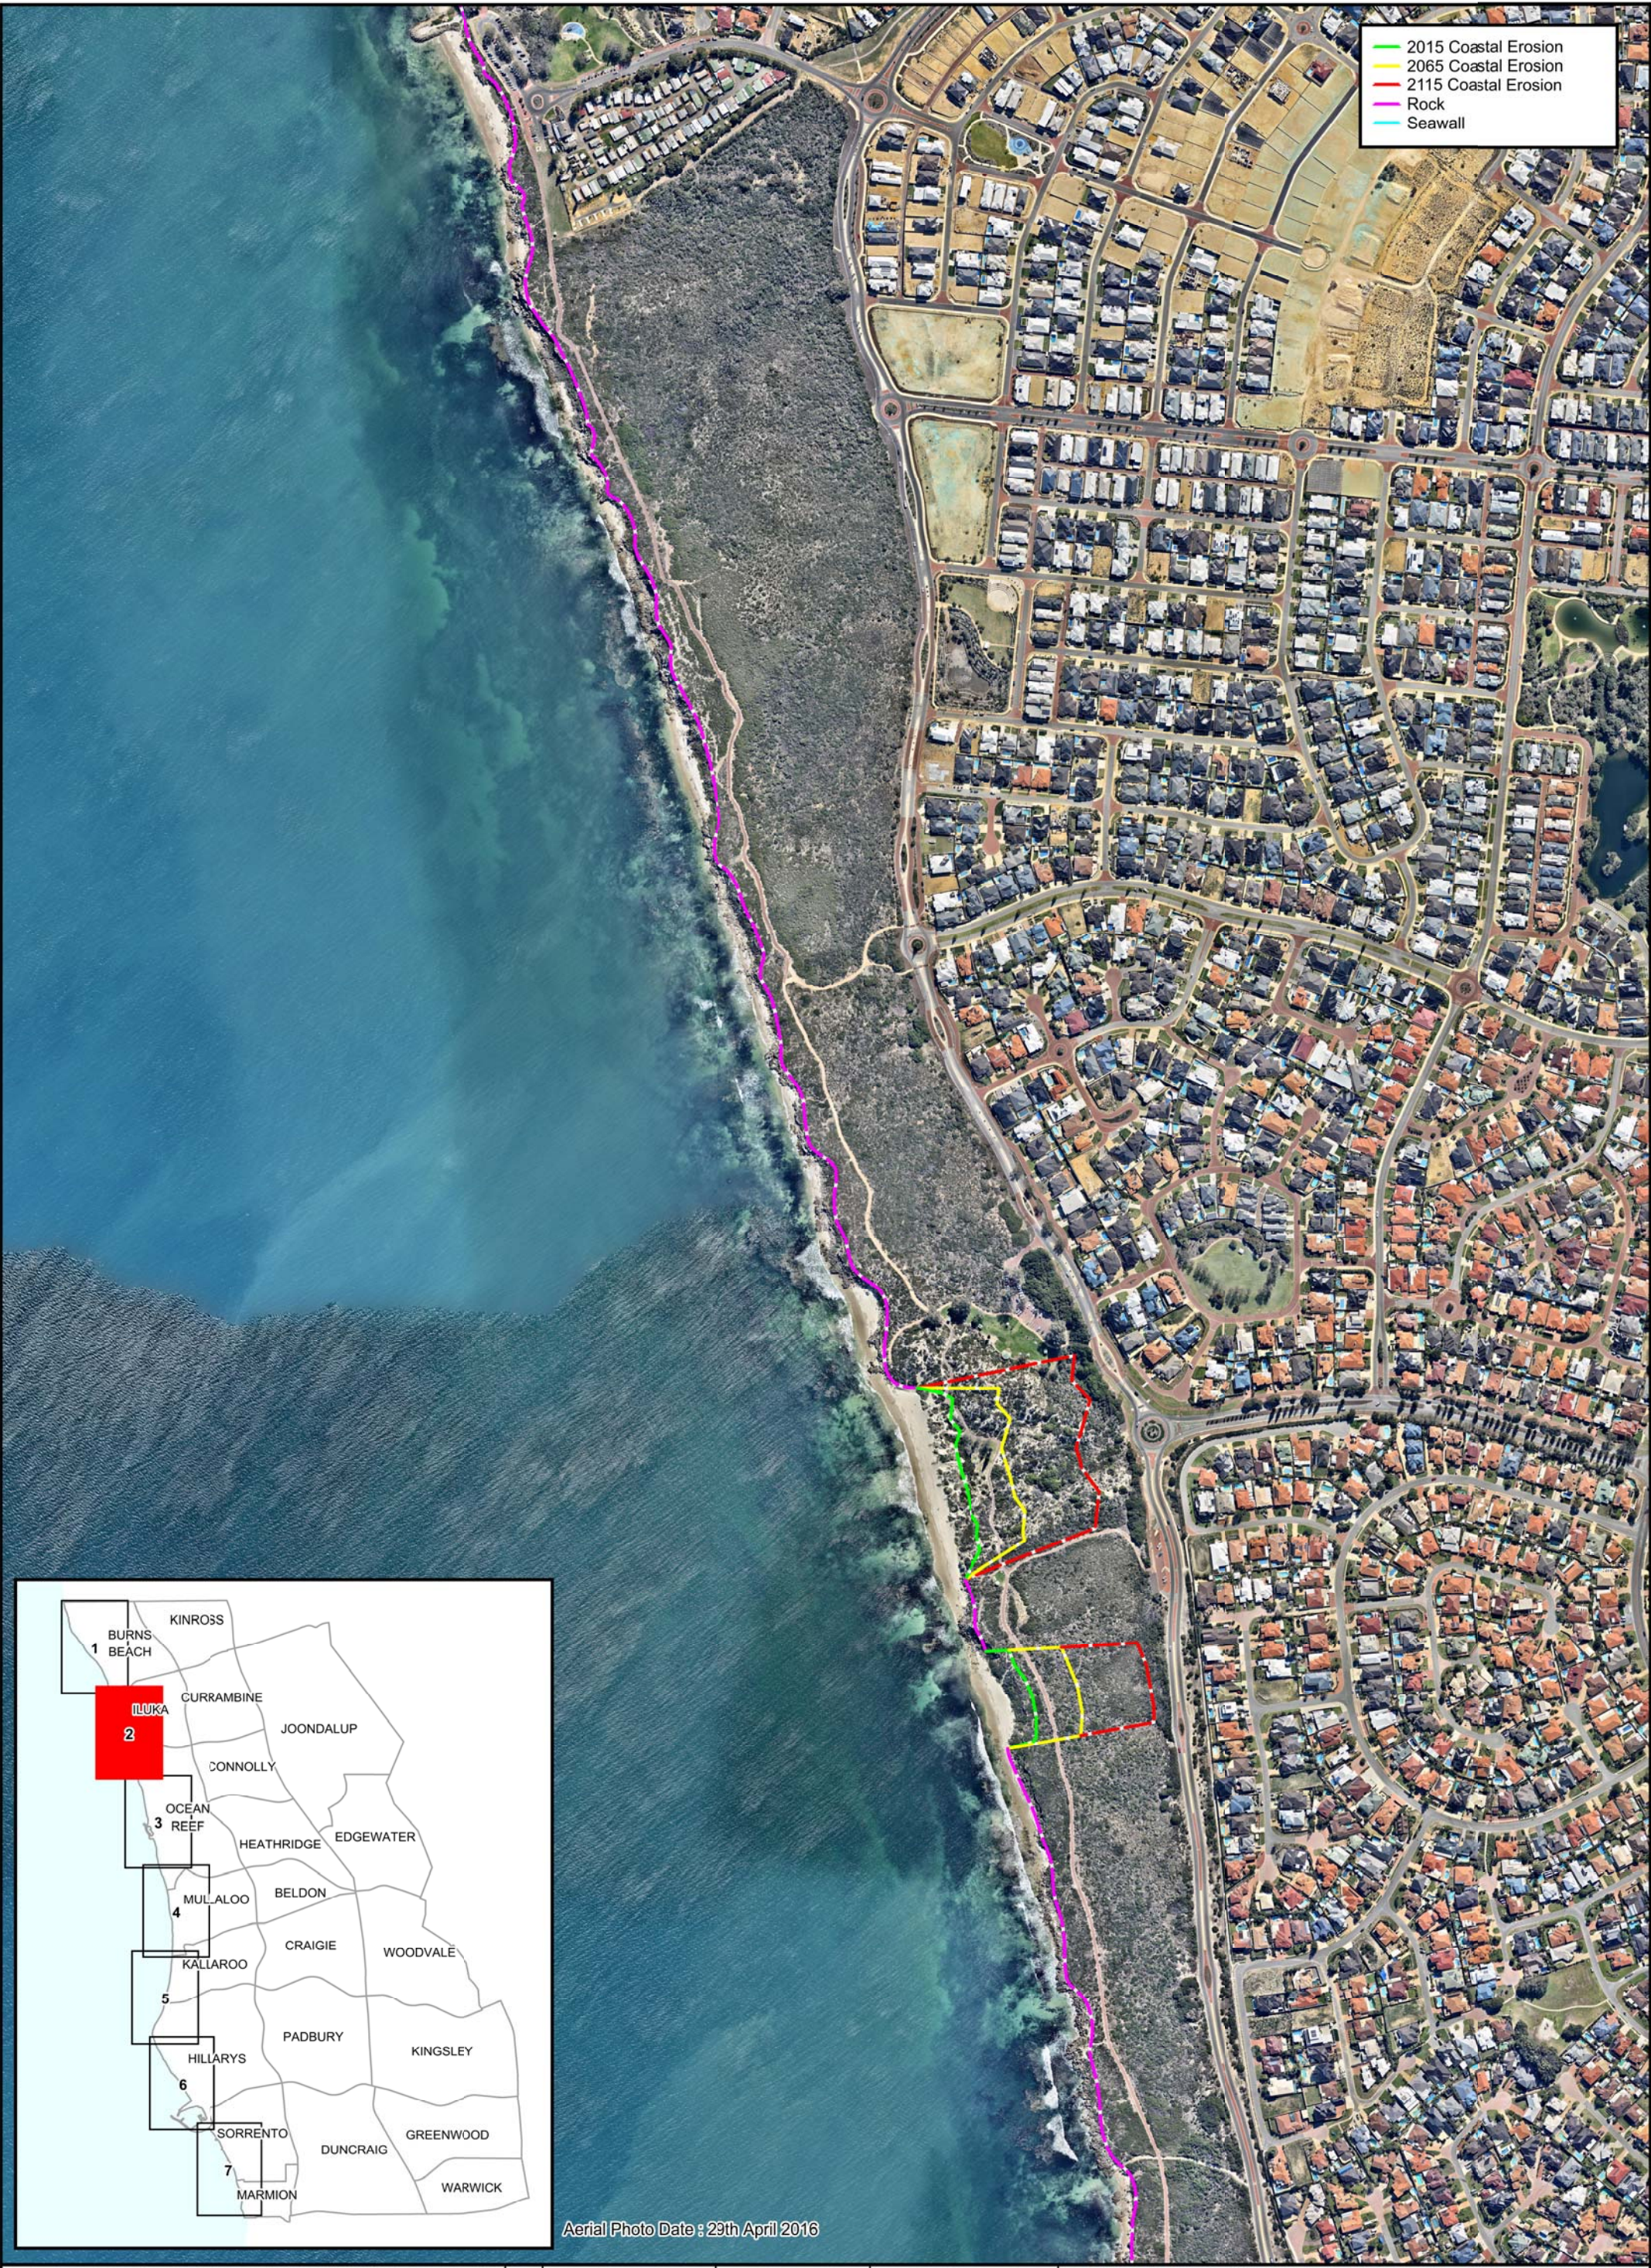
- 2015 Coastal Erosion
- 2065 Coastal Erosion
- 2115 Coastal Erosion
- Rock
- Seawall
