**R1003 Rev 3**

**City of Joondalup**

**Joondalup Coastal Monitoring  
2017/18 Data Report**

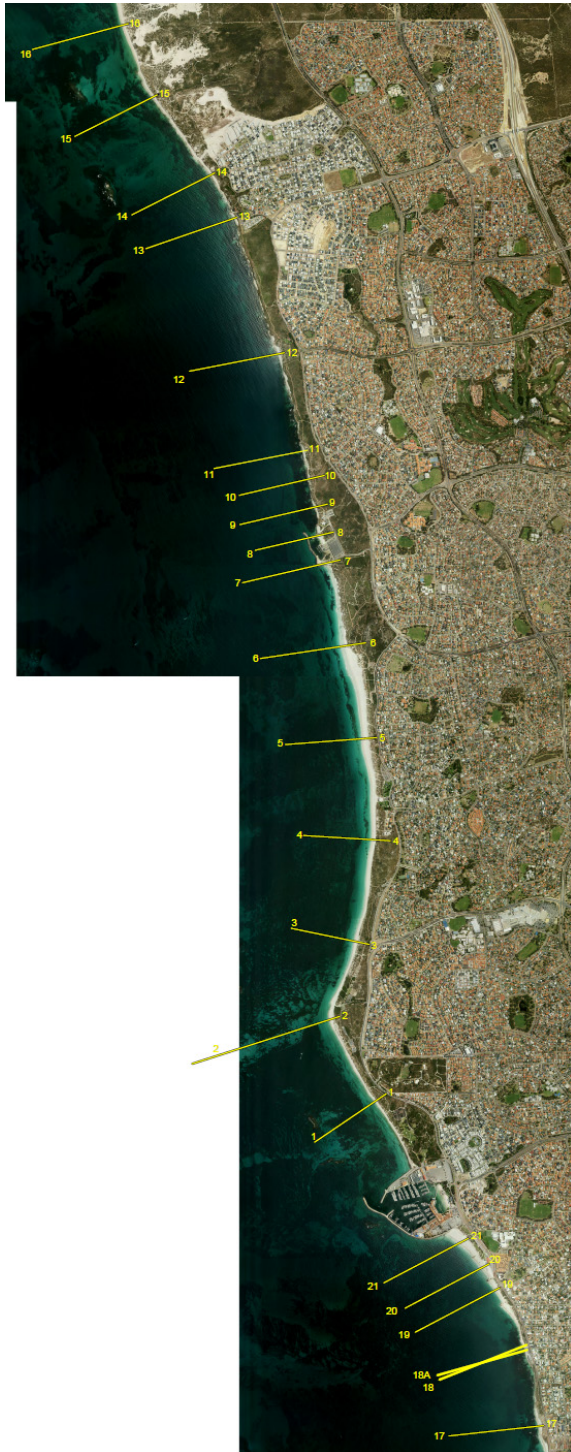
**Figure 3.1 Location of Beach Monitoring Surveys**

The beach monitoring program consists of 22 profiles across the full extent of the City's coastline, approximately 15 km. The location of the profiles are shown in Figure 3.1.

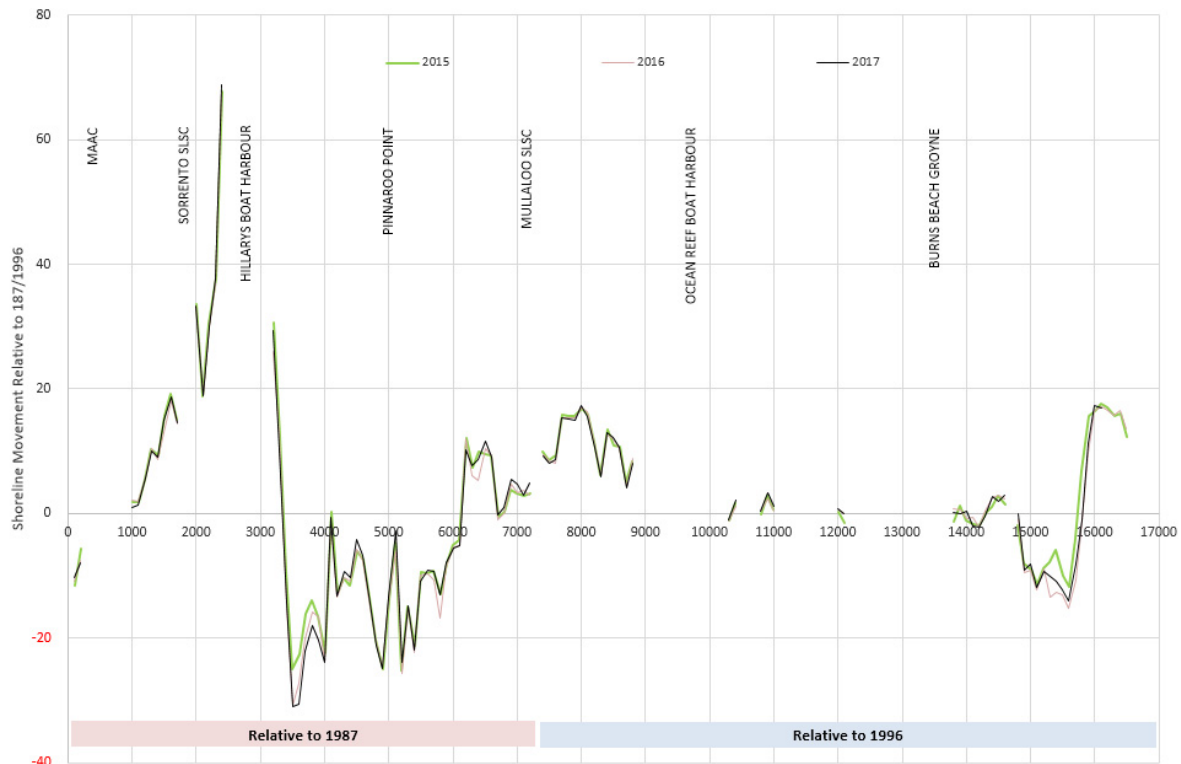
**Figure 6.1 Shoreline Movement 2015 - 2017**

The shoreline movement trend for three areas which were previously identified as having experienced erosion (Whitfords Nodes, Pinnaroo Point and Burns Beach) have also been assessed with the updated shoreline movement data. The findings are summarised below.

- The shoreline along Whitfords Nodes, north of Hillarys Boat Harbour, experienced some additional recession up to 3 m in the last year. This continued an erosion trend that was identified in the previous monitoring reports.
- There was continued accretion at Sorrento Beach, of about 1 m from 2015.
- The shoreline near Pinnaroo Point and along Burns Beach has generally accreted over the past year, halting or reversing the erosion trend identified in the previous monitoring report.

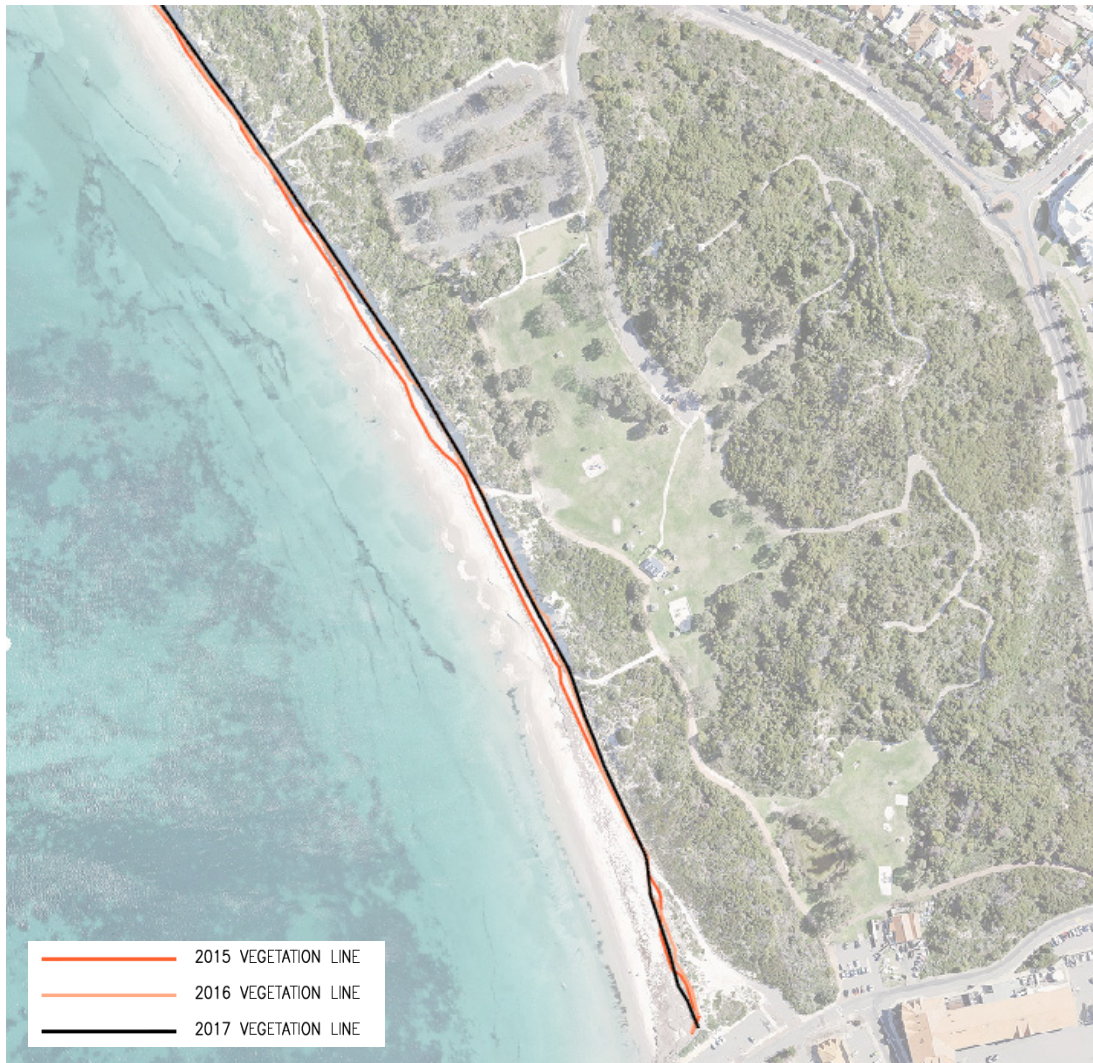
**Figure 6.2 Shoreline Movement at Whitfords Nodes**

The erosion of the shoreline to the immediate north of Hillarys Boat Harbour has continued from 2016 (refer to Figure 6.1). This was identified in MRA (2017) and the latest monitoring data indicate that the dune is continuing to erode, although at a slower rate. The shoreline in this area has experienced an erosion of up to 3 m over the last year, and a net erosion of up to 8 m between 2015 and 2017.

The construction of Hillarys Boat Harbour has interrupted the longshore sediment transport in this area and altered the coastal dynamics, trapping sediment south of the Hillarys Boat Harbour at the Sorrento Beach and cut off sediment supply to the shoreline north of the boat harbour. Without intervention this erosion trend is likely to continue. Based on historical shoreline movement, it is estimated that the long term erosion rate for this area may be up to 1 m/year. The accretion trend at Sorrento Beach is also likely to continue as sediment accumulates at the southern side of the boat harbour.

As this area has been highlighted in several consecutive monitoring reports and the trend appears to be established, MRA recommend the City should consider bypassing the accumulated sediment from the southern side to the northern side of the Harbour.

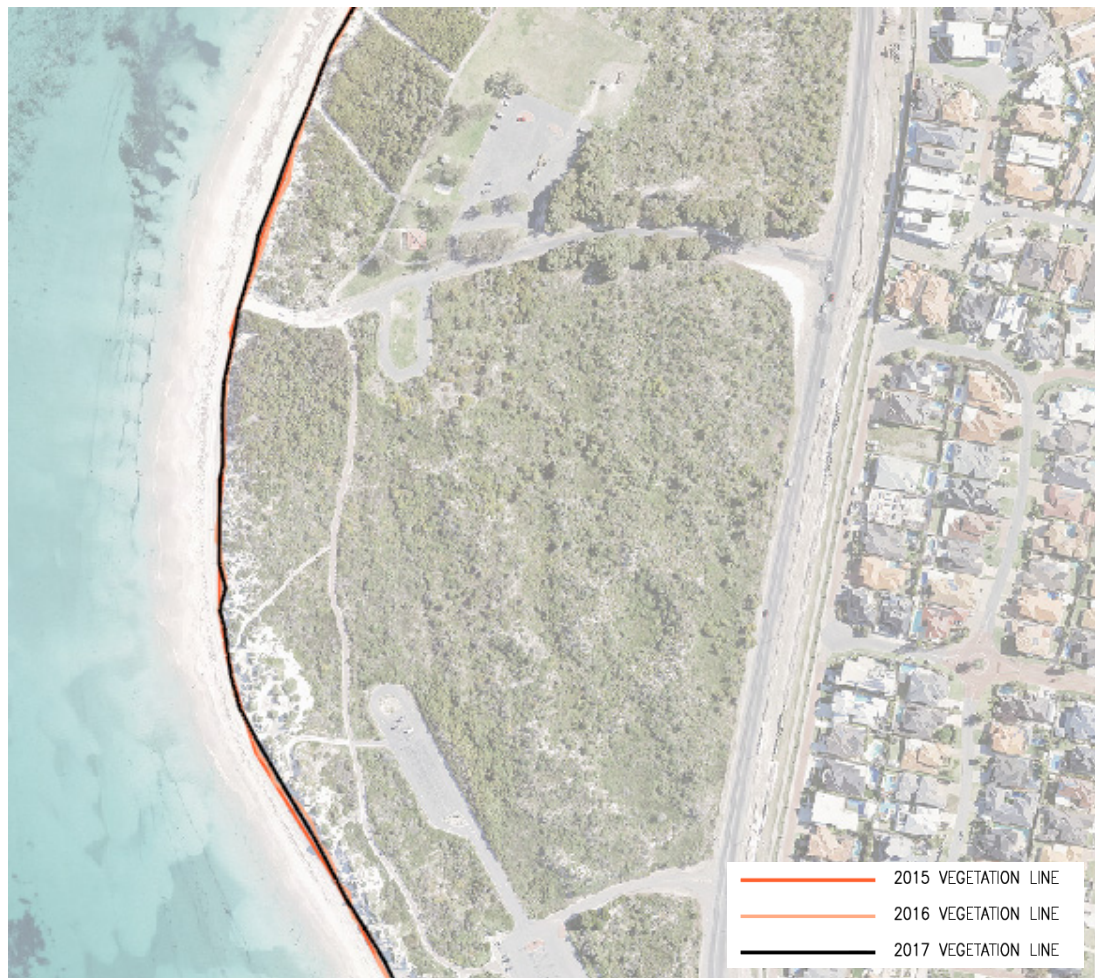
**Figure 6.3 Shoreline Movement at Pinnaroo Point**

The shoreline at this location experienced noticeable erosion between 2015 and 2016, particularly on the southern side of the point where the vegetation line has receded up to 5 m. The updated shoreline mapping indicates that there has been some noticeable accretion in this area from 2016 to 2017, particularly on the northern side of the point, where the vegetation line has accreted up to 5 m. The net movement of the vegetation line between 2015 and 2017 at Pinnaroo Point is a minor accretion of up to 2 m. This appears to be a halt to the erosion trend that has been identified in MRA (2017). The shoreline movement in this area should continue to be monitored, as the buffer may quickly reduce with further erosion. The shoreline movement between 2015 and 2017 in this area is presented in Figure 6.3.

This profile should continue to be monitored at this stage. MRA recommends that coastal management in the form of sand bypassing is considered past Hillarys Boat Harbour. If completed, this would assist in addressing the erosion observed at Pinnaroo Point.

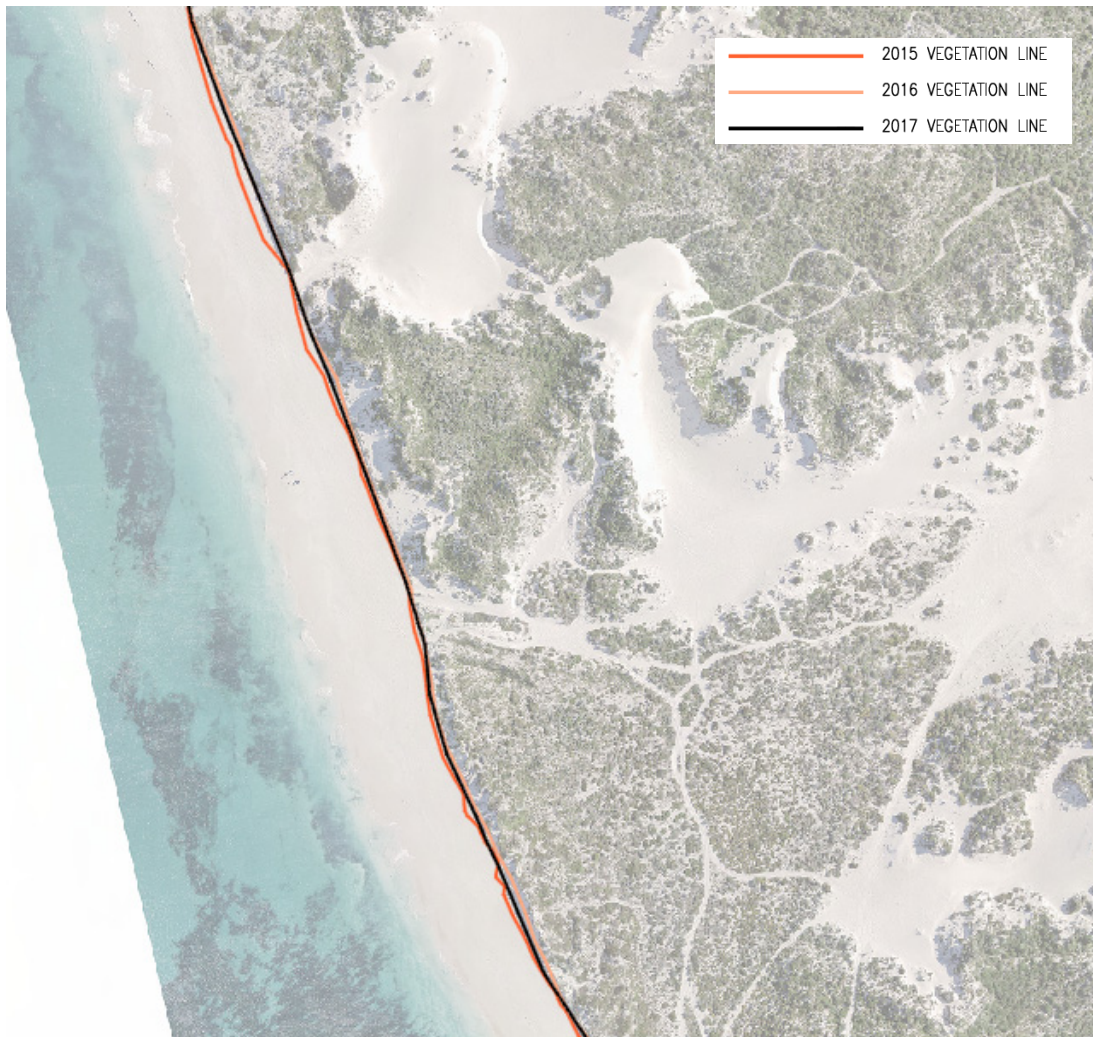
Figure 6.4 Shoreline Movement at Burns Beach

The shoreline in this area has generally experienced minor accretion of up to 5 m in the past year. This is a halt of the erosion trend noted in MRA (2017), which indicated an erosion of up to 10 m in this area between 2015 and 2016. The net movement of the vegetation line between 2015 and 2017 indicate an erosion of up to 8 m. Given the proposed subdivisions and foreshore development in this area, it is recommended that the shoreline in this area should continue to be monitored. The shoreline movement between 2015 and 2017 in this area is presented in Figure 6.4.

Sections of shoreline at Burns Beach had previously experienced erosion, as identified in MRA (2017). The 2017/18 monitoring data has shown that the erosion in these areas appeared to have slowed down or reversed to minor accretion. Therefore, no coastal management for this area is recommended at this stage.

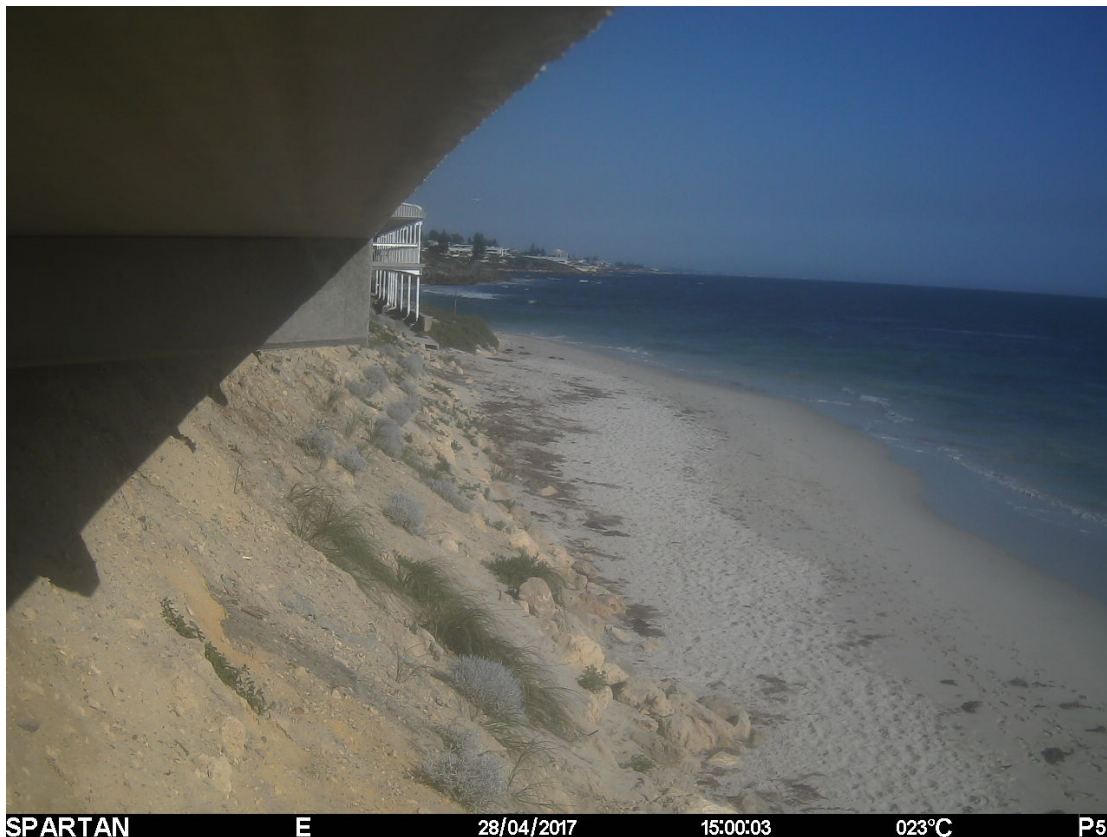
**Figure 7.2 April 2017**

Overall, the photographs indicate that there are some seasonal fluctuations such that the beach level and width varies over time. However there does not appear to be any significant changes to the shoreline position between April 2017 and March 2018.

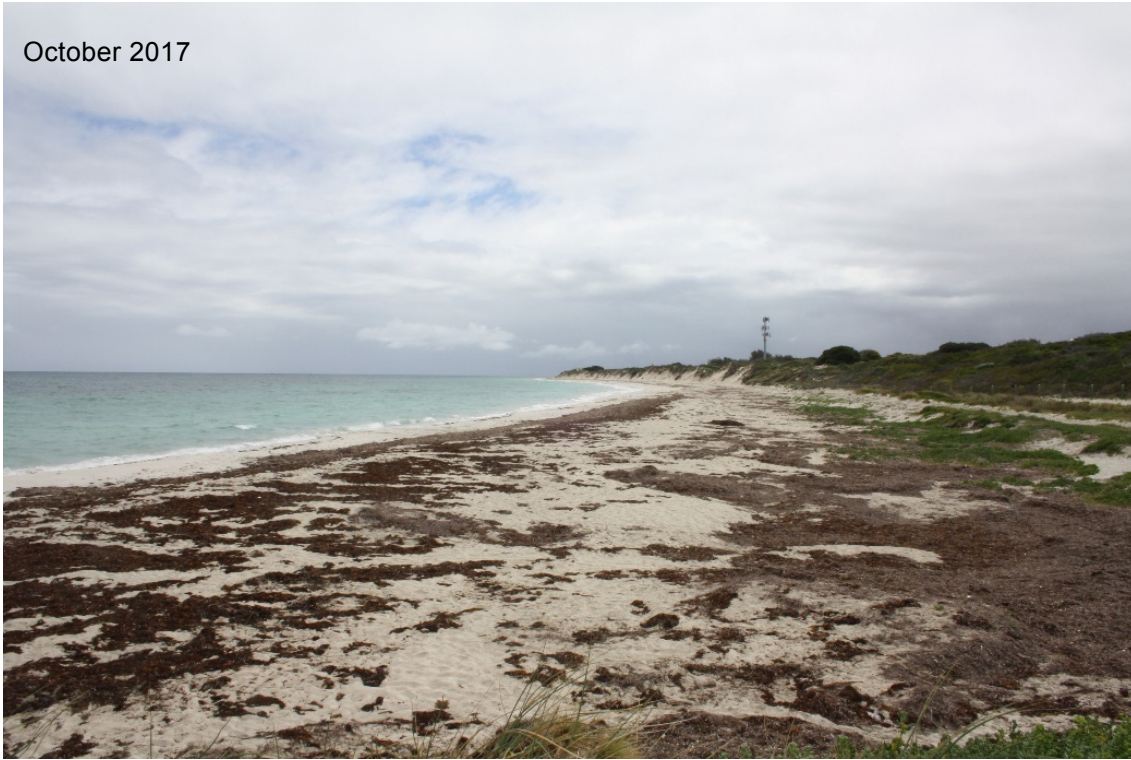
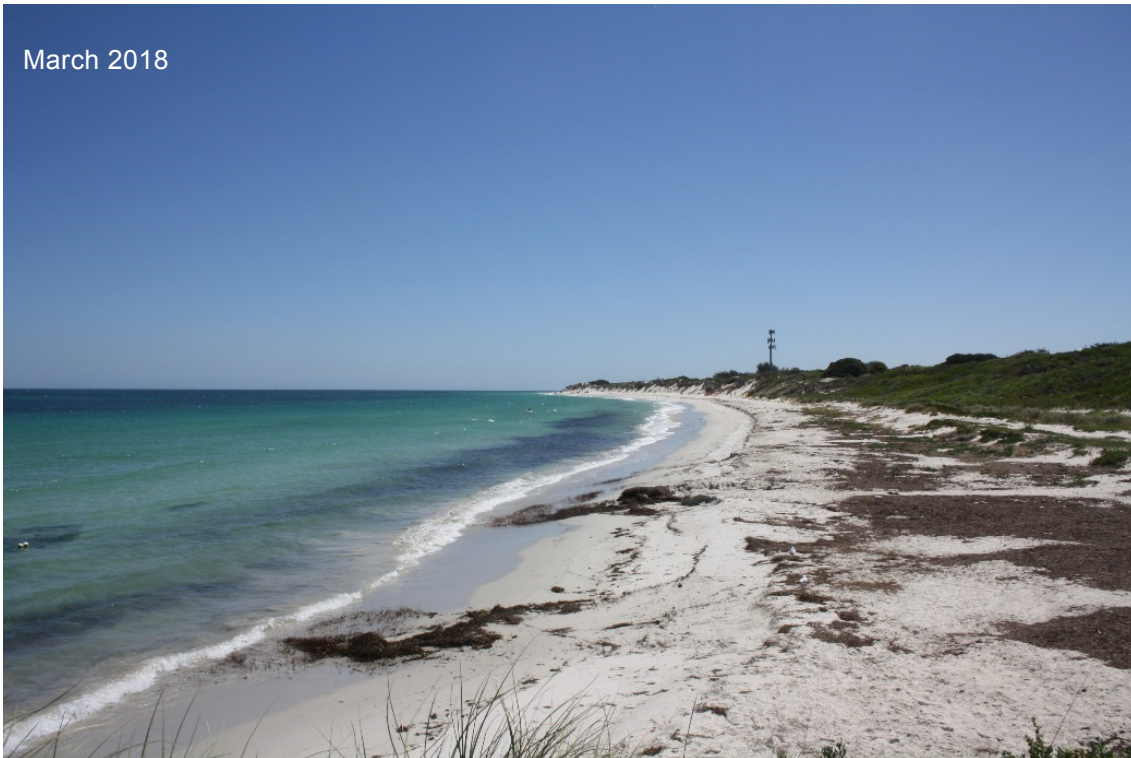
**Figure 8.1 Monitoring Photographs North of Hillarys Boat Harbour**

The photographs collected from the 21 photographic monitoring locations were inspected and compared to the photographs from previous monitoring periods. These show seasonal and inter-annual changes to the beach at a number of locations, however no noticeable ongoing change. Figure 8.1 presents seasonal changes between October 2017 and March 2018 at Location 8, immediately north of Hillarys Boat Harbour.

There were no significant areas of change identified from the monitoring photographs. They will continue to be inspected for trends in movement and changes in key areas.
