R1319 Rev 2

June 2020

City of Joondalup

**Joondalup Coastal Monitoring
2019/2020 Data Report**

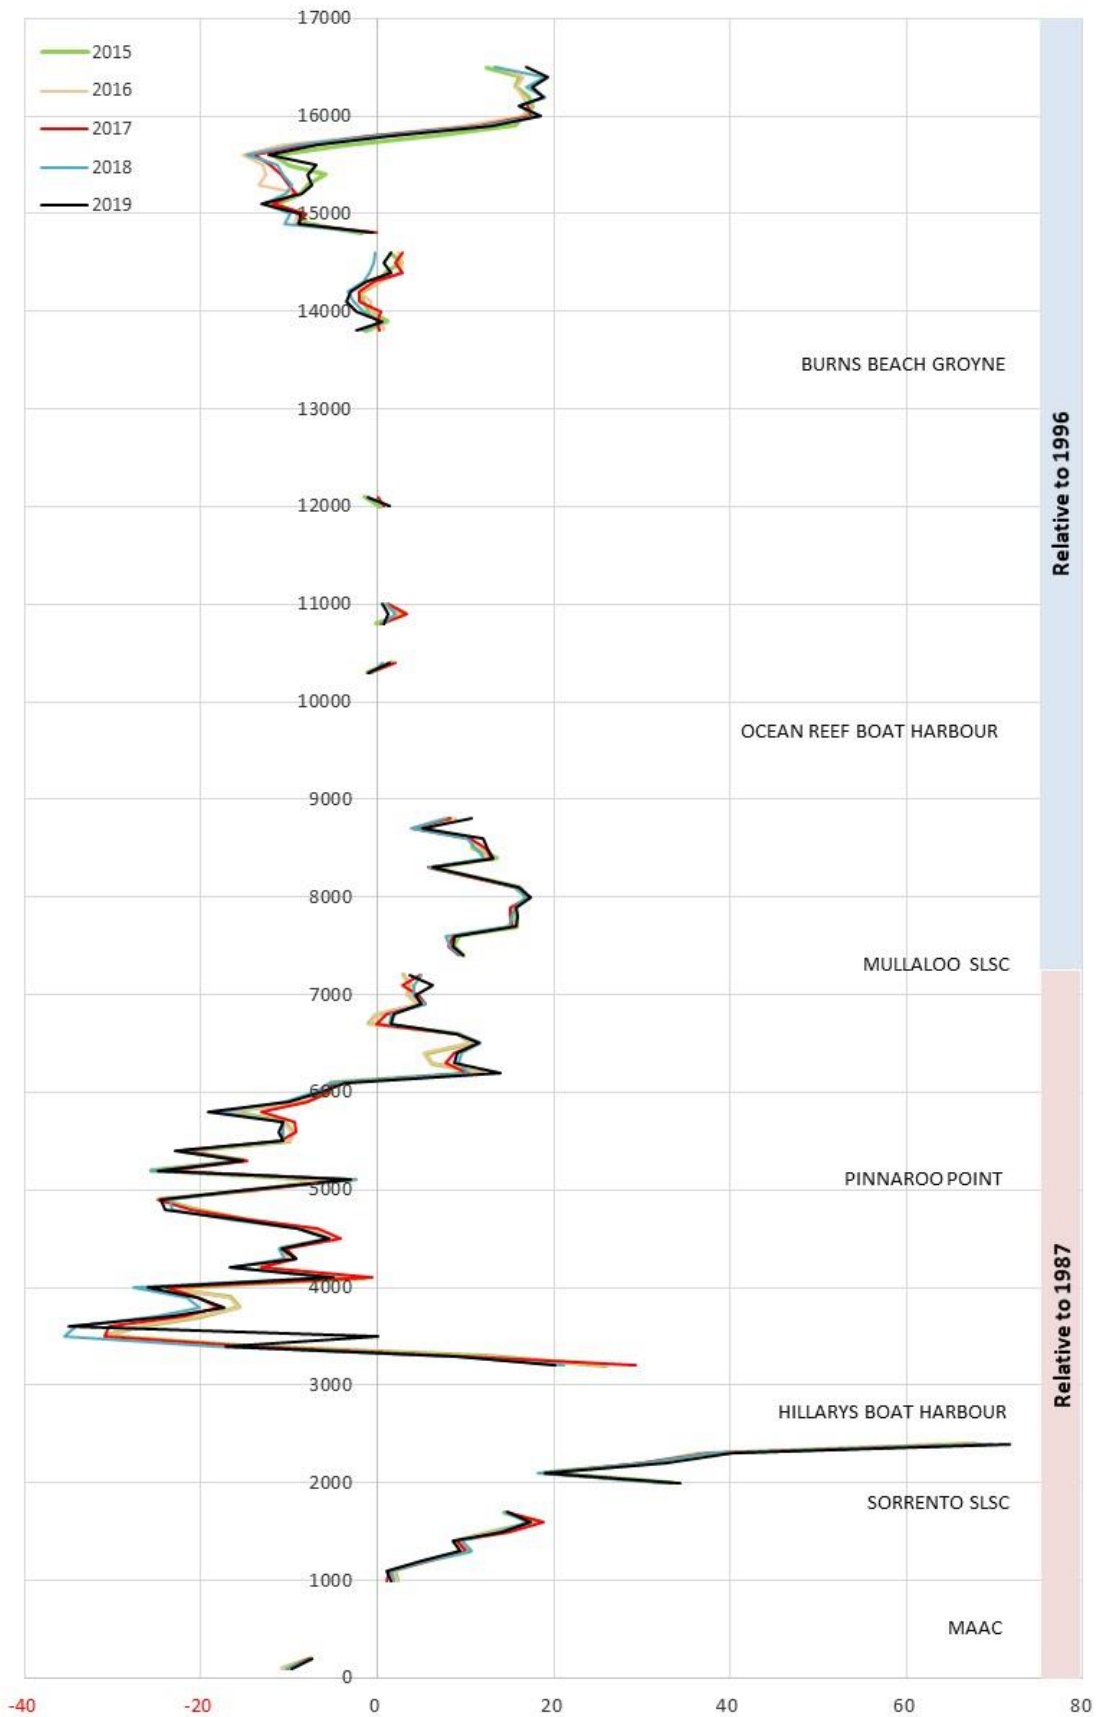
Figure 3.2 Shoreline Movement to 2019

- There were generally only minor (<2 m of recession and up to 4 m of accretion) changes to the shoreline position between August 2018 and August 2019.
- The overall change to shoreline position between 2015 and 2019 is generally less than 5 m. The only exceptions are the following previously identified sites:
 - Whitfords Nodes.
 - Pinnaroo Point.
 - The northern end of Burns Beach.

The first available vegetation lines after these developments (1987 and 1996) are therefore used as the baseline for analysis in Figure 3.2. This has been discussed in detail in previous monitoring reports and assessments for the City (MRA 2016, MRA 2017, MRA 2018b and MRA 2019)).

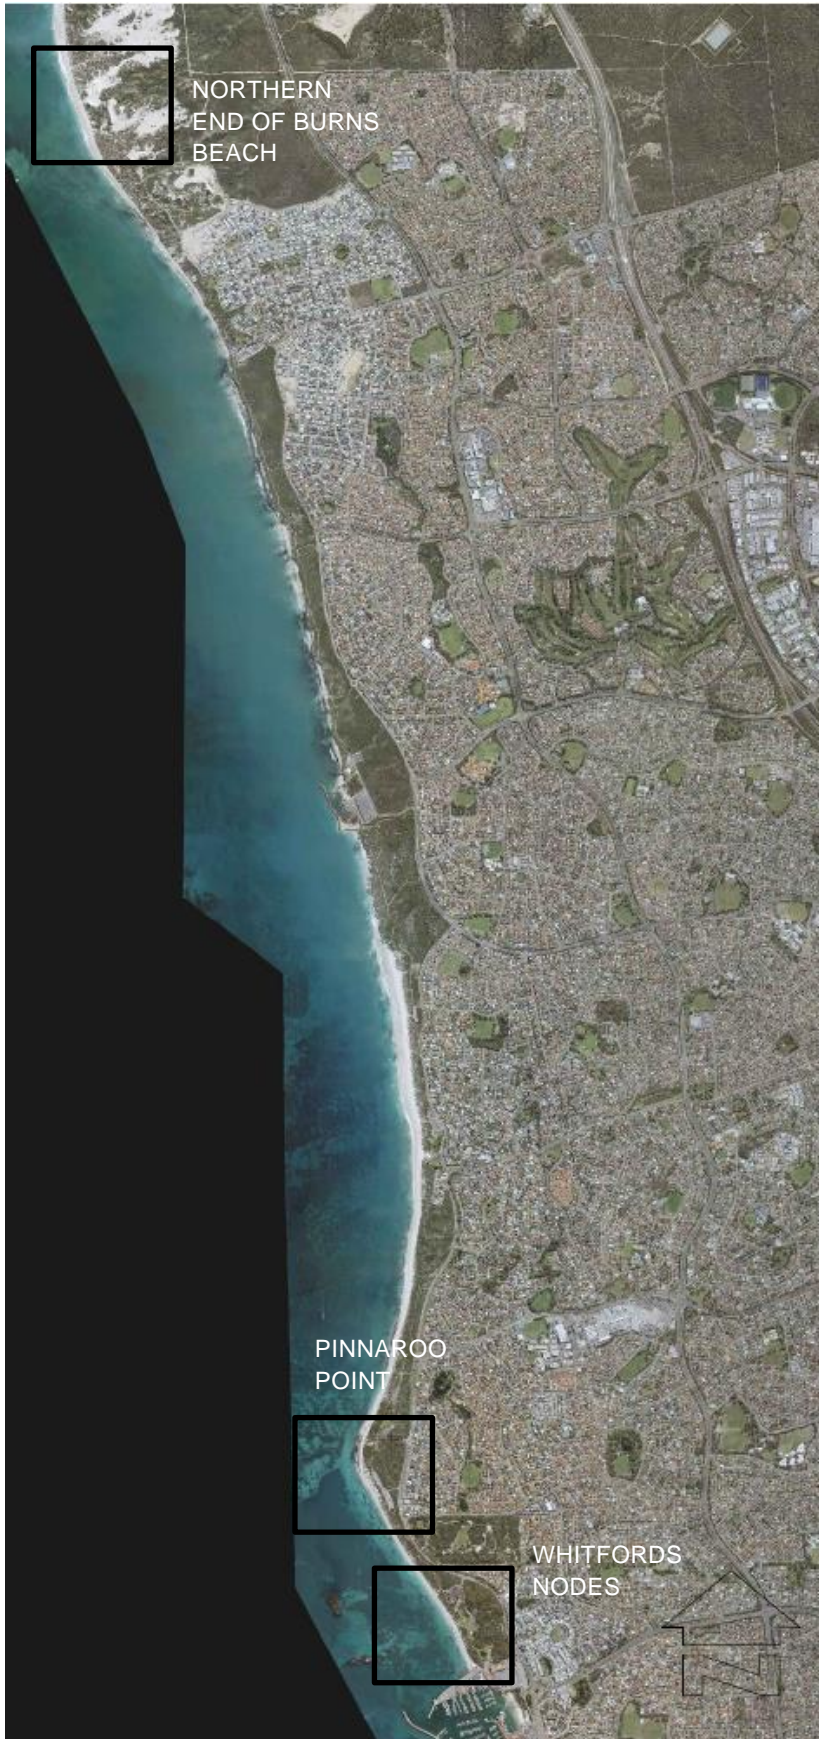
Figure 3.3 Previously Identified Sites for Further Investigation

These locations are highlighted in Figure 3.3.

The shoreline movement for each of the areas in Figure 3.3 that were previously identified as requiring specific monitoring (Whitfords Nodes, Pinnaroo Point and Burns Beach) have been assessed in more detail with the updated shoreline movement data. Extracts showing the vegetation lines between 2015 and 2019 for each of these locations are provided below and discussed thereafter.

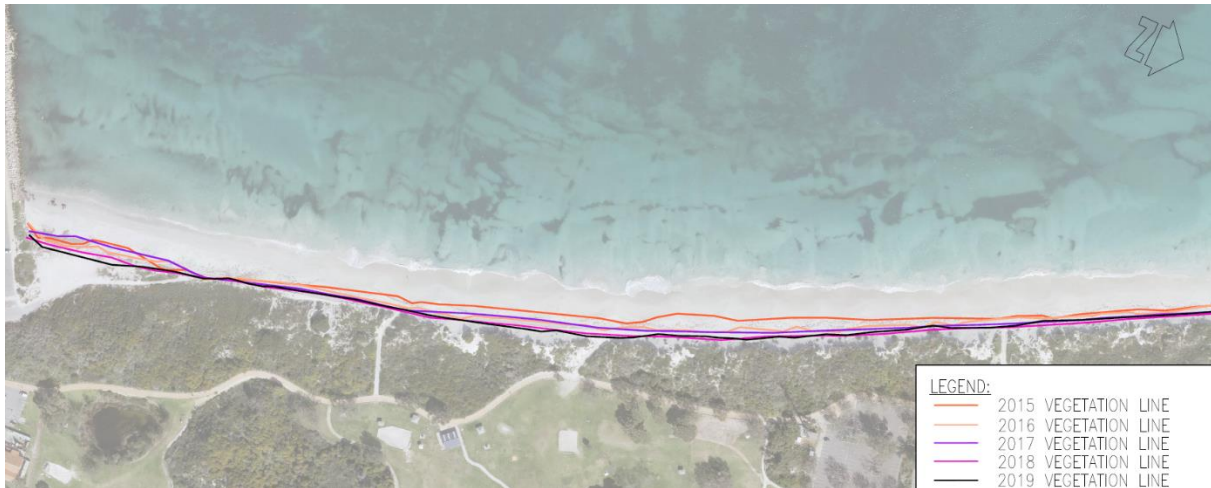
Figure 3.4 Recent Shoreline Movement at Whitfords Nodes

The shoreline along Whitfords Nodes, north of Hillarys Boat Harbour, experienced some additional recession of up to 2 m between August 2018 and August 2019. This was recognised as the continuation of a previously identified erosion trend. However, the recession recorded between August 2018 and August 2019 is less than in previous years (MRA 2019).

The significantly higher number of seabreeze days in 2019 when compared to the averages may have contributed to the erosion observed along the Whitfords Nodes shoreline, given their potential to cause northerly longshore sediment transport.

Conversely, coastal management in the form of sand bypassing completed between August 2018 and August 2019 may have somewhat alleviated the erosion of the Whitfords Nodes shoreline. This is discussed in more detail in Section 6 of this report.

- The vegetation line at Whitfords Nodes receded by up to 2 m over the last year. This was recognised as a continuation of the previously identified trend, however was significantly less than the 5 m recorded in MRA (2019). The metocean conditions experienced during this period, including a significantly higher number of seabreeze days compared to the averages, may have contributed to the erosion observed along this shoreline. However, the previously identified trend may have been partially alleviated over the recent period by the sand bypassing completed in December 2018.

- Continue to monitor and actively manage (if required) erosion between and including Whitfords Nodes and Pinnaroo Point.
- Continue to complete annual sand bypassing around Hillarys Boat Harbour (around 10,000 to 15,000 m³, depending on budget) to address the windblown sand issues at Sorrento Beach and the recession identified at Whitfords Nodes and Pinnaroo Point. Future monitoring data analysis should specifically analyse the effect of the sand bypassing operations completed to date, including in March and April 2020.
- Continue to specifically monitor the shoreline movement at Burns Beach.

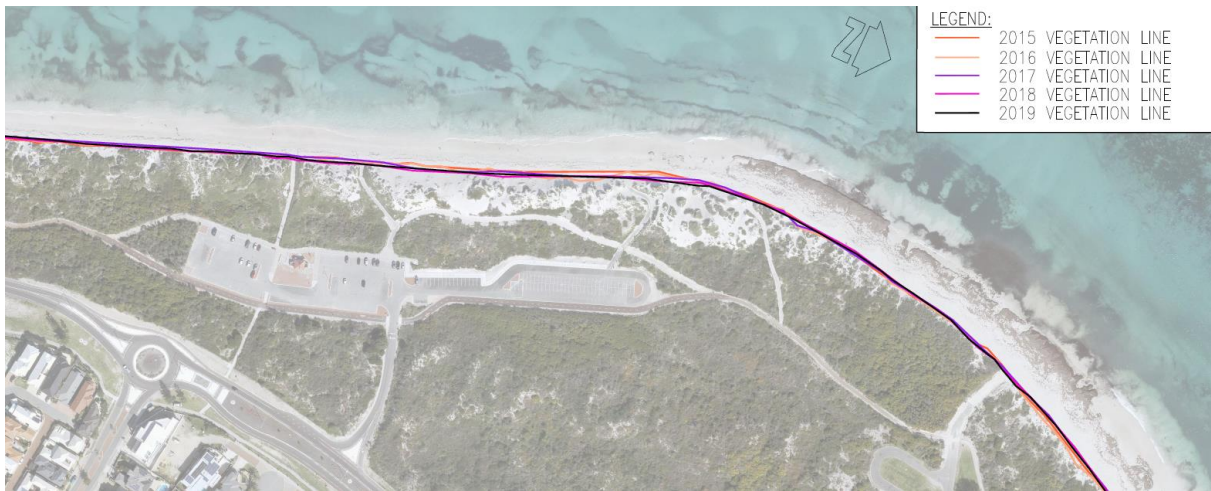
Figure 3.5 Recent Shoreline Movement at Pinnaroo Point

The shoreline at Pinnaroo Point has generally remained relatively stable in the last year. The vegetation line within 500 m either side of Pinnaroo Point experienced changes of up to 1 m between August 2018 and August 2019. This is notably less than the 3 m of recession identified in places in MRA (2019).

Similar to Whitfords Nodes, the metocean conditions experienced in 2019 and the sand bypassing works are likely to have influenced the Pinnaroo Point shoreline. This is discussed in more detail in Section 6 of this report.

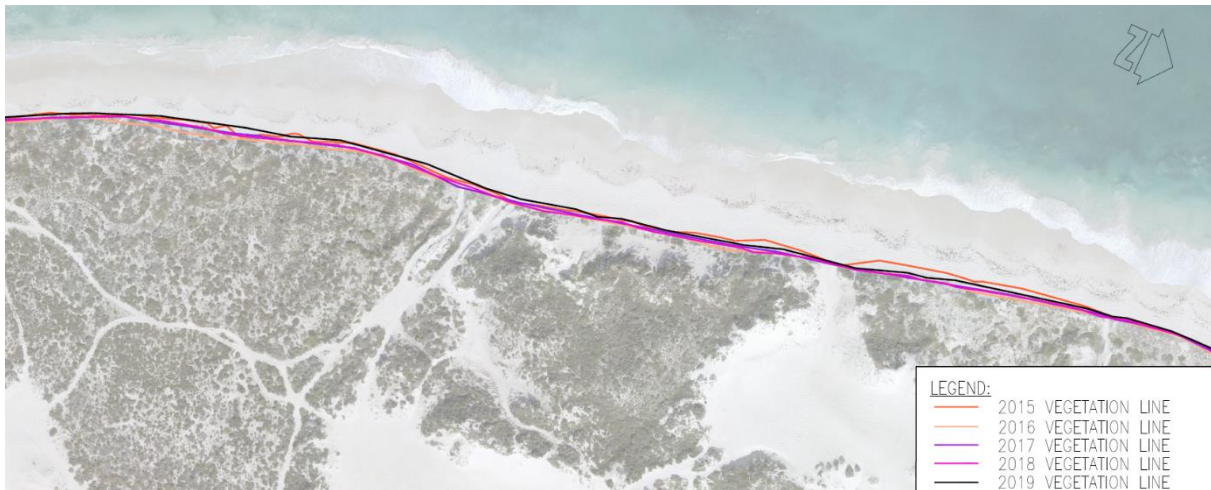
Figure 3.6 Recent Shoreline Movement at Northern End of Burns Beach

The shoreline along Burns Beach, including the northern end shown above, generally accreted between August 2018 and August 2019, resulting in little net change over the 2015 to 2019 period.

- The vegetation line at Burns Beach generally accreted over the last year, resulting in little net change over the 2015 to 2019 period.
- Beach survey Profiles 2 and 3 at Pinnaroo Point appear to have stabilised somewhat at the MSL since the recession trigger values were originally exceeded. Beach survey Profile 5 at Mullaloo SLSC appears to have recovered at the MSL following previous erosion. There appears to have been erosion at Burns Beach (beach survey Profile 15) over the last 2 years that has returned the MSL almost back to its 2015 position. It is noted that fluctuations of the MSL are expected between years, based on the metocean conditions experienced.

Over the past year, the shoreline at Burns Beach appears to have accreted somewhat. The profile surveys indicate there are still some changes at the waterline, although the photo monitoring indicates this may have been experienced in 2017 to 2018 and the changes in the past year are likely reduced. It is recommended that this area continue to be specifically monitored. At the moment there is a significant buffer to infrastructure and assets at Burns Beach, but the monitoring should be continued to ensure that it does not accelerate and that an adequate buffer remains.

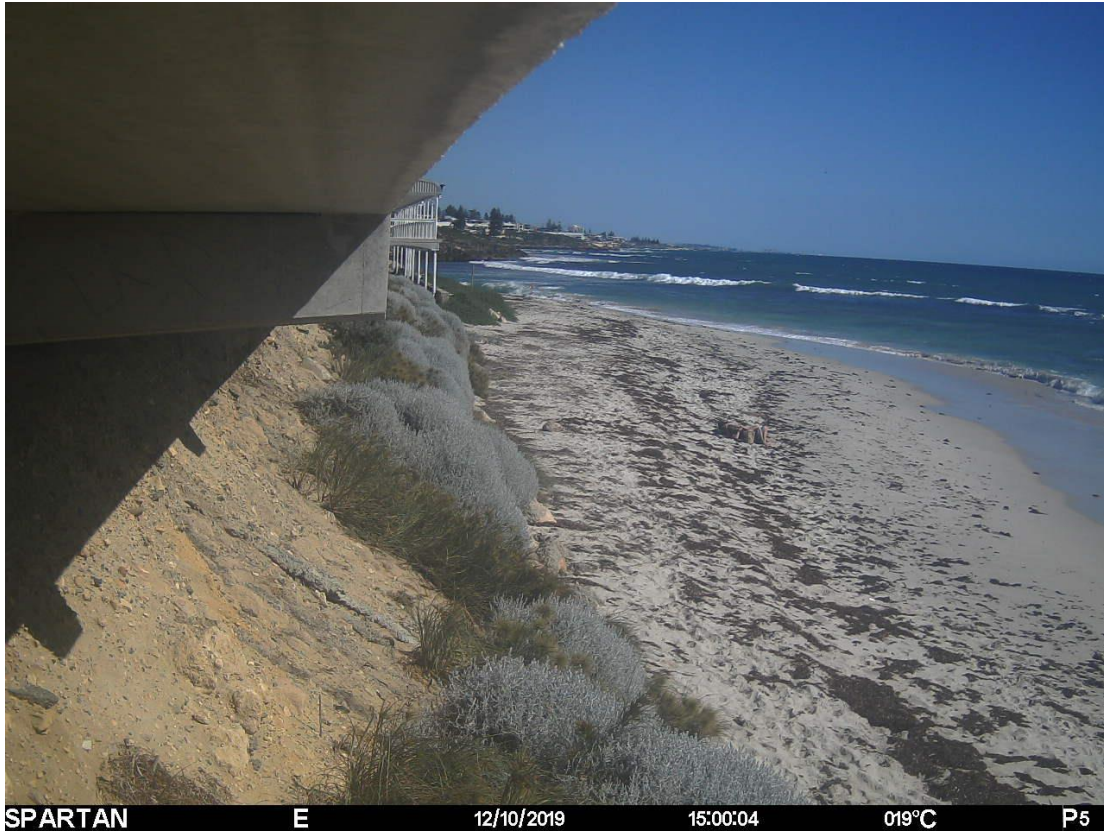
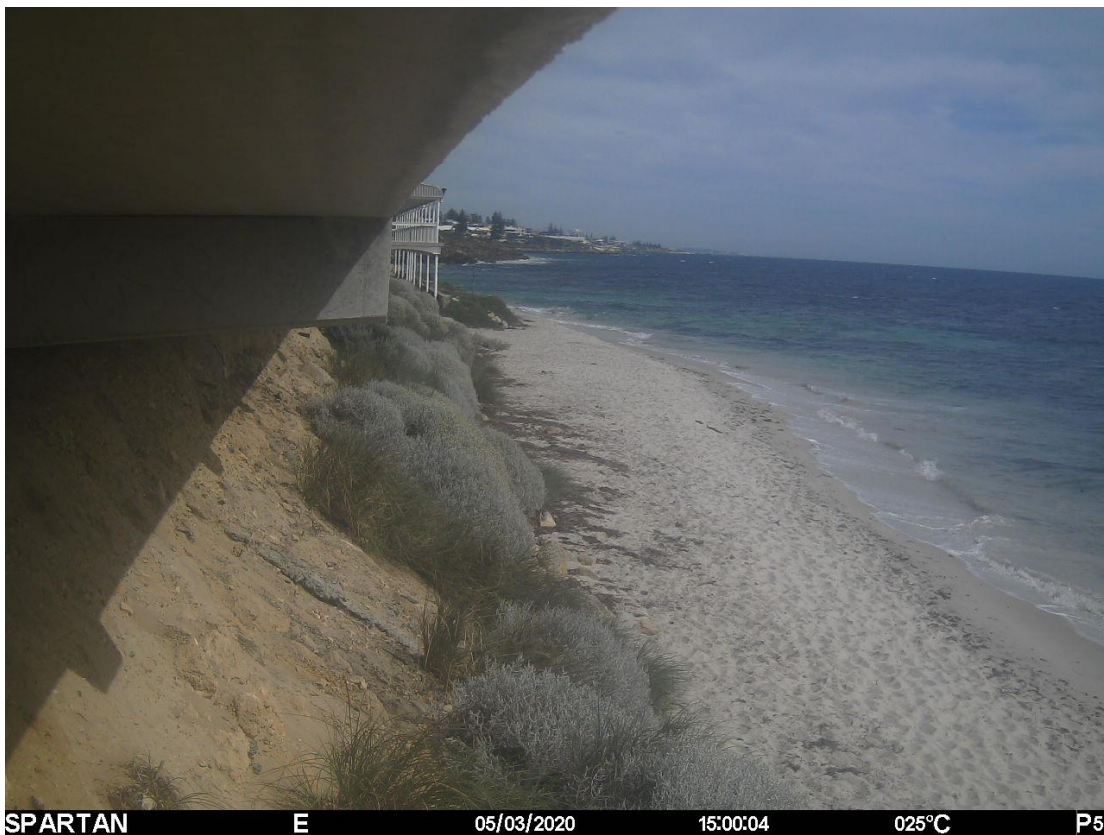
Some example photographs taken between October 2019 and March 2020 are shown in Figures 5.2 and 5.3.

The photographs indicate that there are some seasonal fluctuations of the beach level and width. The photographs indicate that there is now substantial vegetation growing over the bank in front of the car park (see Figures 5.2 and 5.3). The vegetation growth is an indication that there has been very little recent movement of the dune and potential accretion at this location.

Overall, there does not appear to be any significant change to the shoreline position between October 2019 and March 2020.

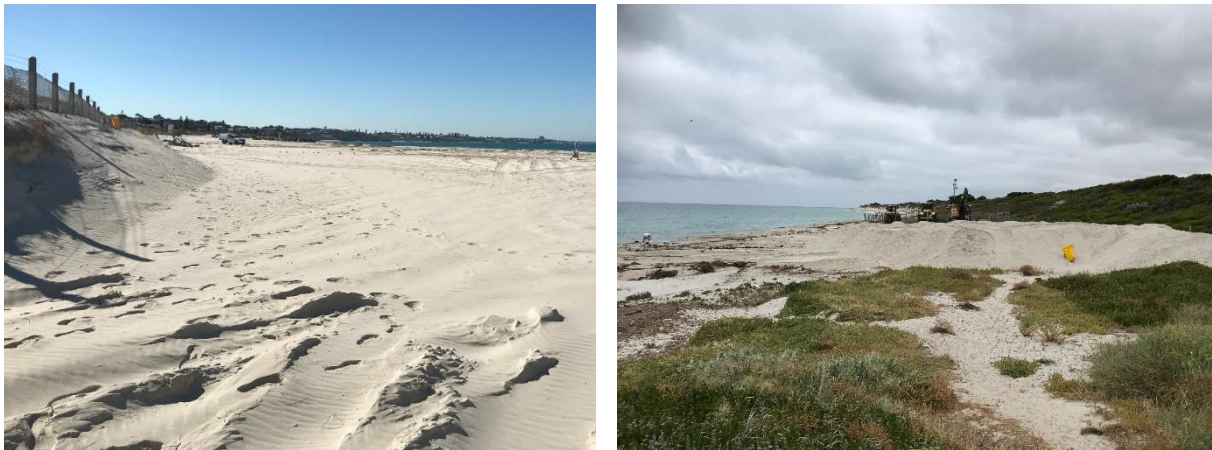
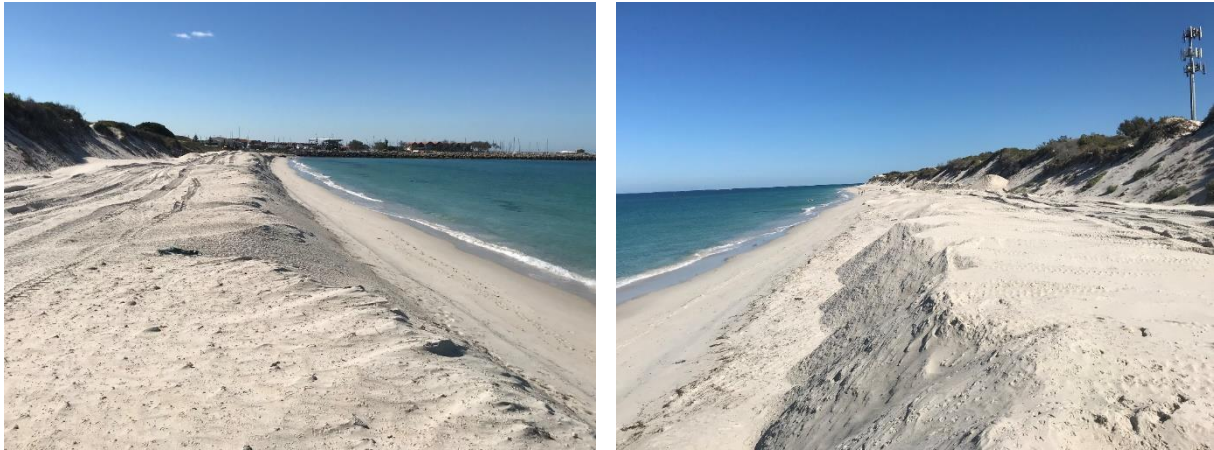
The City subsequently completed sand bypassing works in December 2018. Sand was excavated from the northern section of Sorrento Beach and trucked to Whitfords Nodes where it was placed at the back of the beach. Photographs showing these works are presented in the following figures.

Determining the effectiveness of the 2018 sand bypassing project was one of the aims of the 2019/20 monitoring program and is discussed in Section 7 of this report.

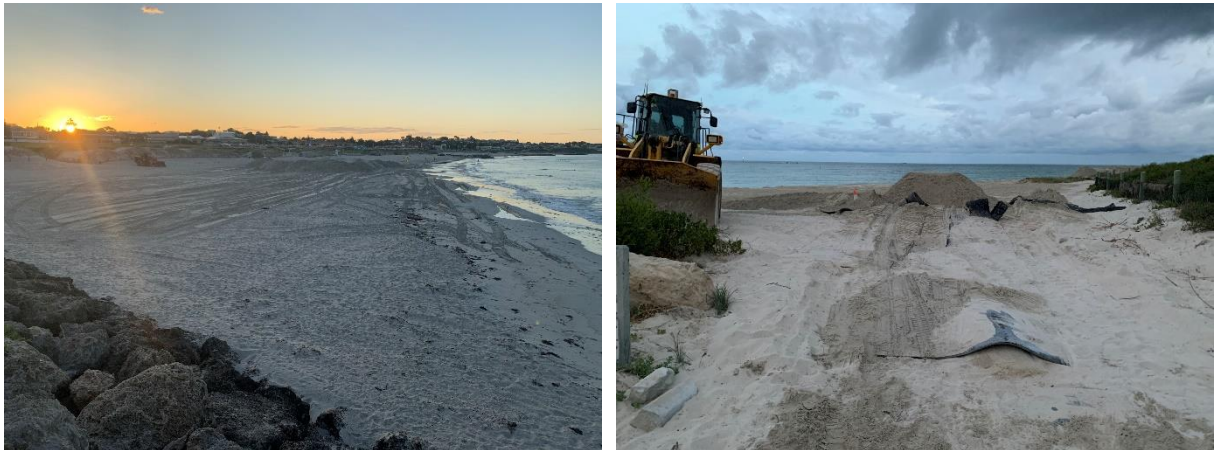
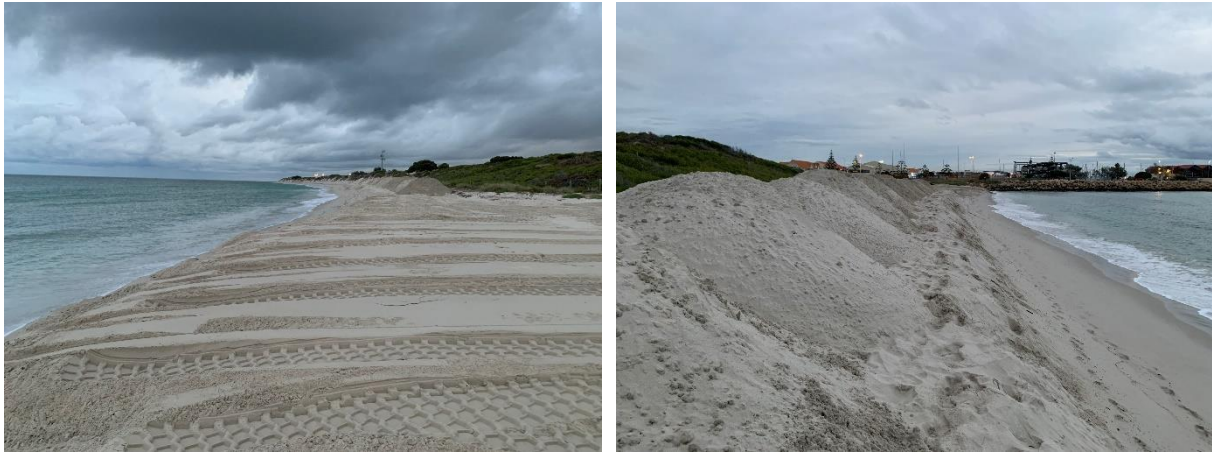
MRA (2019) again recommended that sand bypassing be completed over the 2019/20 summer. This was undertaken recently in March/April 2020 and photographs taken during the works are provided below.

- A large quantity of material appears to have been placed outside the disposal area. As such, the 5,612 m³ volume determined in the disposal area is likely underestimated.
- The extraction volume of 8,731 m³ is likely a more accurate representation of what was bypassed and, as such, is the volume documented in Table 6.1.
- It is important to note that the extraction volume determined captures the volume change of the in-situ material. The material placed in the disposal area was quite loose and ungraded and may even be an overestimate of what was actually placed in that area.
- The vast majority of material was extracted from the upper beach at Sorrento, where cuts of over 1 m in depth are evident. As per the Drawings and Specification for the works (MRA 2018a) it was intended for the cut depths to be limited to 0.5 m in that area. As a

result of this area being targeted for extraction, the beach south of Hillarys is likely to continue to widen at a lower elevation, rather than building up.

- The grading of the disposal area appears to be much steeper than the 1V:5H specified. It is unclear if it was graded at all and appears to have just been dumped and is loose in stockpiles. It was noted that further grading may have been completed following the post-works survey capture. As a result of the disposal placement mentioned above, as well as the likely steeper than 1V:5H grading, steeper scarps may form and there will likely be less usable beach width once erosive pressures are experienced. This has the potential to make the area potentially unsafe at the bottom of the scarps if they are approximately 2 to 3 m high.
