Camberwarra Local Structure Plan

STRUCTURE PLAN No. 16

This Structure Plan is prepared under the provisions of Part 9 of the City of Joondalup *District Planning Scheme No. 2.*

This structure plan is intended to be the primary document that will guide subdivision and development of the former Camberwarra Primary School Site, which is located at Lot 12811 (34) Currajong Crescent, Craigie (The Subject Site).

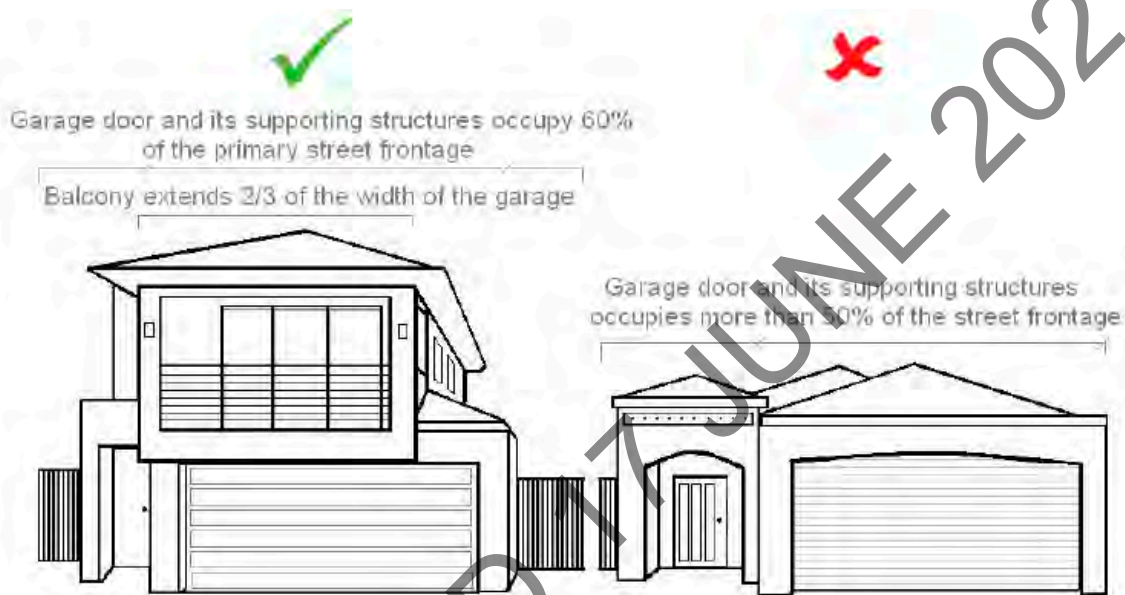
Source: City of Joondalup's Draft Dual Density Code Policy (2010)

- a) The roof and design features of garages and carports shall be consistent with the form and materials of the remainder of the dwelling.
- b) The 'deemed-to comply' requirement C2 of Clause 5.2.2 (Garage Width) of the Residential Design Codes is replaced with the following; A garage door and its supporting structures shall not occupy more than 50% of the primary street frontage at the setback line as viewed from the street. This may be varied to 60% where a balcony or upper floor with major openings extends 2/3 of the width of the garage (refer below figure).

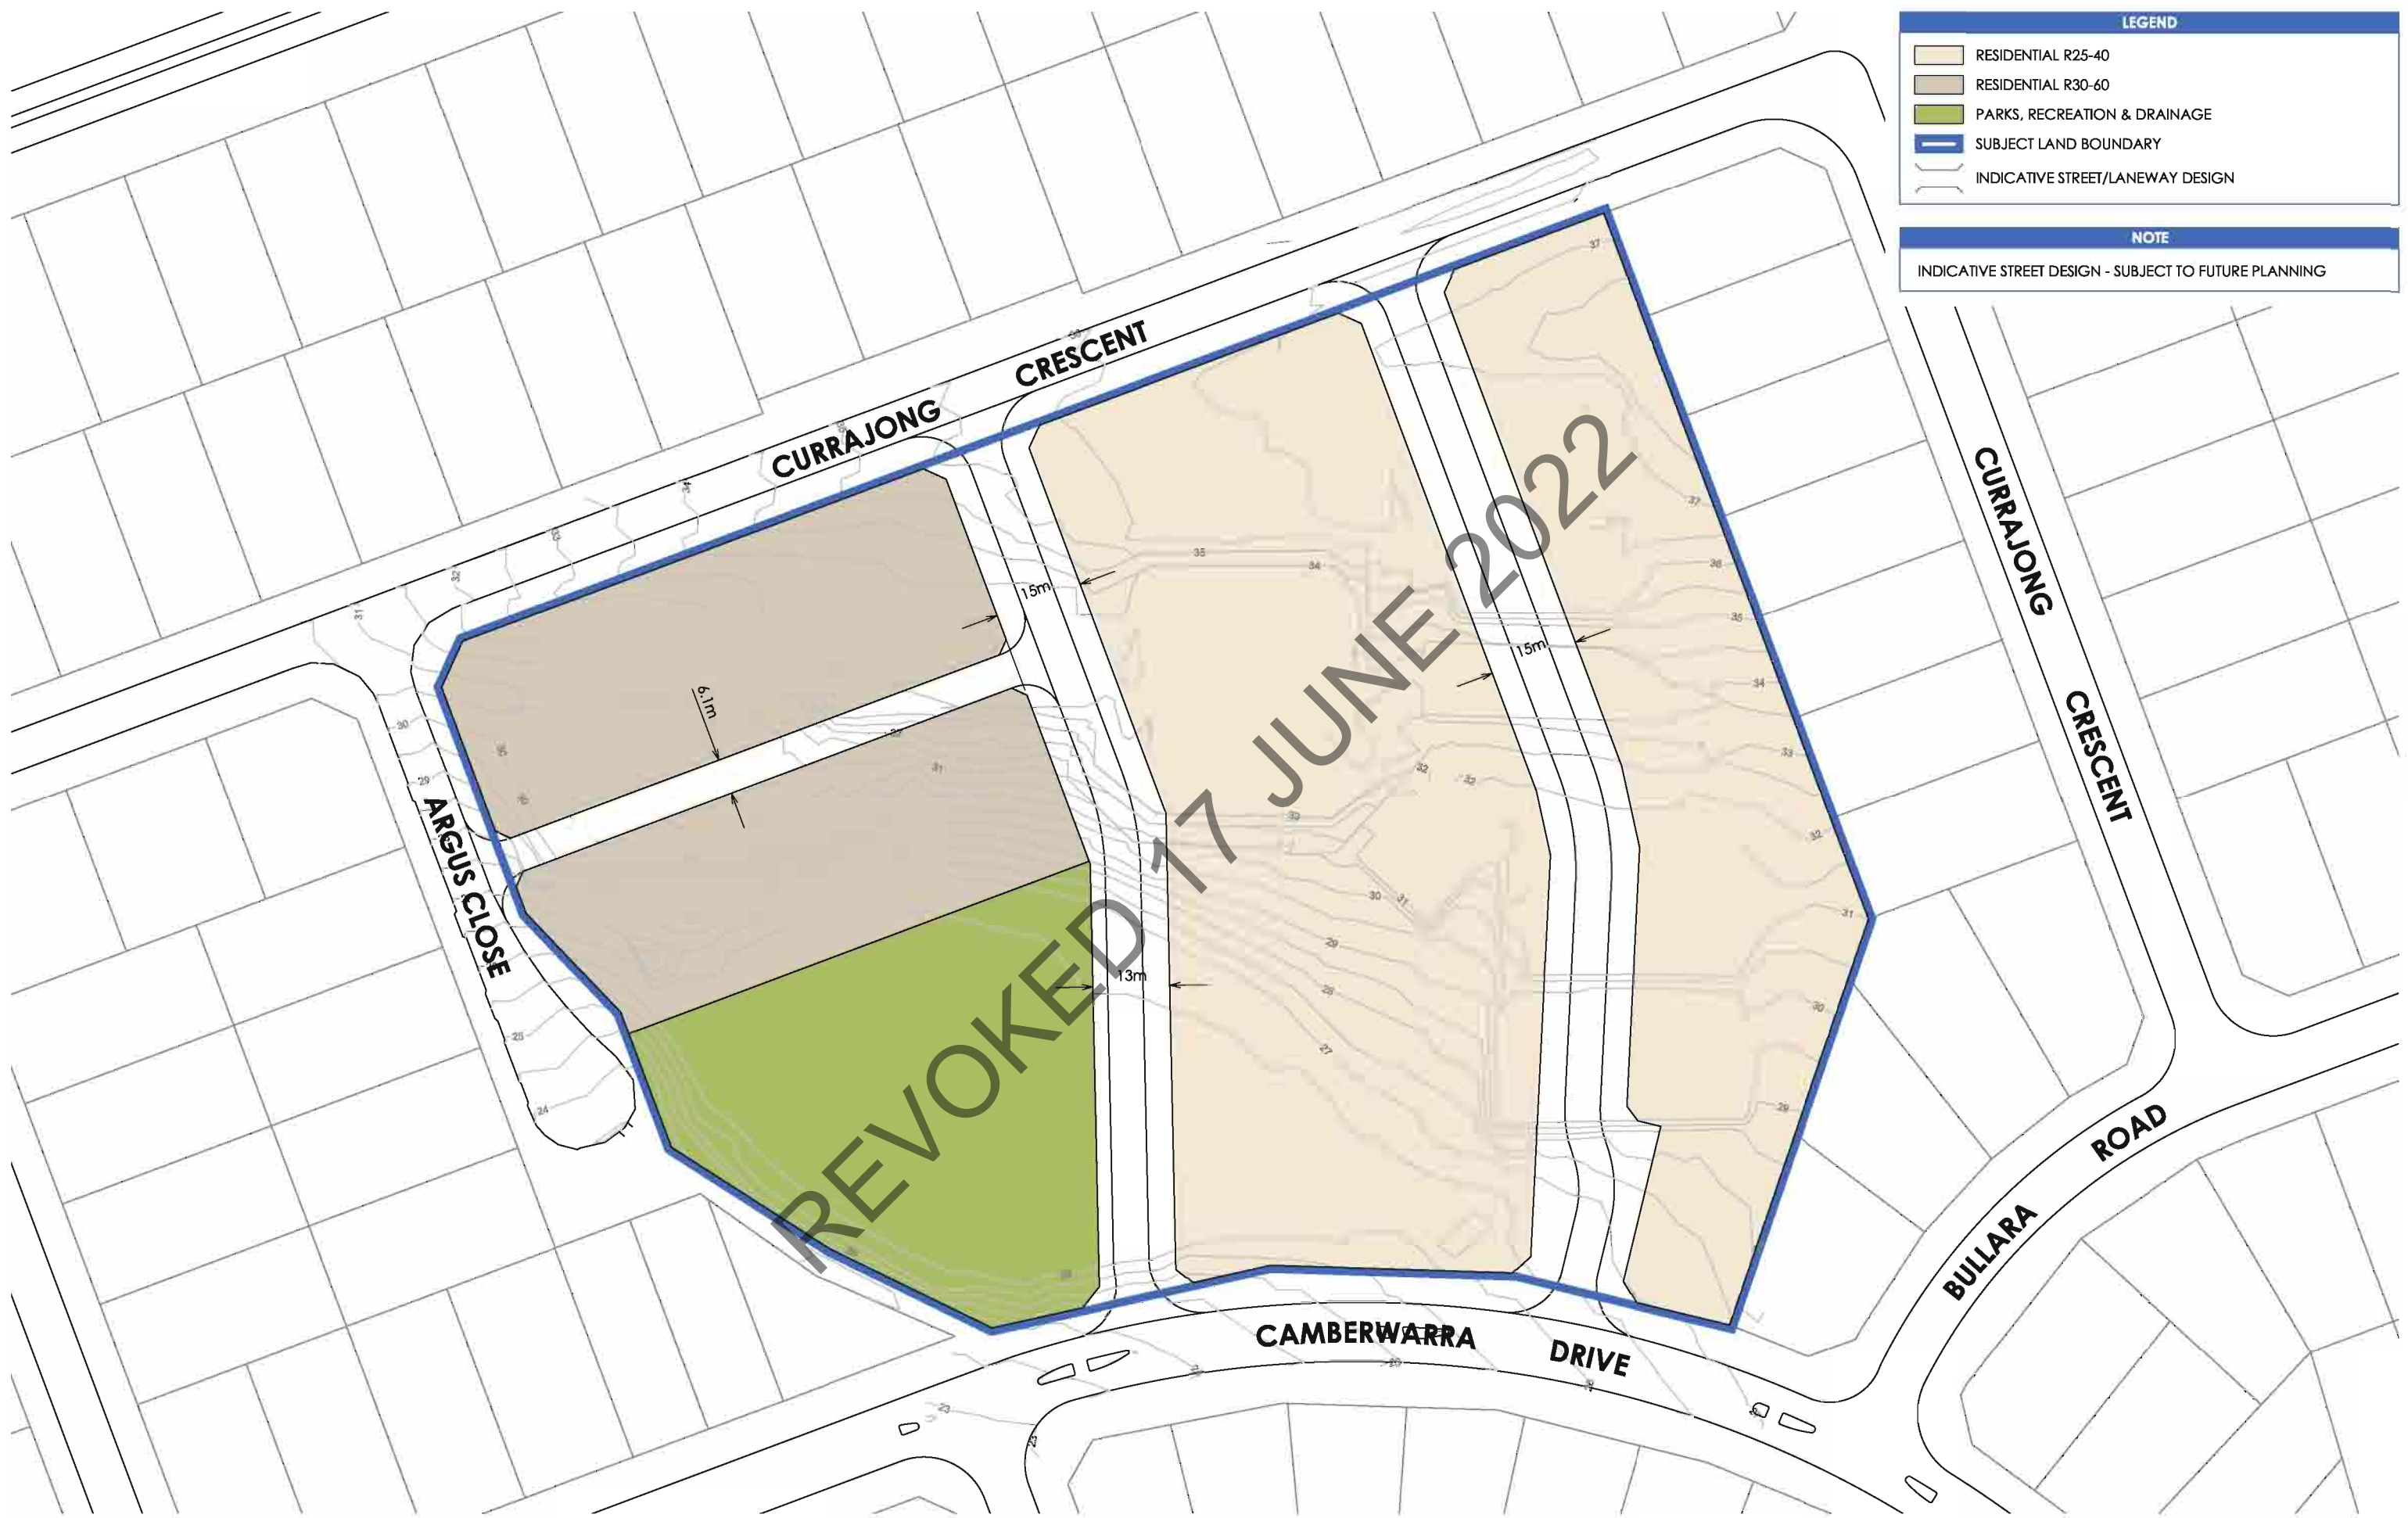
LEGEND	
	RESIDENTIAL R25-40
	RESIDENTIAL R30-60
	PARKS, RECREATION & DRAINAGE
	SUBJECT LAND BOUNDARY
	INDICATIVE STREET/LANEWAY DESIGN

NOTE
INDICATIVE STREET DESIGN - SUBJECT TO FUTURE PLANNING

The intended development of the subject site is outlined within the Masterplan as shown in **Figure 1**.

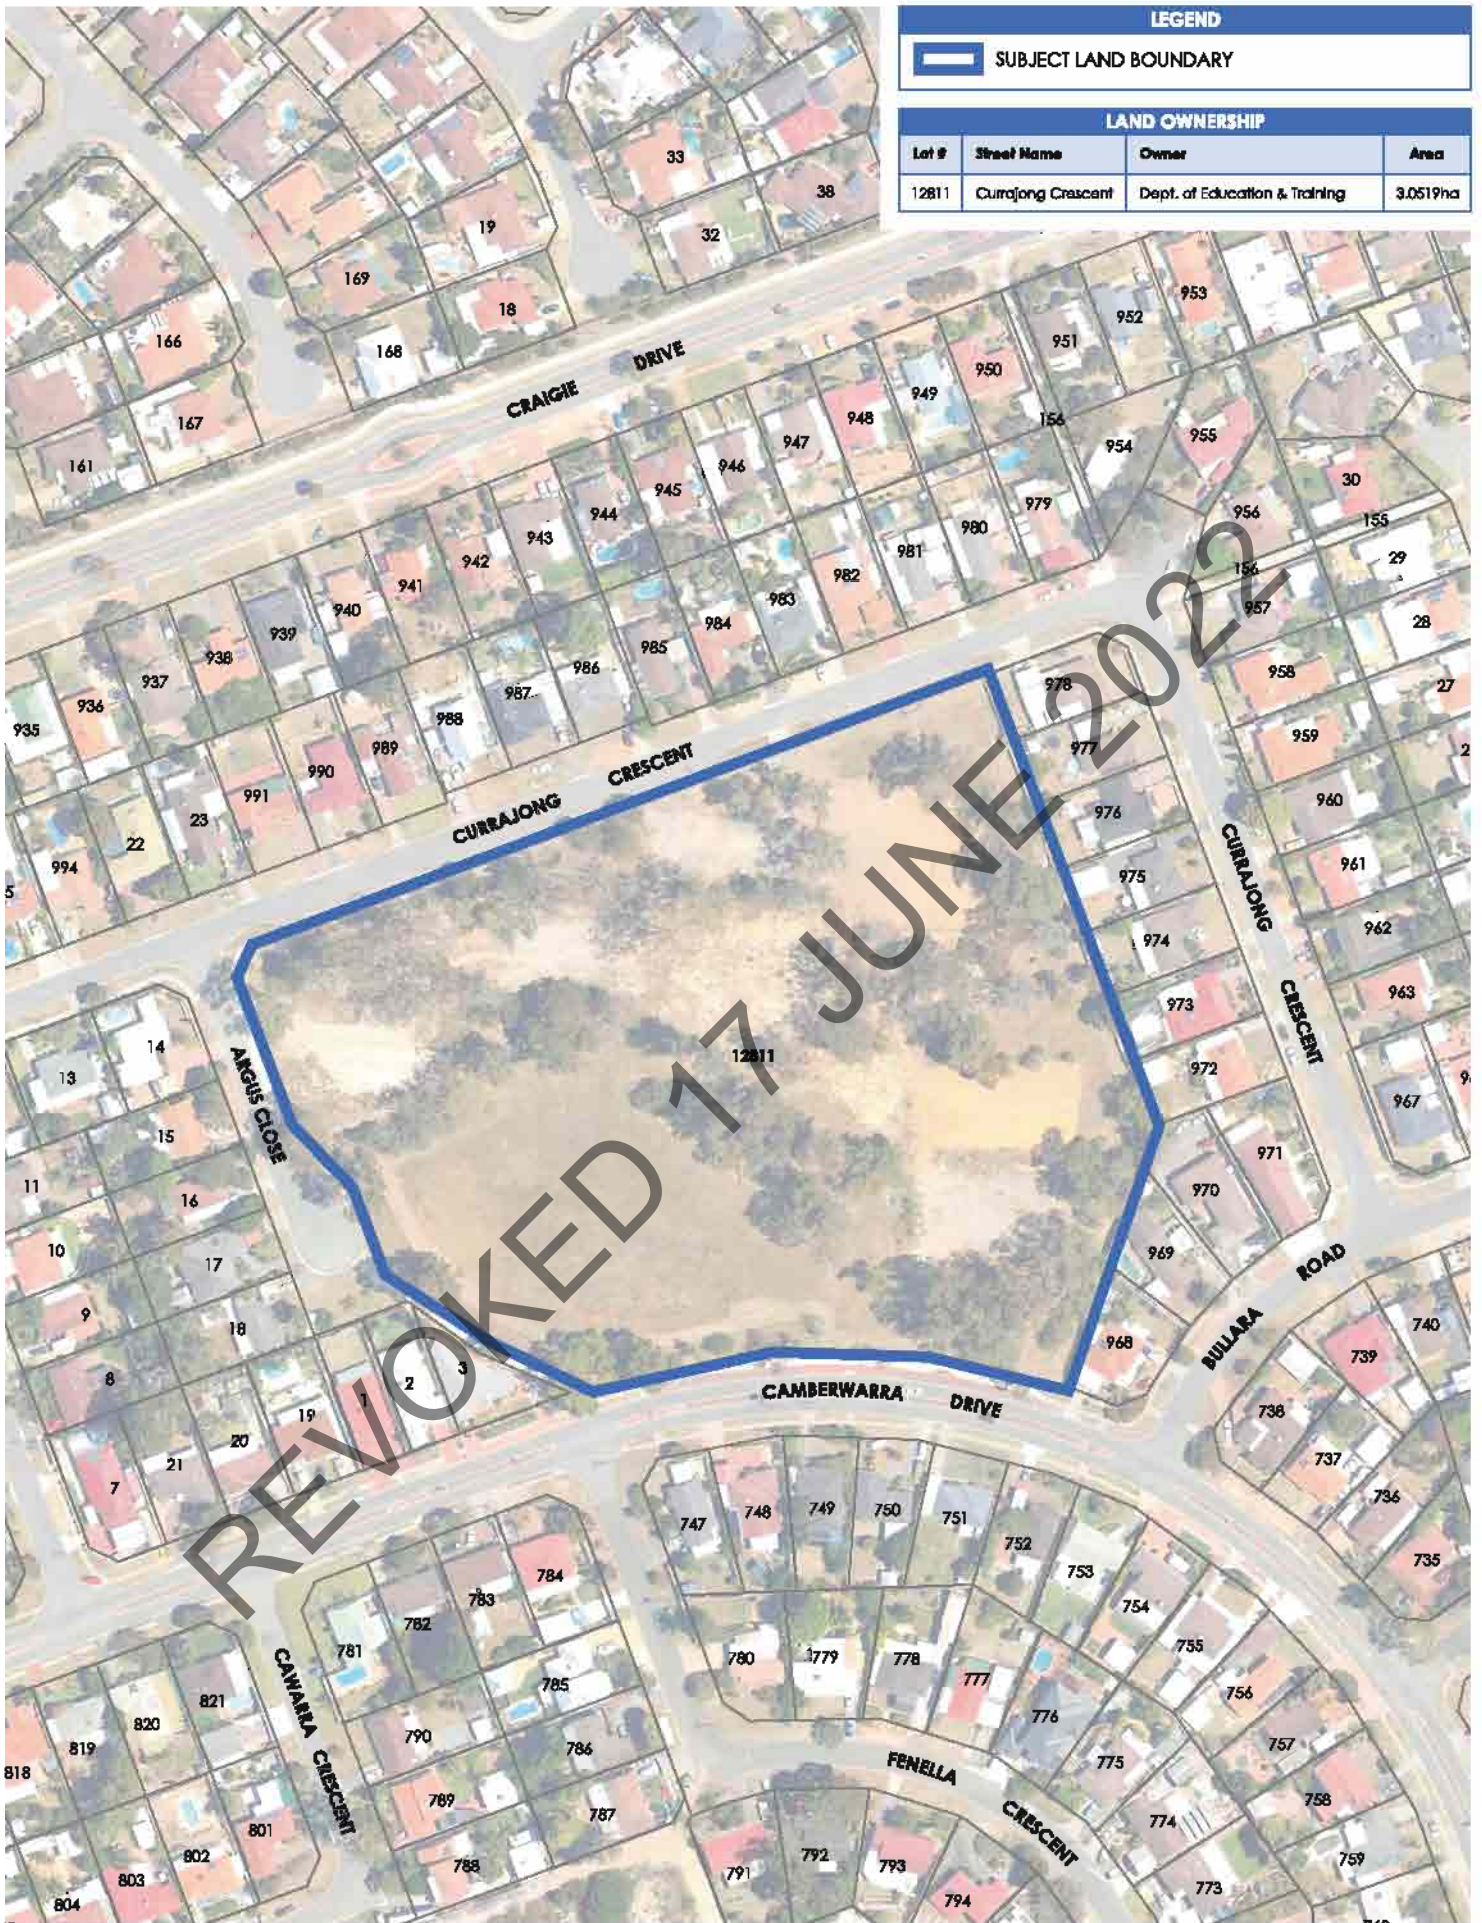
LEGEND	
	SUBJECT LAND BOUNDARY

LAND OWNERSHIP			
Lot #	Street Name	Owner	Area
12811	Currajong Crescent	Dept. of Education & Training	3.0519ha

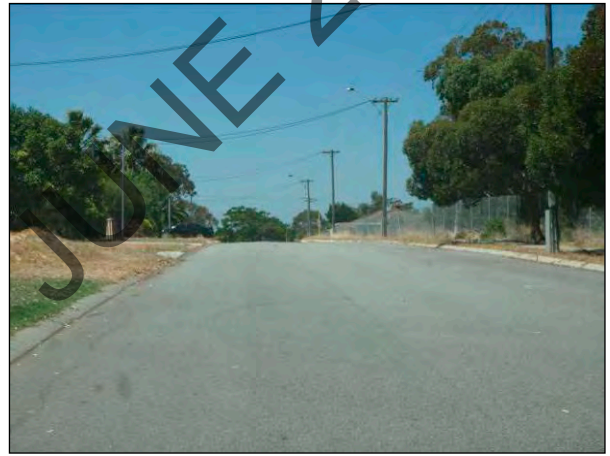
Currajong Cres looking east adjacent to old school site

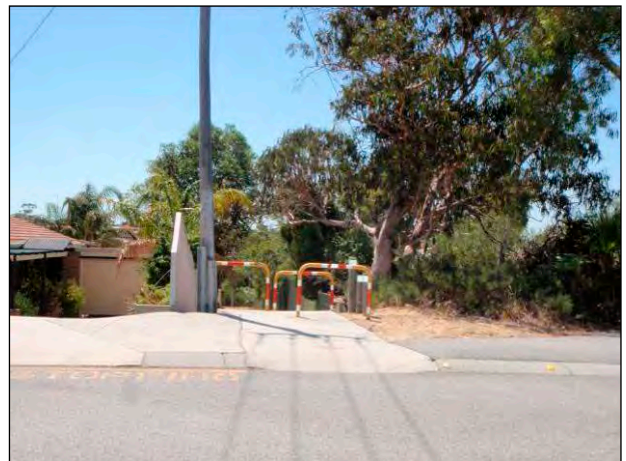
Pedestrian Link from Currajong Cres to Craigie Drive

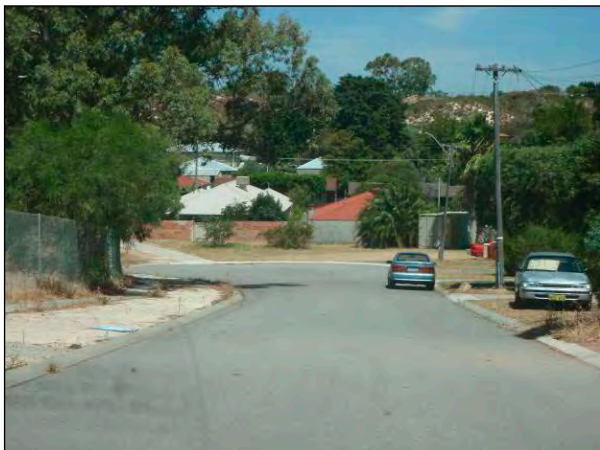
Argus Close, looking south towards cul-de-sac end

Argus Close is constructed to a kerbed, two lane undivided single carriageway road. The approximate pavement width is 6.2m. There is an existing 1.2m wide footpath located on the eastern side of Argus Close adjacent to the site.

The built up area speed limit of 50km/h would apply past the site although the local conditions i.e. road length and cul-de-sac form would likely restrict speeds to less than this.

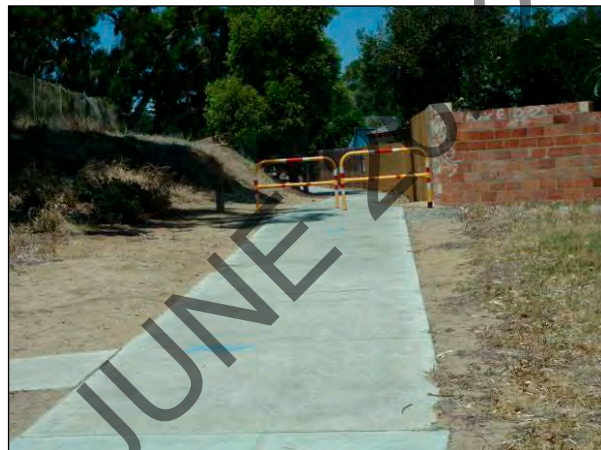
Pedestrian Link from Argus Close to Camberwarra Drive

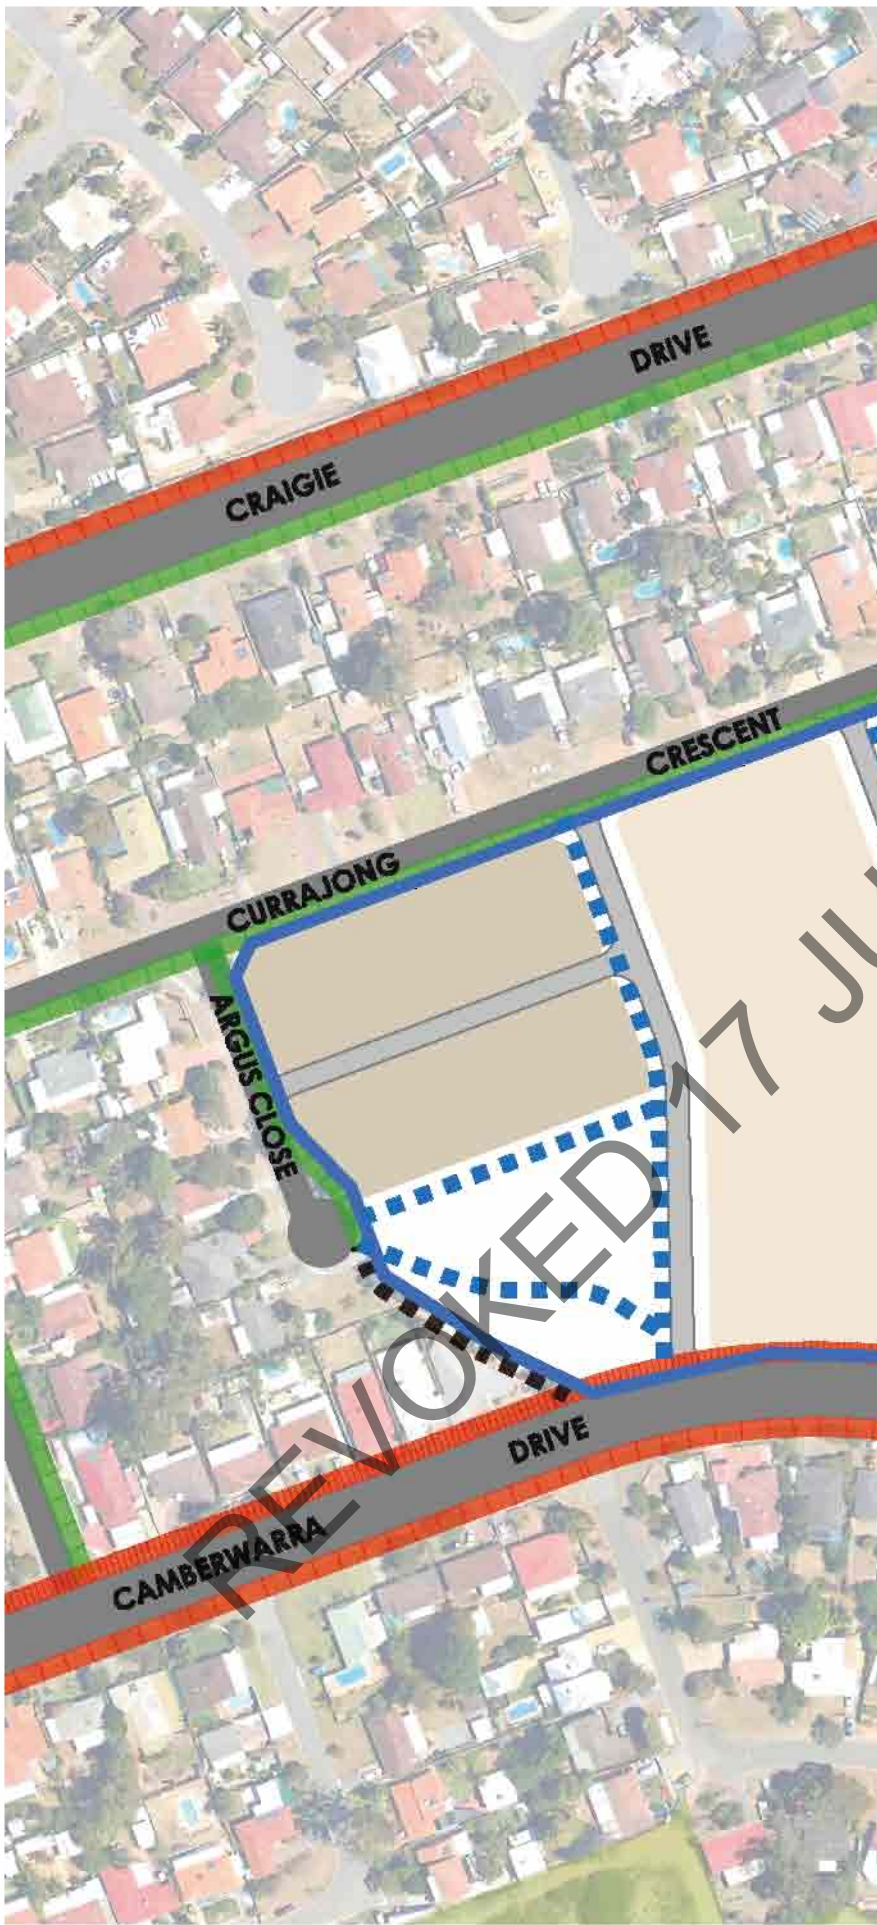
LEGEND

- SUBJECT LAND BOUNDARY
- LOCAL ROADS
- LOCAL DISTRIBUTOR ROADS
- EXISTING SHARED PATH
- EXISTING PATH
- EXISTING PATH TO BE RELOCATED
- PROPOSED RESIDENTIAL LOTS R25 - R40
- PROPOSED RESIDENTIAL LOTS R30 - R60
- PROPOSED ROAD
- PROPOSED PATH (1.5m width)

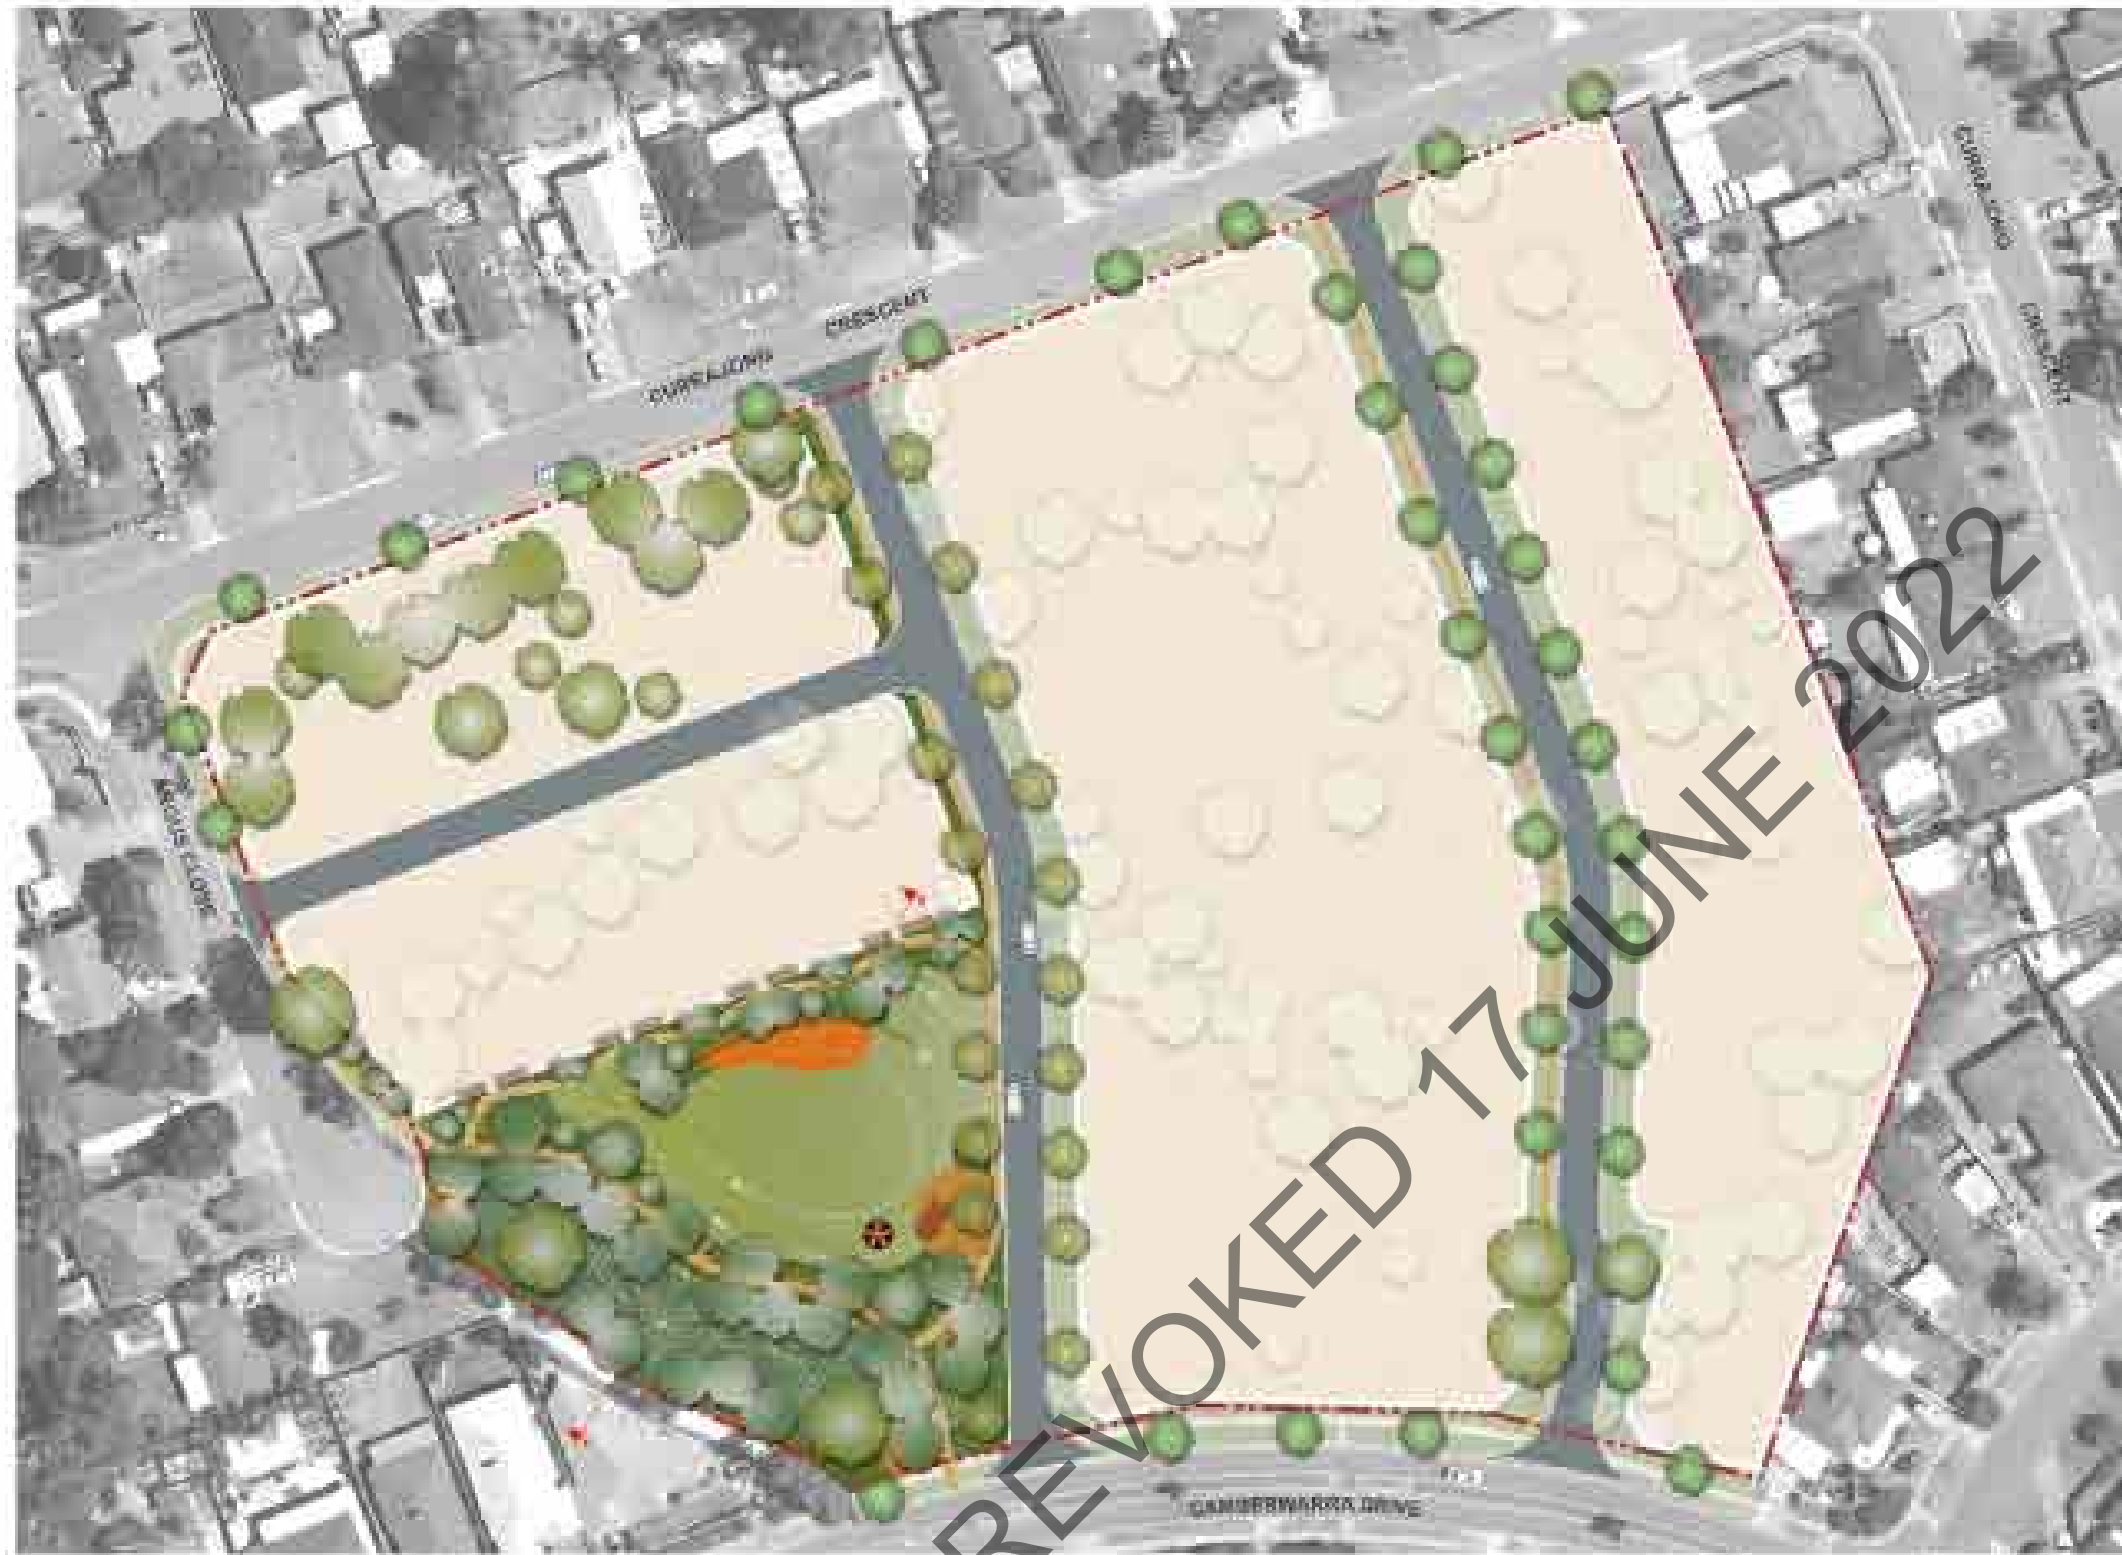
- | | | | |

| site boundary | existing trees to be considered for retention | proposed contours | proposed fruit street tree |

The public open space area shown in **Figure 11** represents approximately 3,991m² in the south-west precinct of the subject area. It should be noted that this POS Area is inclusive of a 550m² drainage swale for a 1:1 year rainfall event, resulting in a creditable POS area of 3441m². The selected POS location is considered to be optimal as it:

- Provides an area of accessible POS for both the new development and the existing surrounding development;
- Forms a natural low point in the topography, allowing the collocation of drainage and POS as per Liveable Neighbourhoods standards;
- Provides an attractive outlook for new lots immediately abutting the POS, in addition to the surrounding existing development; and
- Reflects the historic use of this portion of the site, which was the school oval, as open space for the benefit of the community.

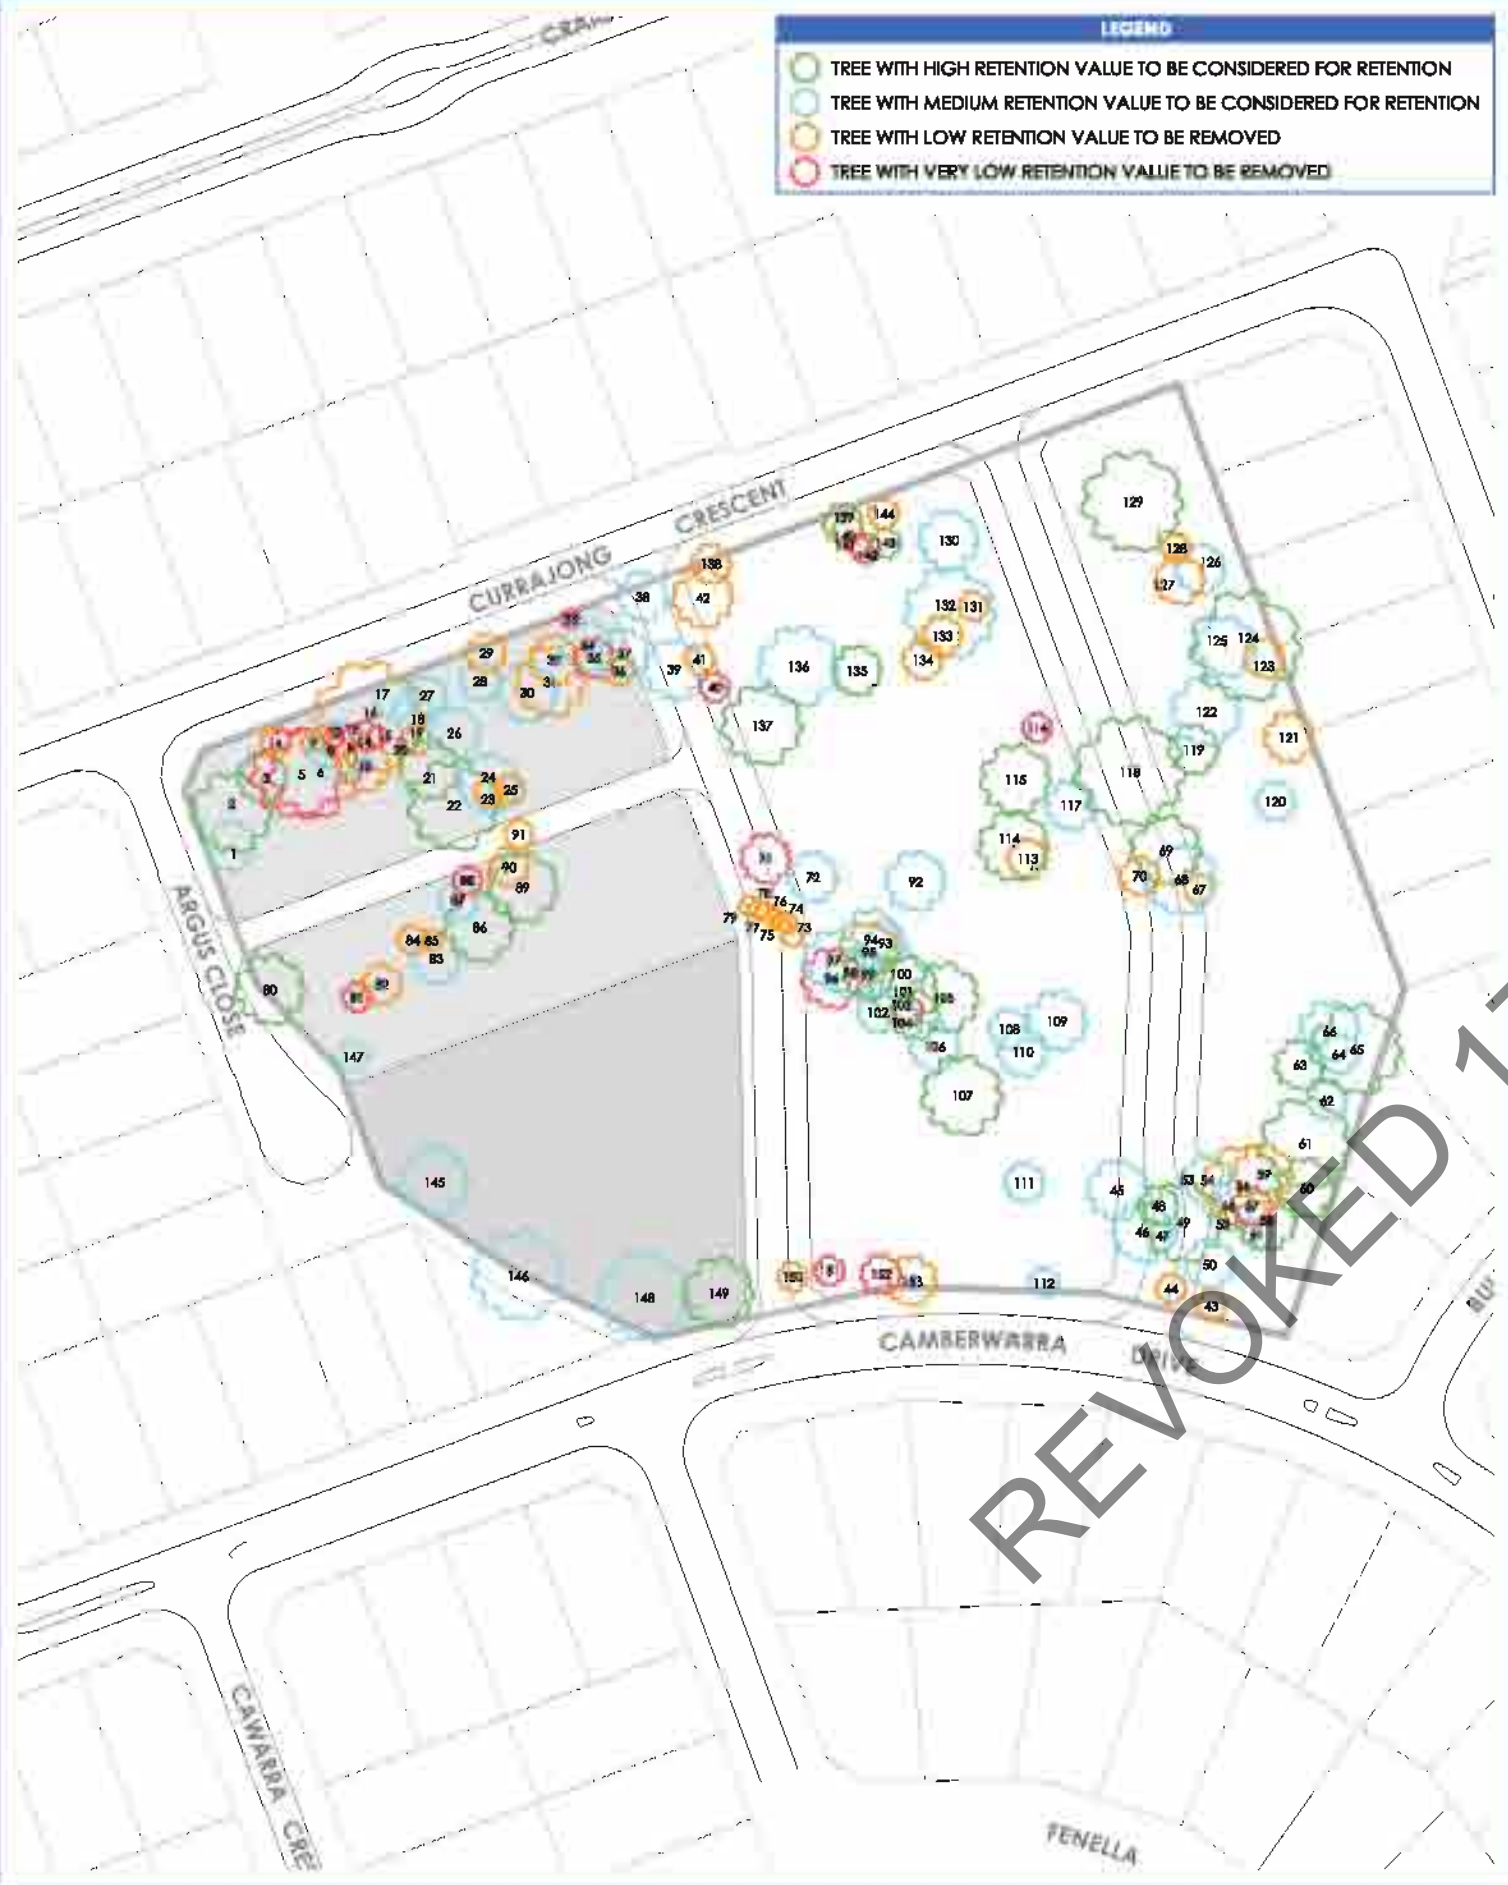
PROPOSED TREE RETENTION

- TREE WITH HIGH RETENTION VALUE TO BE CONSIDERED FOR RETENTION
- TREE WITH MEDIUM RETENTION VALUE TO BE CONSIDERED FOR RETENTION
- TREE WITH LOW RETENTION VALUE TO BE REMOVED
- TREE WITH VERY LOW RETENTION VALUE TO BE REMOVED

Many of the trees to be potentially retained on site are located in the grouped housing site along with some key specimens at site entry points and the lower lying drainage basin proposed to the southwest corner of the site.

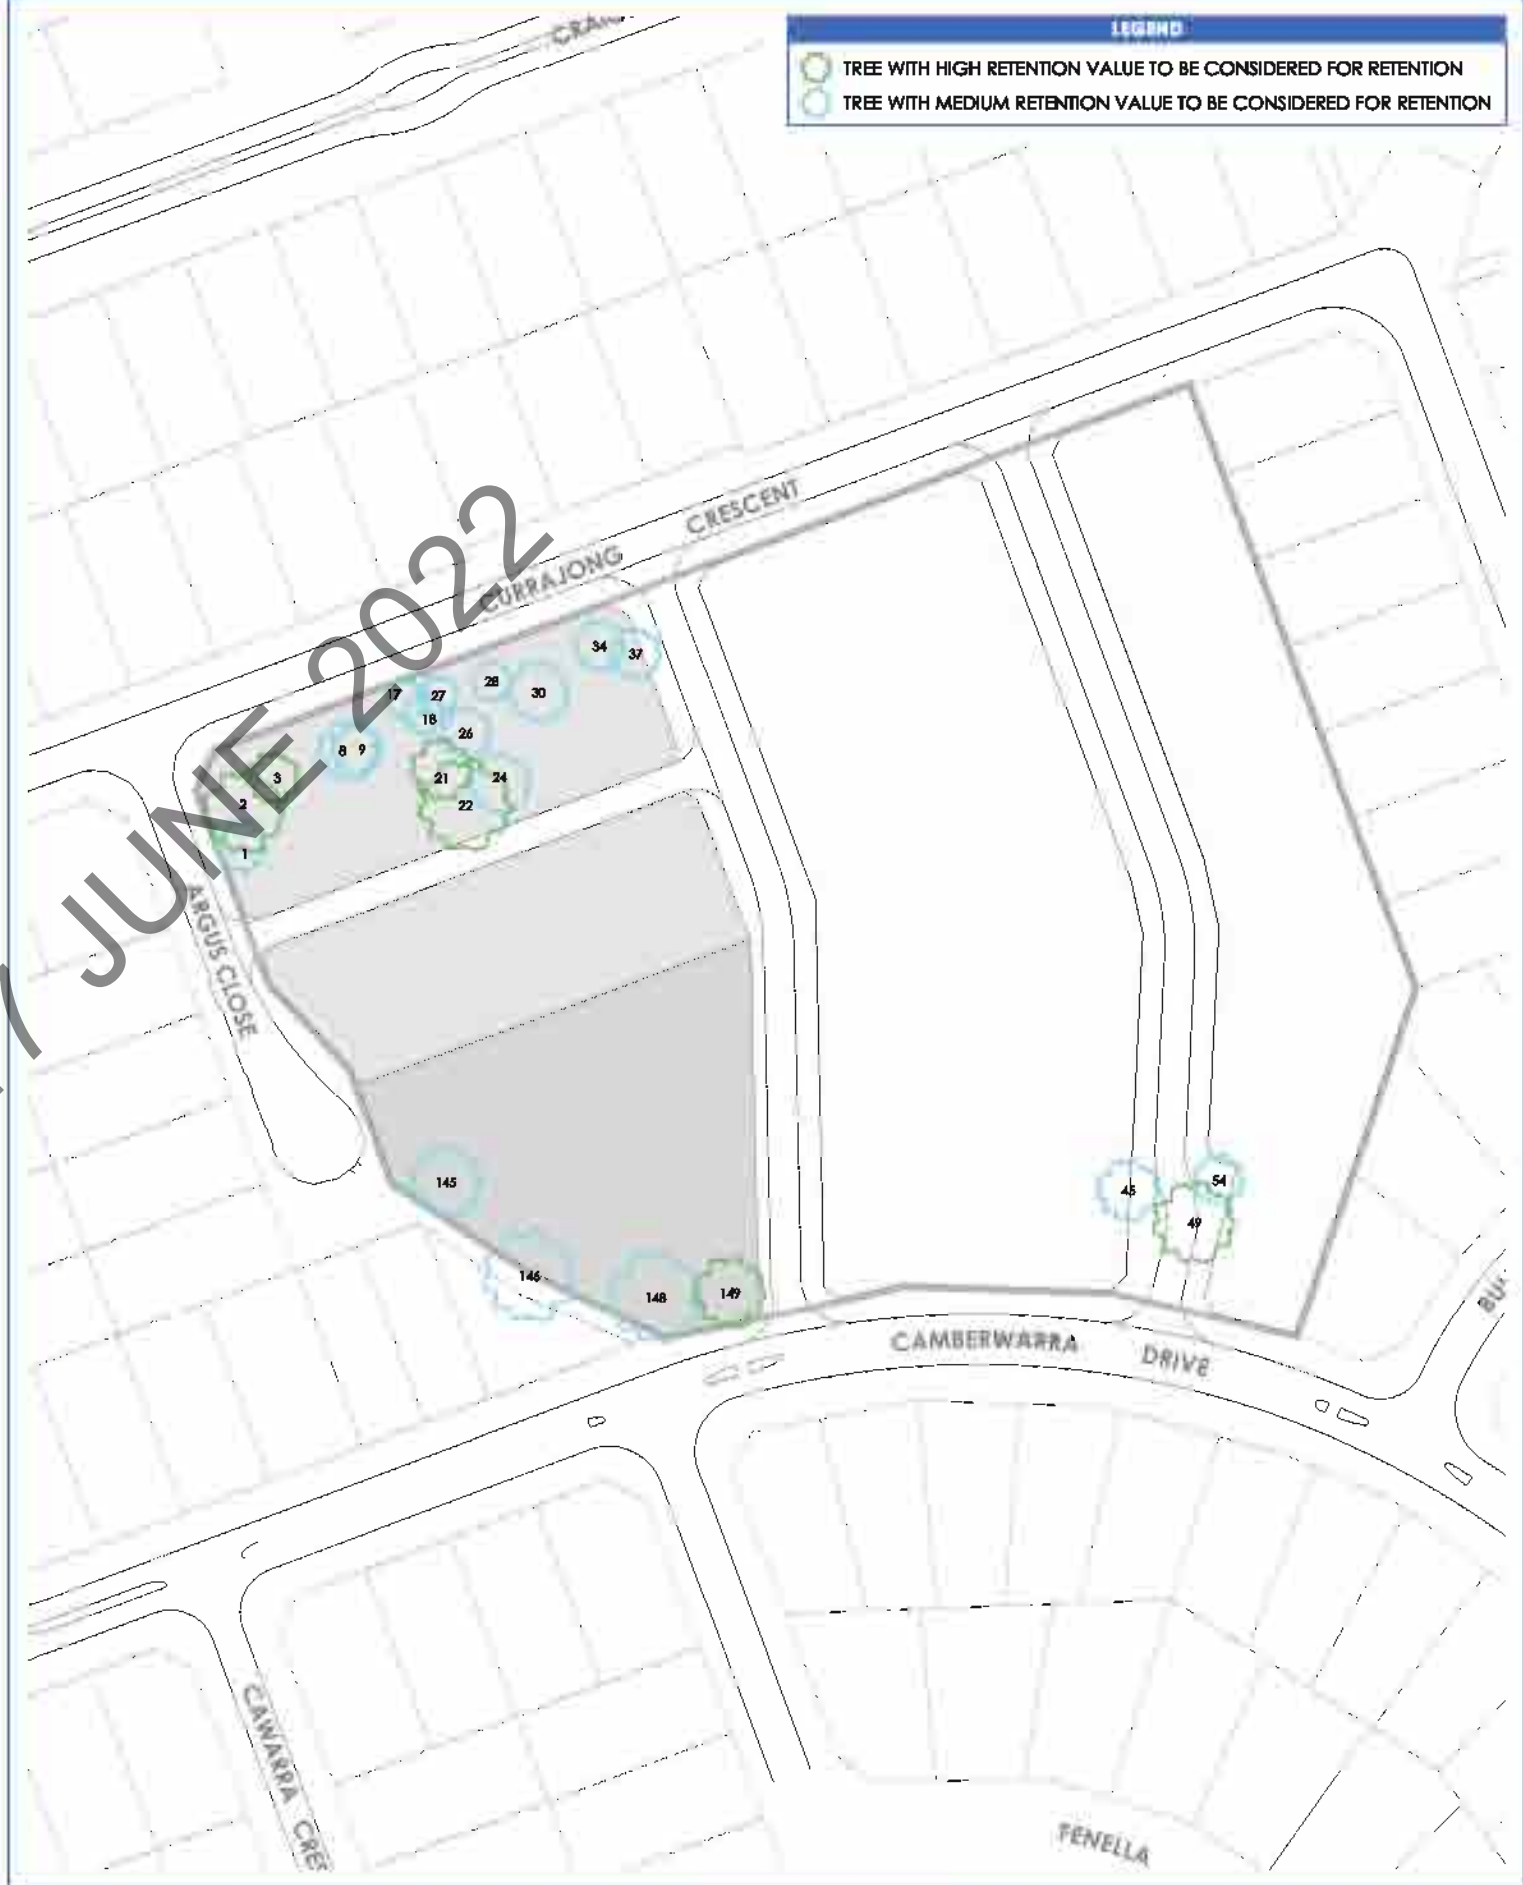
Where trees proposed for possible retention are located in areas to be earth-worked, root zones will be identified, fenced-off and retained in their natural state for the duration of the project development phase. These existing trees provide:

LEGEND

- TREE WITH HIGH RETENTION VALUE TO BE CONSIDERED FOR RETENTION
- TREE WITH MEDIUM RETENTION VALUE TO BE CONSIDERED FOR RETENTION
