Camberwarra Local Structure Plan

STRUCTURE PLAN No. 16

This Structure Plan is prepared under the provisions of Part 9 of the City of Joondalup *District Planning Scheme No. 2.*

This structure plan is intended to be the primary document that will guide subdivision and development of the former Camberwarra Primary School Site, which is located at Lot 12811 (34) Currajong Crescent, Craigie (The Subject Site).

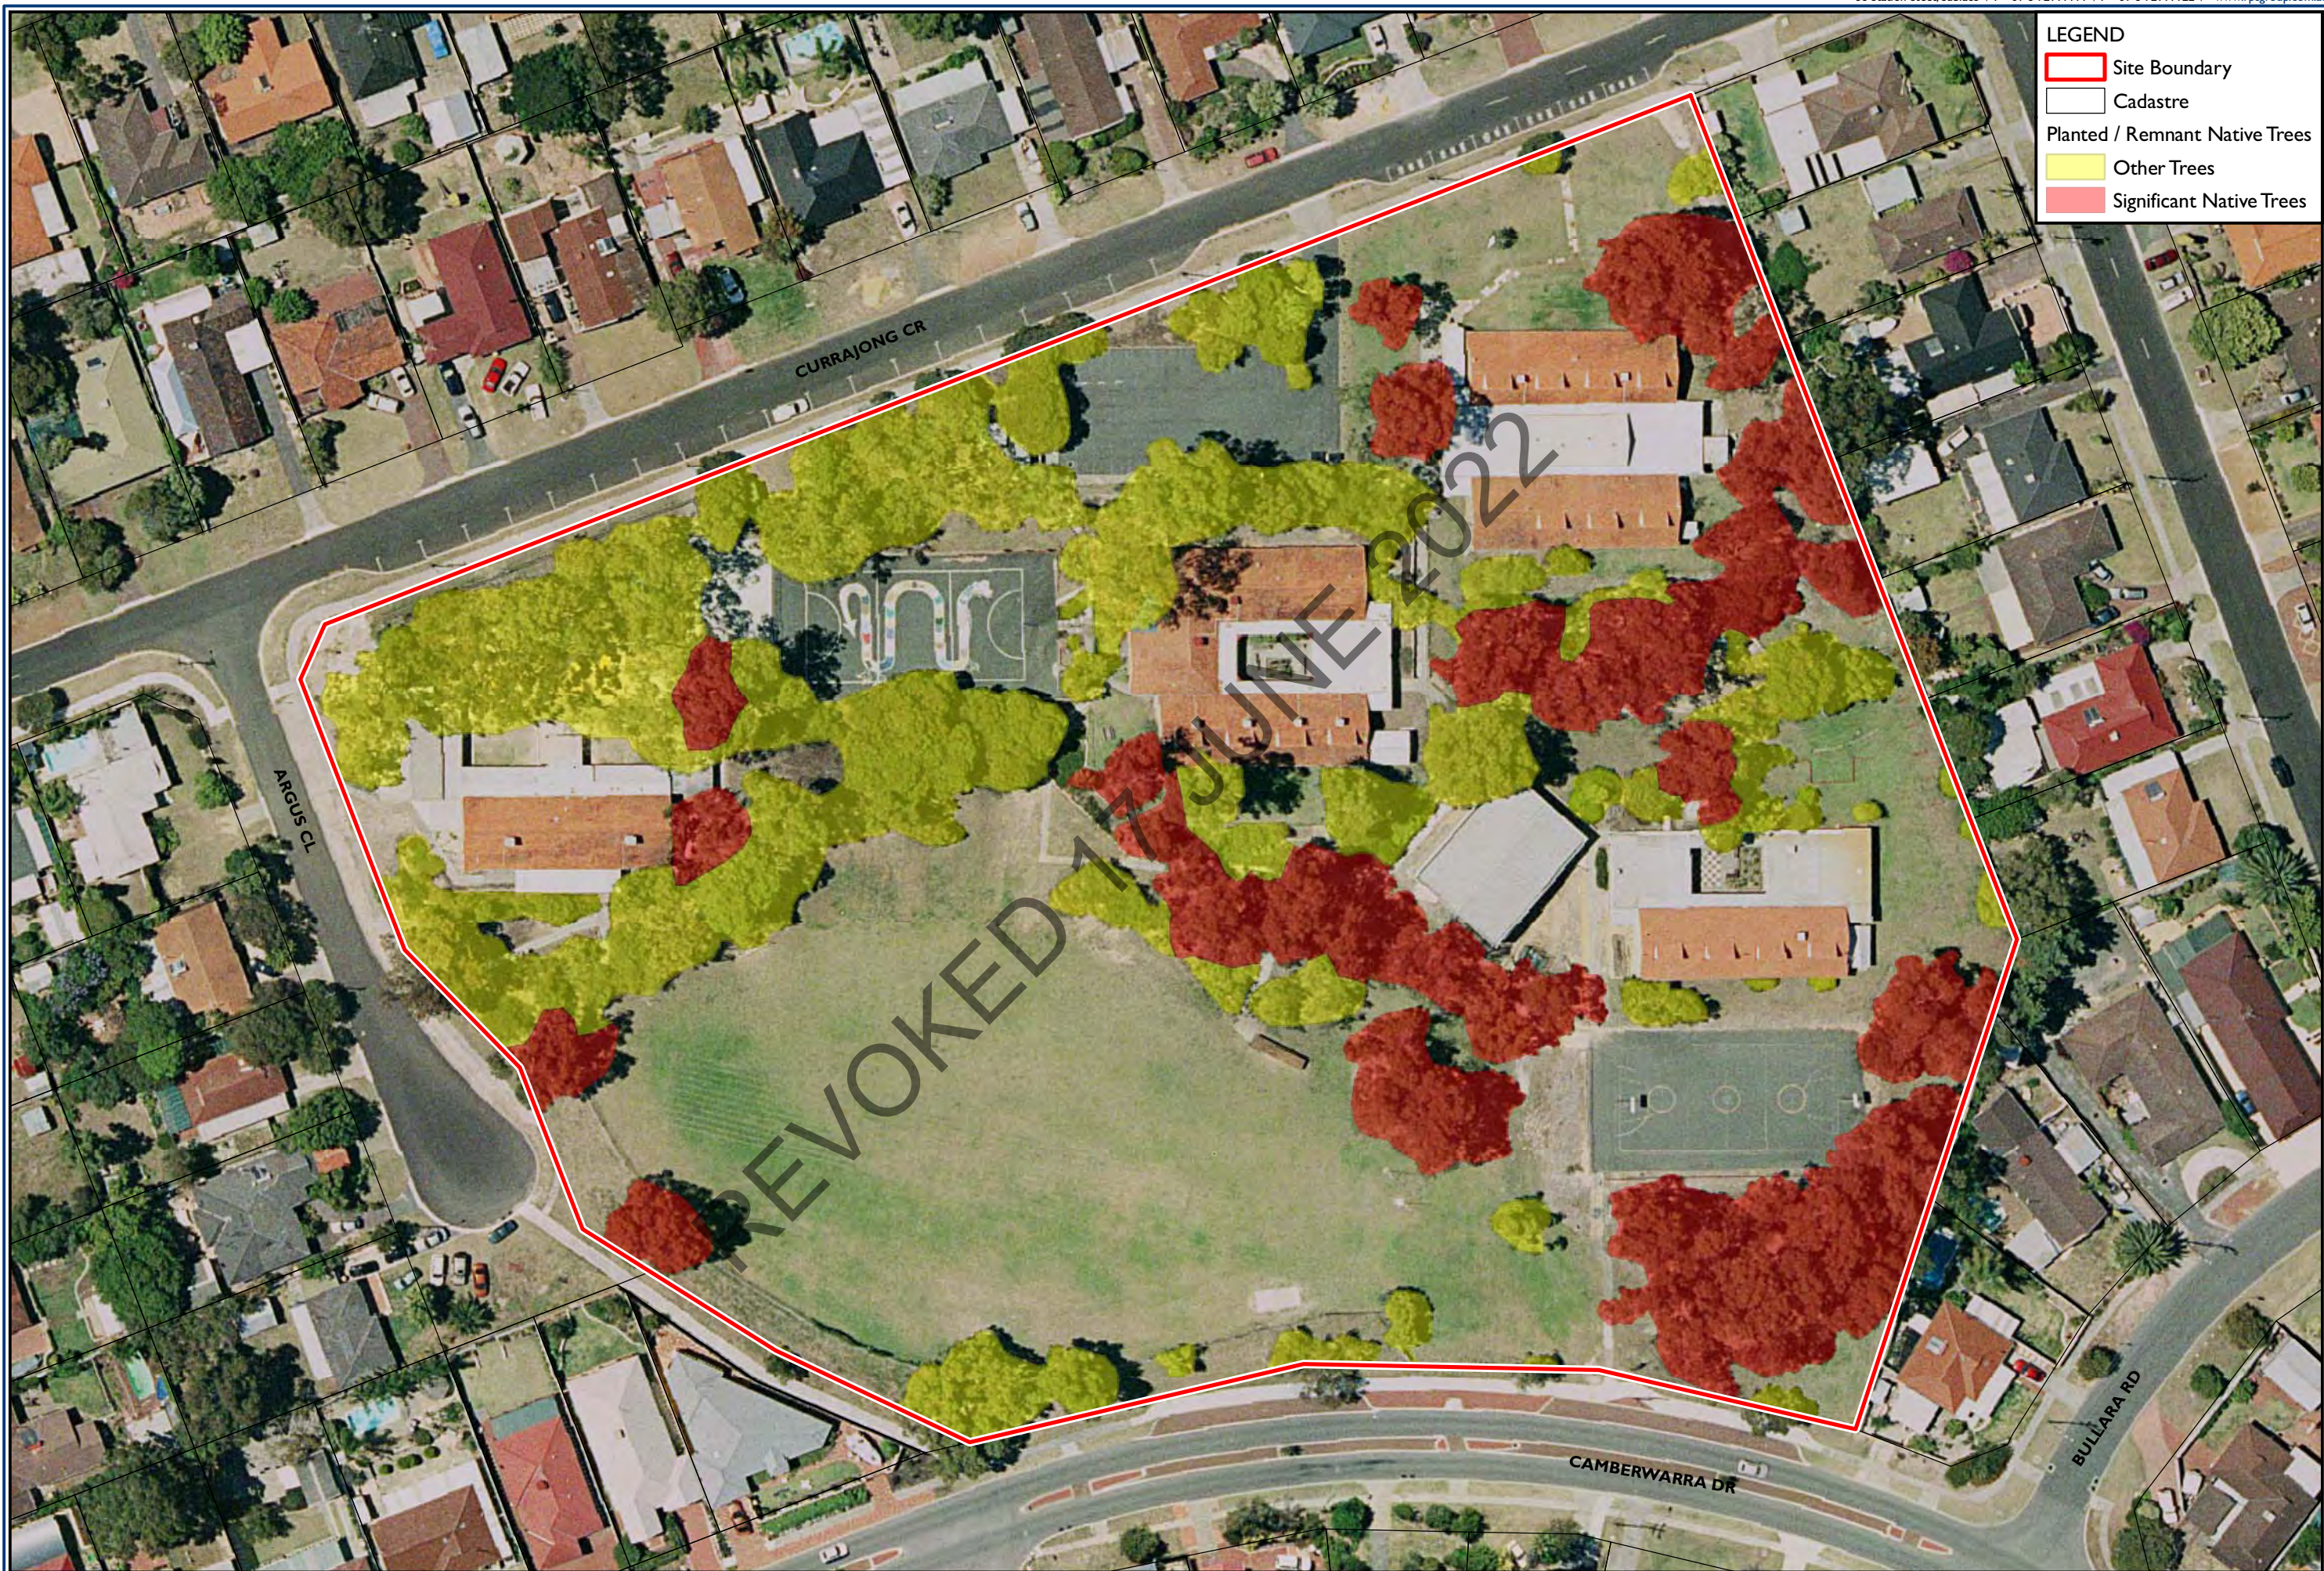
Figure 1

Site Location

LEGEND

- Site Boundary
- Cadastre
- Planted / Remnant Native Trees
- Other Trees
- Significant Native Trees

The survey was conducted as part of preliminary investigations to formulate a concept plan for development of the site by Landcorp and to provide the necessary site report to obtain environmental approvals as appropriate. Location of the study area is shown in Figure 1.

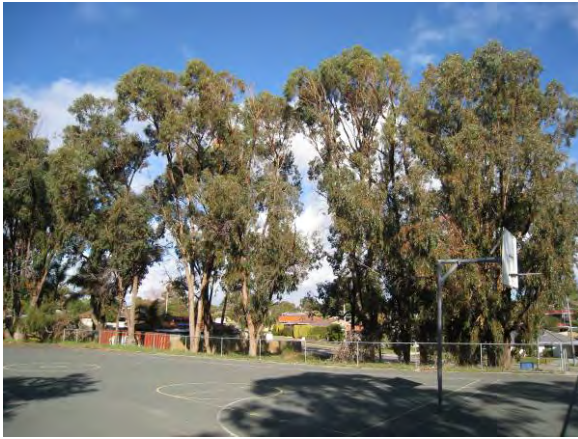
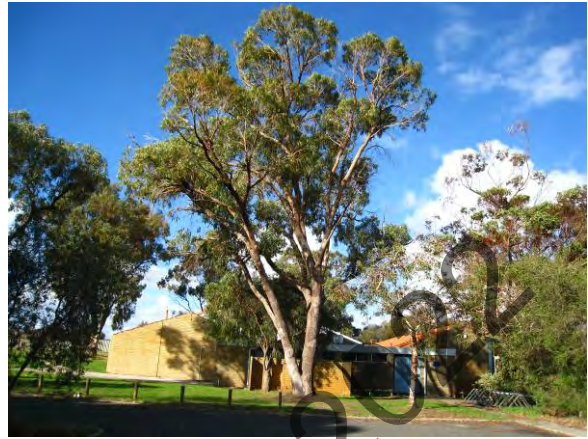
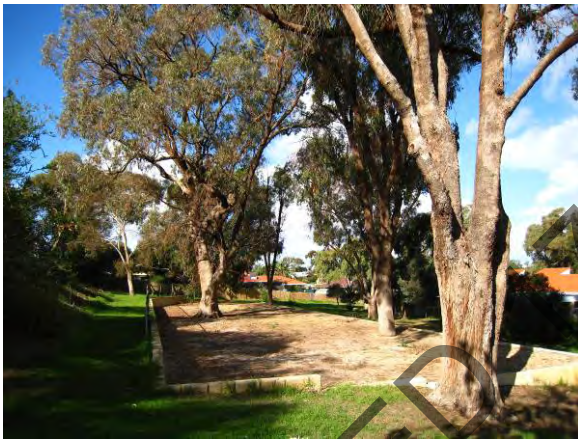
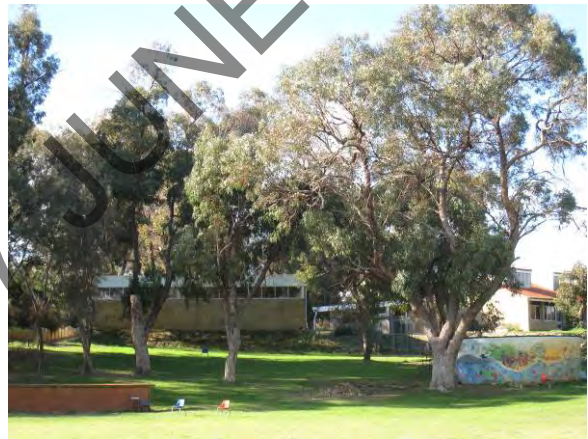
**Remnant Tuart trees (Significant Habitat Trees) across the Site**

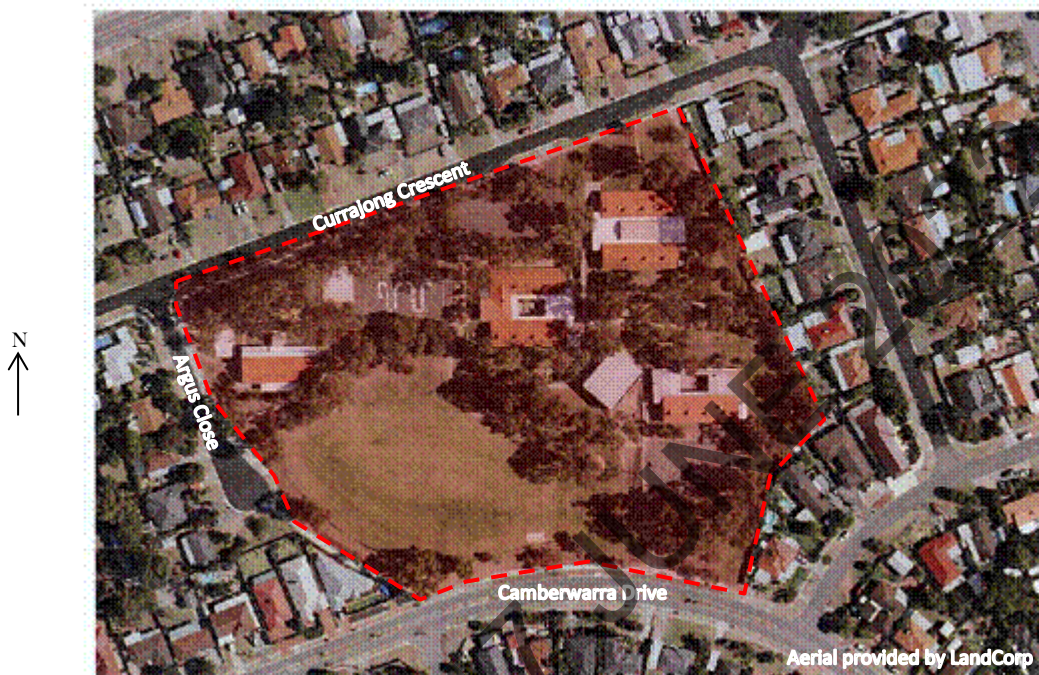
At the request of LandCorp I have been commissioned to undertake an inspection of the trees found in an area proposed for development of (what was) the Camberwarra Primary School, Craigie ("Site"); identified on the aerial image below.

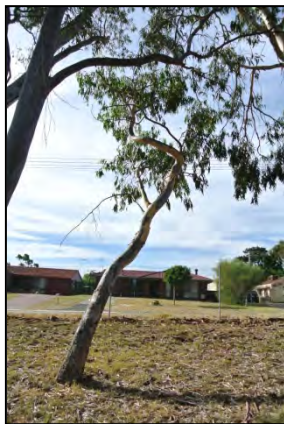
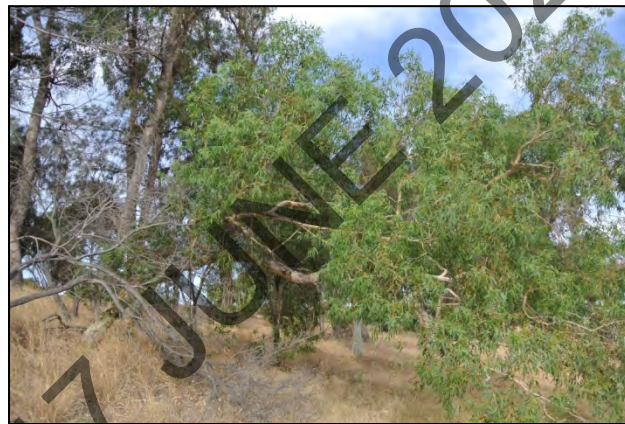
A number of the trees on this Site also showed to have grown on lean (in some instances severely so) as a result of their proximity to each other and influence of adjacent trees (limiting availability of physical space and light); examples of which can be seen in the images below.

In many instances specimens of this nature will develop amounts of reactive woody tissues to enable them to maintain support of their above ground parts, and as such the risks associated with such trees is not necessarily greater than if they had grown on a more vertical plane.

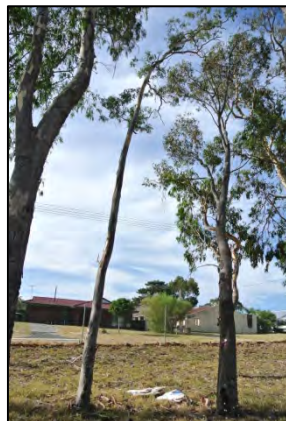
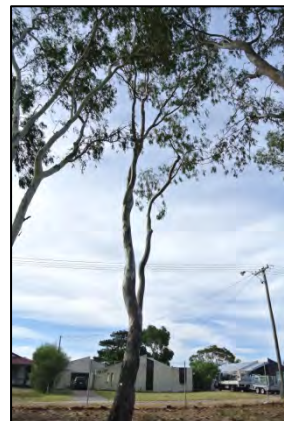
A number of the trees also showed to have developed (what can be best described as) a somewhat 'leggy' upright canopy habit with relatively little lower canopy mass; again due to their proximity to each other and availability of physical space and light; examples seen in the images below.

Whilst this is again not necessarily always a cause of major concern, trees with structures of this nature can have an increased potential for failure; particularly if they become suddenly exposed to wind forces that they are currently protected from as a result of the clearing of other adjacent trees.

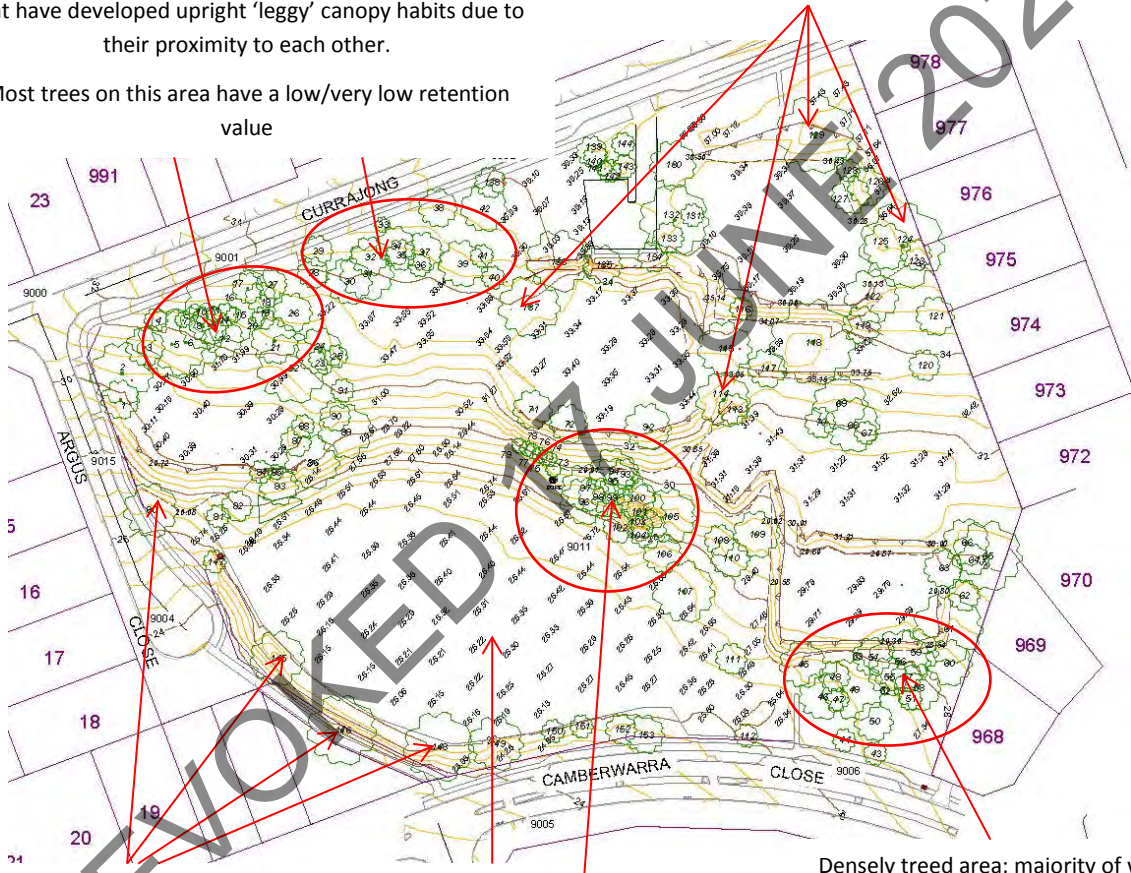
Large mature individual specimens of some note

Open area with relatively few trees

Densely treed area; majority of which are mature Tuart some of which are considered to (potentially be) remnant trees for this area

Densely treed area of mixed species

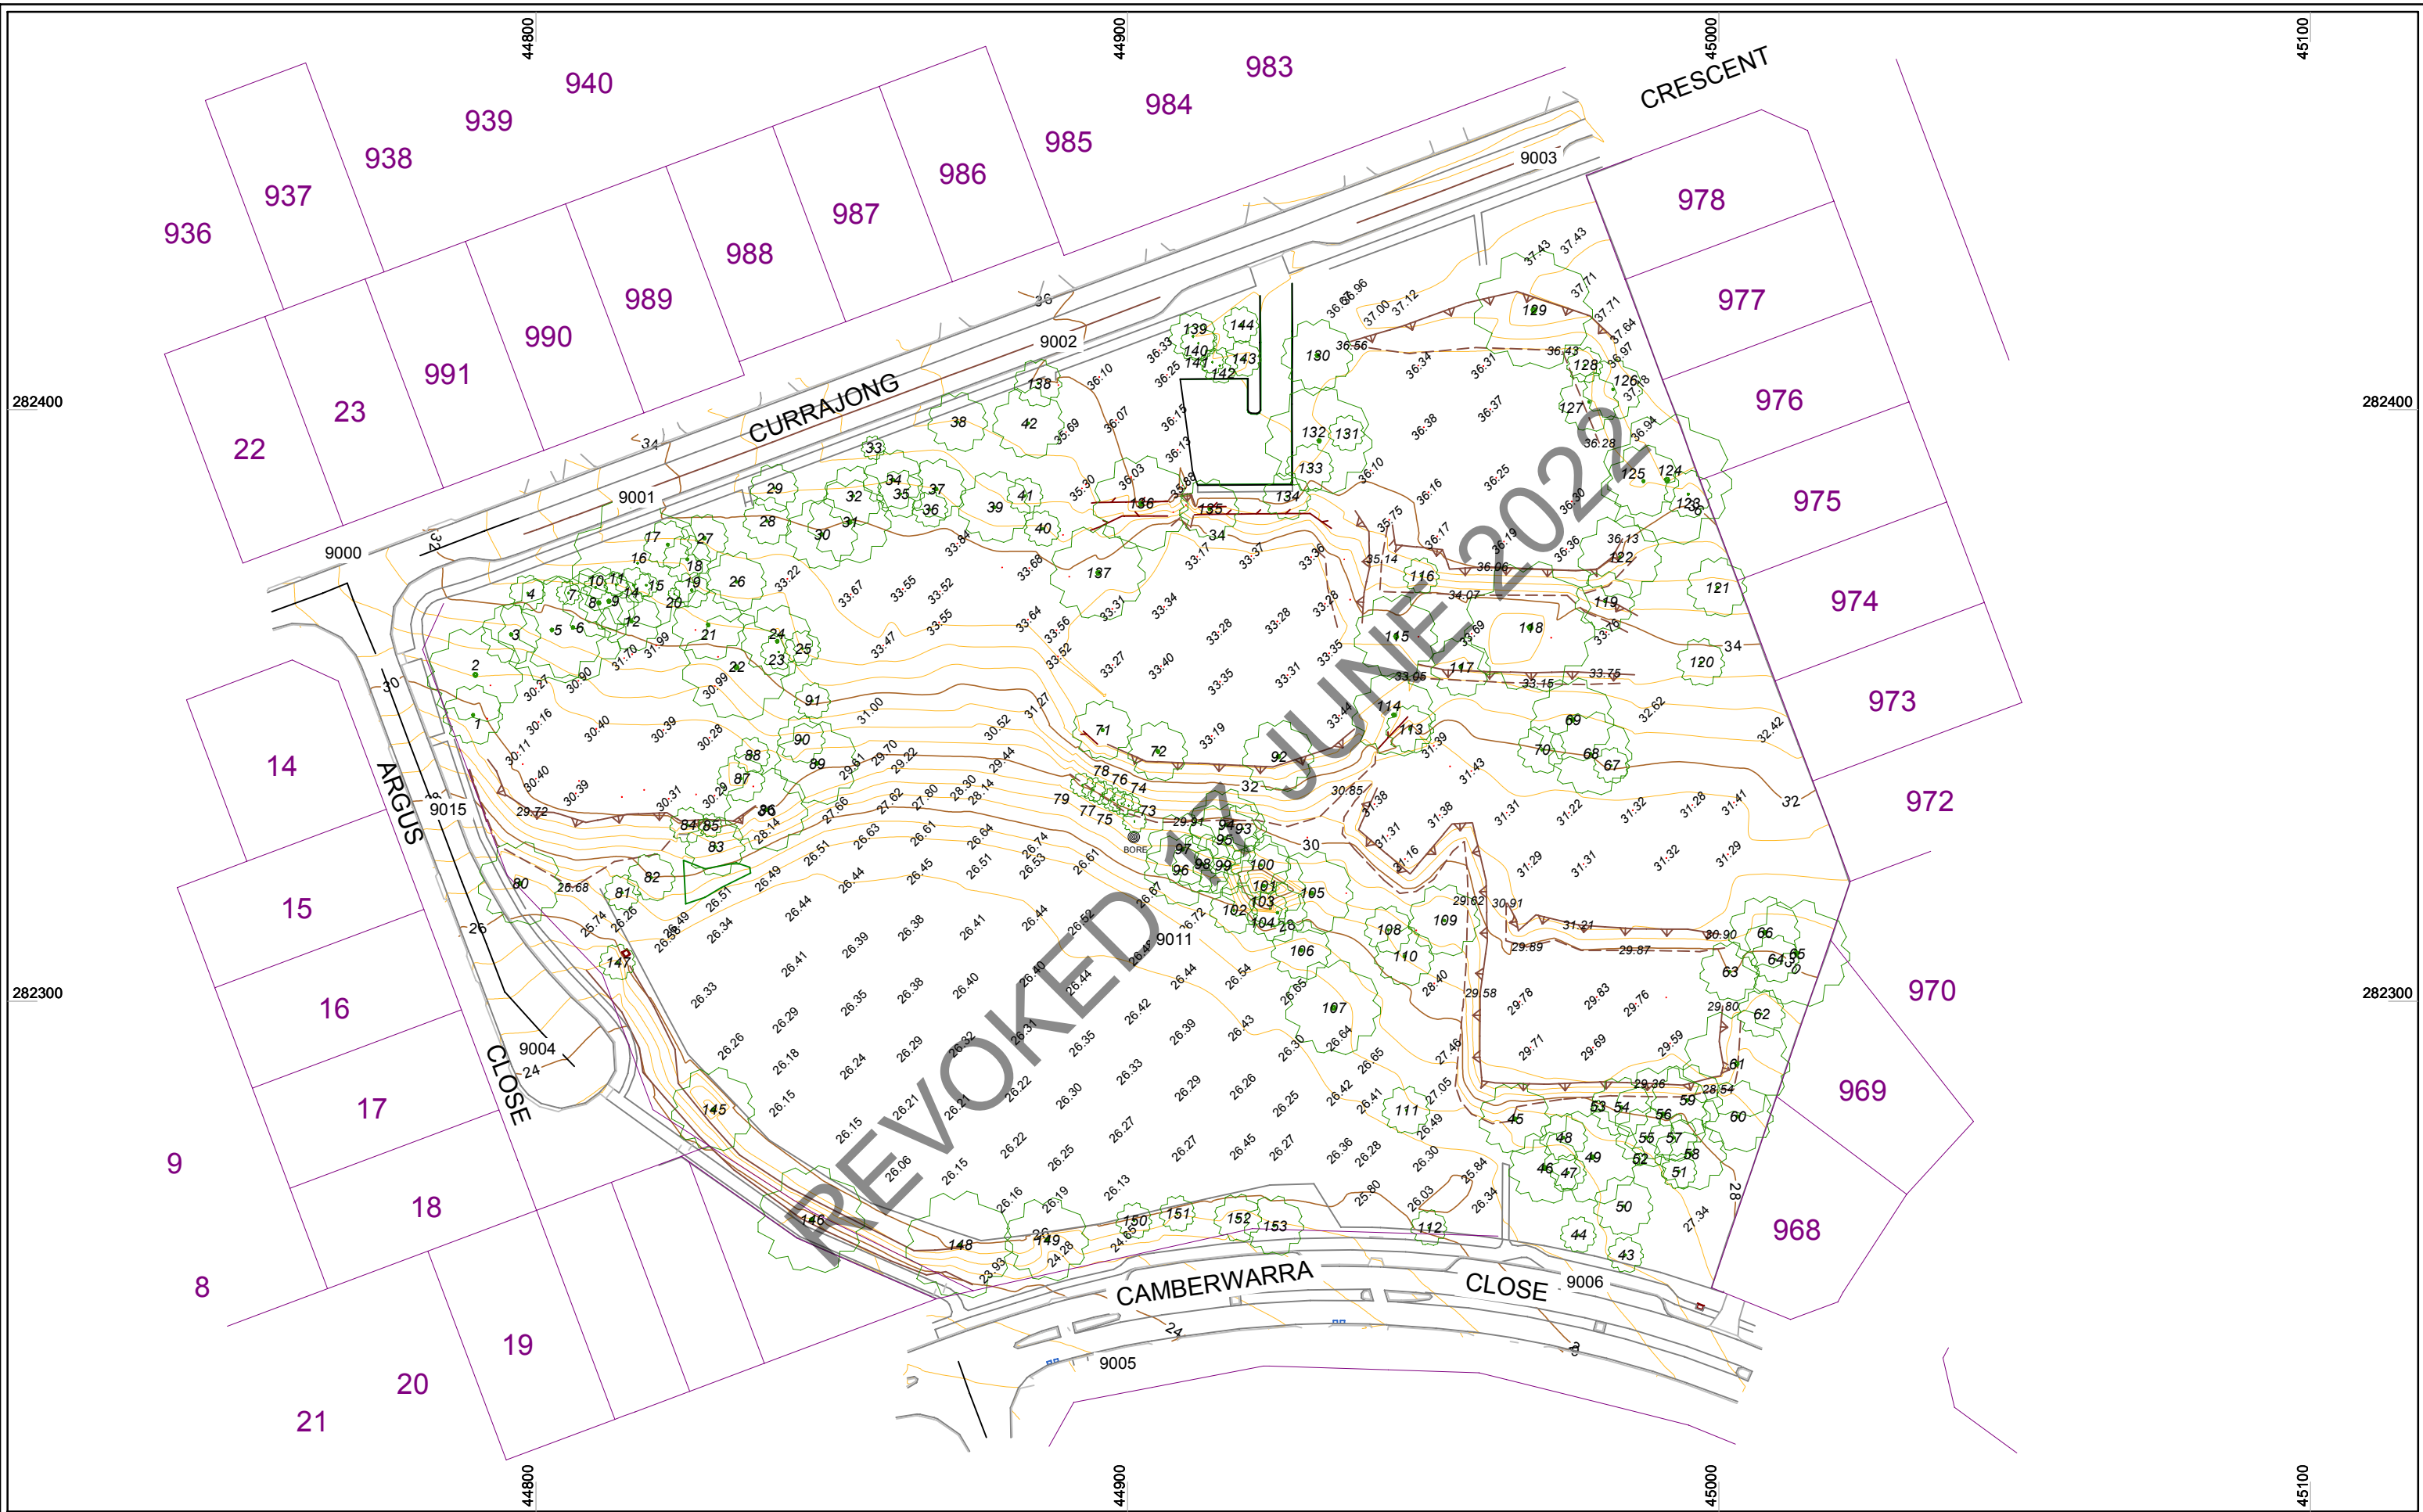
Attachment 1; Tree Location Guide

Rev.	Description	Drawn	Date	Checked
B	Tree Details Added	DHI	01/03/2012	TAV
A	Initial Issue	PKA	21/12/2012	TAV

SCALE 1:1000 @ A3
 0 10 20 30 40 50
 ALL DISTANCES ARE IN METRES
 For a true to scale reproduction of this plan, plot it to A3 with the Paging Scaling set to None.

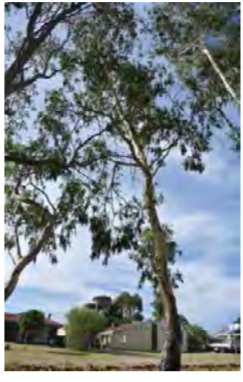
Reasonably good mature specimen. Upright canopy habit due to past powerline pruning	5	Medium	382785.269	6483118.553
18	River Red Gum	16	500	6-8	6-8	Excellent	Acceptable - Good

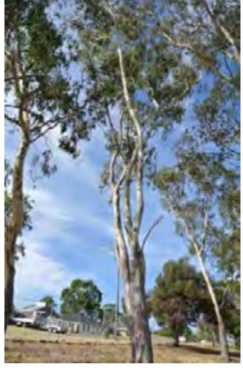
Reasonably good mature specimen. Relatively upright canopy habit due to proximity and influence of the adjacent trees	5	Medium	382788.391	6483115.525
19	River Red Gum	16	450	4-6	4-6	Good	Acceptable

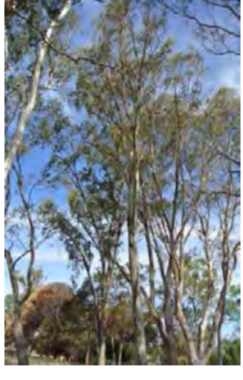
Reasonably good mature specimen. Tall upright canopy habit due to proximity and influence of the adjacent trees. Main stem bi furcates but union looks to be ok	4.5	Low	382789.914	6483111.146
20	River Red Gum	6	150	1-2	1-2	Poor (Indicating Decline)	Acceptable

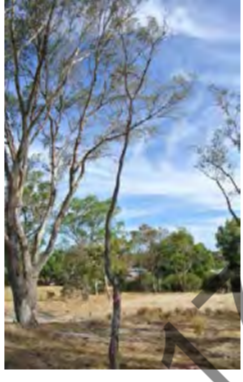
Near dead tree	2	Very Low	382783.587	6483110.859
21	River Red Gum	18	650	10-12	10-12	Good	Good

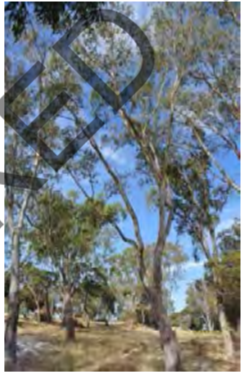
Good mature specimen. Canopy is slightly sparse but otherwise ok	6	High	382792.931	6483100.865

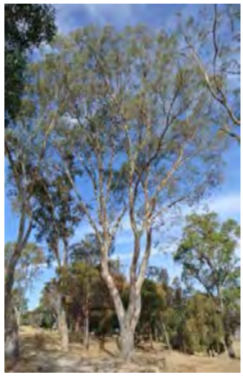
Large mature specimen. High aesthetic and amenity value. Canopy is slightly sparse but otherwise ok	9	High	382798.521	6483096.693
23	Bald Island Marlock	7	250	4-6	8-10	Fair	Acceptable - Good

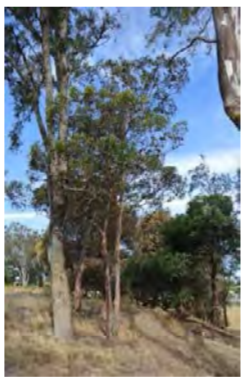
Ok specimen. Canopy is slightly sparse. Main stem bi furcates but union looks to be ok at this stage	3.5	Low	382801.207	6483098.909
24	Tuart	18	650	10-12	8-10	Fair	Acceptable - Good

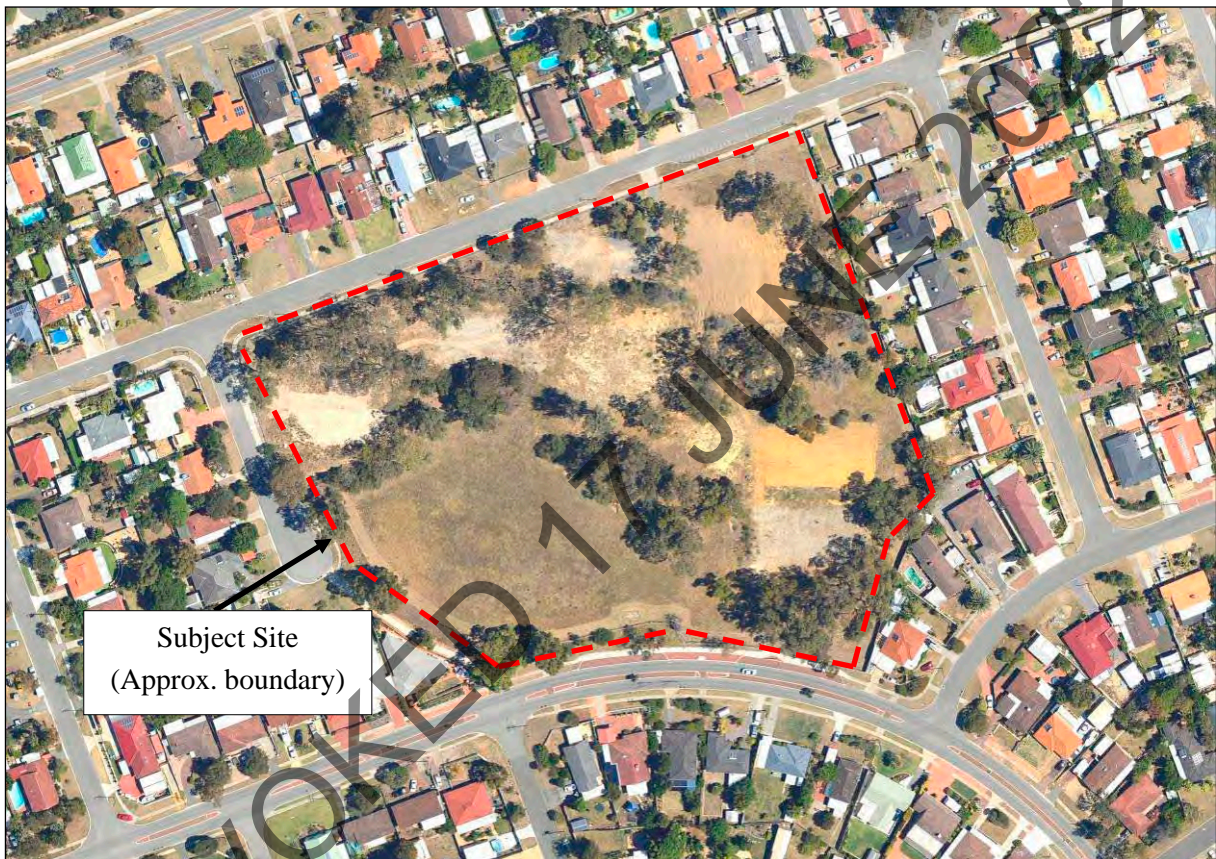
Figure 2.1: Site location – Local context

The subject land is currently vacant and undeveloped. The site is typically surrounded by existing residential land uses. Craigie is an established suburb and as such surrounding land is subsequently fully developed. **Figure 2.1** contains an aerial view of the subject site and its immediate surrounds and its location in a local context. **Figure 2.2** shows the site in a regional context.

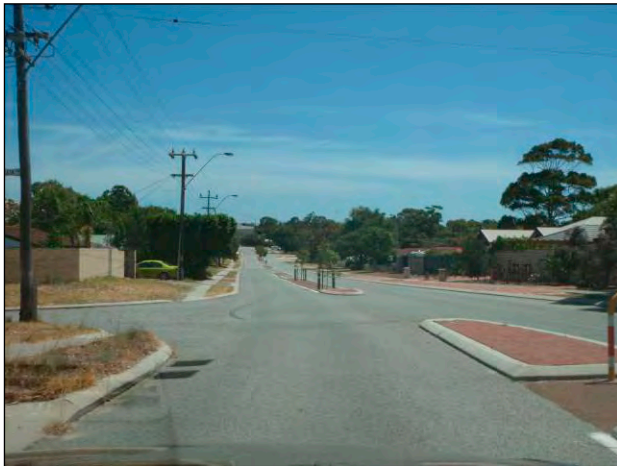
Photo 1: Camberwarra Dr, looking west towards Fenellia Cres

There are existing footpaths on both sides of Camberwarra Drive. Typical widths are 1.2m however immediately adjacent to the site the footpath is widened locally to accommodate the increased pedestrian usage during the operation of the old school.

The built up area speed limit of 50km/h would apply past the site. Camberwarra Drive forms a continuous loop within the adjacent residential area with numerous road connections along its lengths.

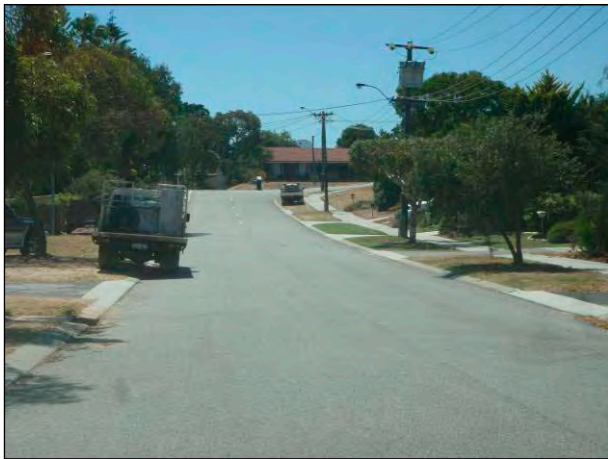
Photo 3: Currajong Cres, looking north from Camberwarra Dr

There is an existing 2.0m wide footpath located on the southern side of Currajong Crescent adjacent to the site. Pedestrian links from Currajong Crescent connect through to Craigie Drive, Barwon Road and Allinga Crescent.

The built up area speed limit of 50km/h would apply past the site. Currajong Crescent forms a u-shaped road connecting with Camberwarra Drive and Bullara Road.

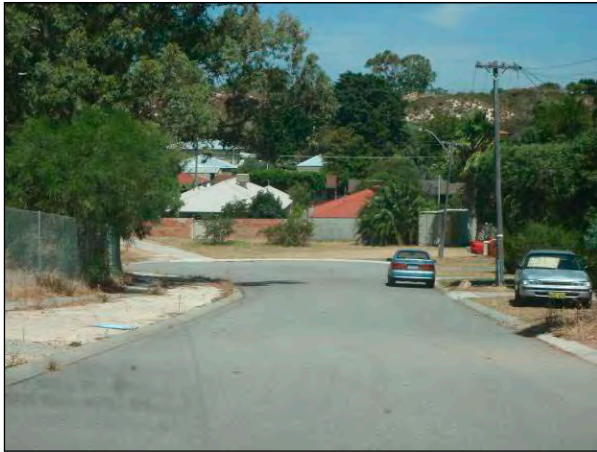
Photo 7: Argus Cl, looking south towards cul-de-sac end

Argus Close is constructed to a kerbed, two lane undivided single carriageway road. The approximate pavement width is 6.2m. There is an existing 1.2m wide footpath located on the eastern side of Argus Close adjacent to the site.

The built up area speed limit of 50km/h would apply past the site although the local conditions i.e. road length and cul-de-sac form would likely restrict speeds to less than this.

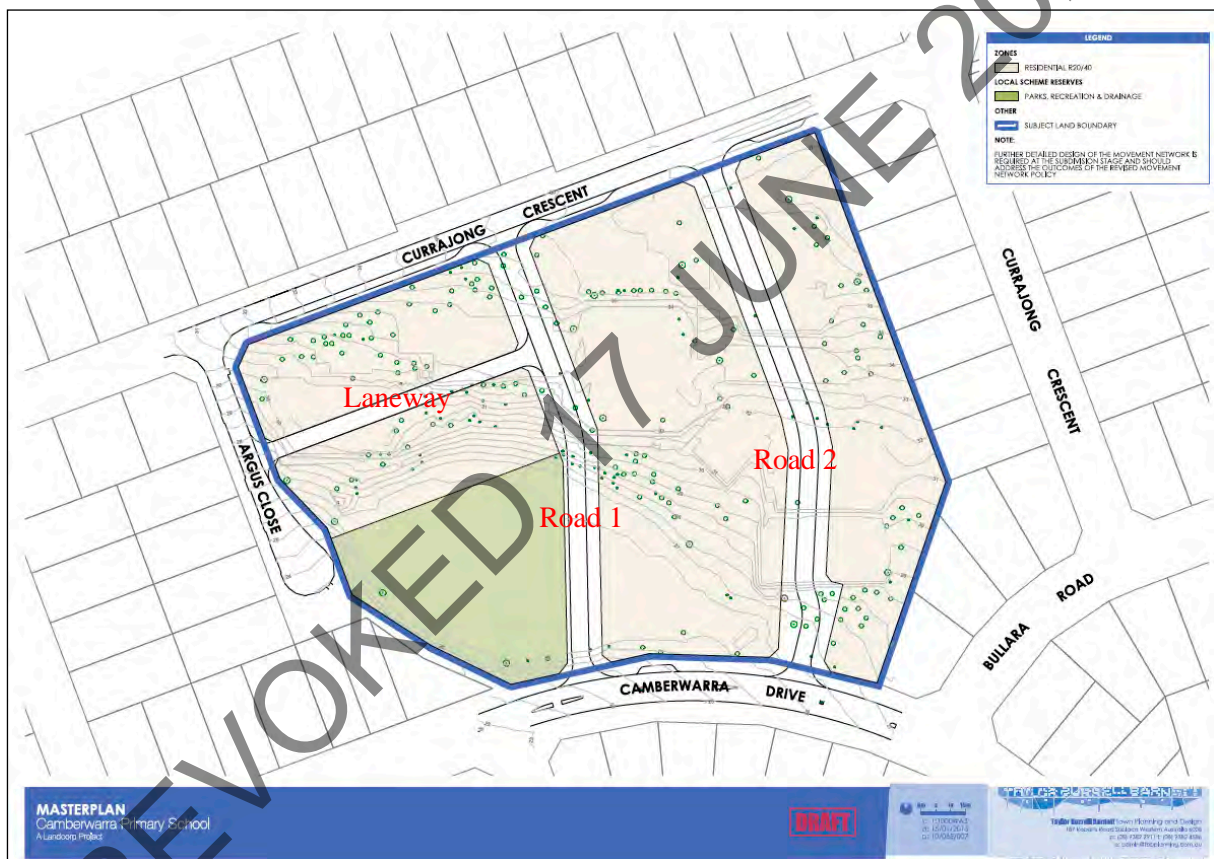
Figure 4.1: Internal Road Network and Identifying Names

The proposed road network is shown in **Figure 4.1**. As the proposed roads are yet to be named, the identifying names as per **Figure 4.1** have been adopted for use in this assessment. The two internal roads of the subdivision simply connect in a north-south orientation between Camberwarra Drive and Currajong Crescent. The nature of the road layout is such that minimal external traffic is likely to use the newly created roads with the exception being local traffic whose origin/destination is Currajong Crescent itself.

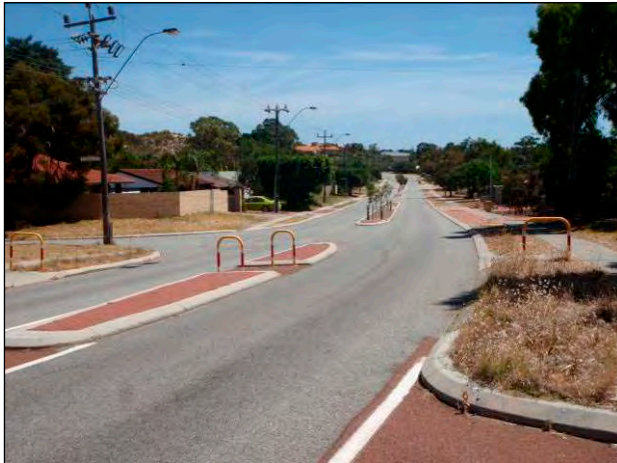
Photo 9: Approximate sight lines from Road 1 along Camberwarra Dr to the west

Potential sight lines from the proposed intersection connections were observed on site. The sight lines are good and are appropriate within the residential environment.

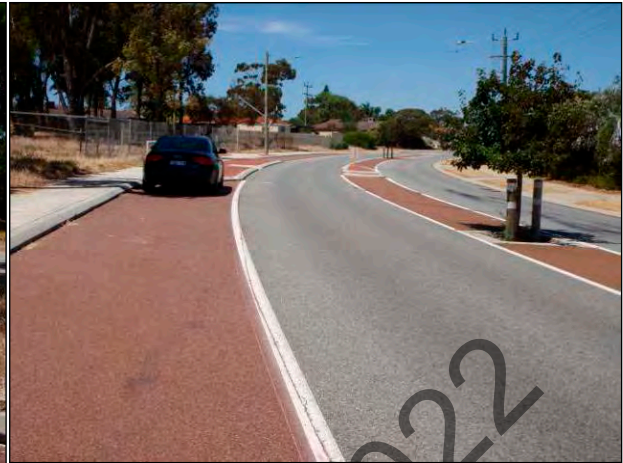
Photo 10: Approximate sight lines from Road 1 along Camberwarra Dr to the east

Potential sight lines from the proposed intersection connections were observed on site as shown in **Photos 9 to 12**. The sight lines are good and are appropriate within the residential environment.

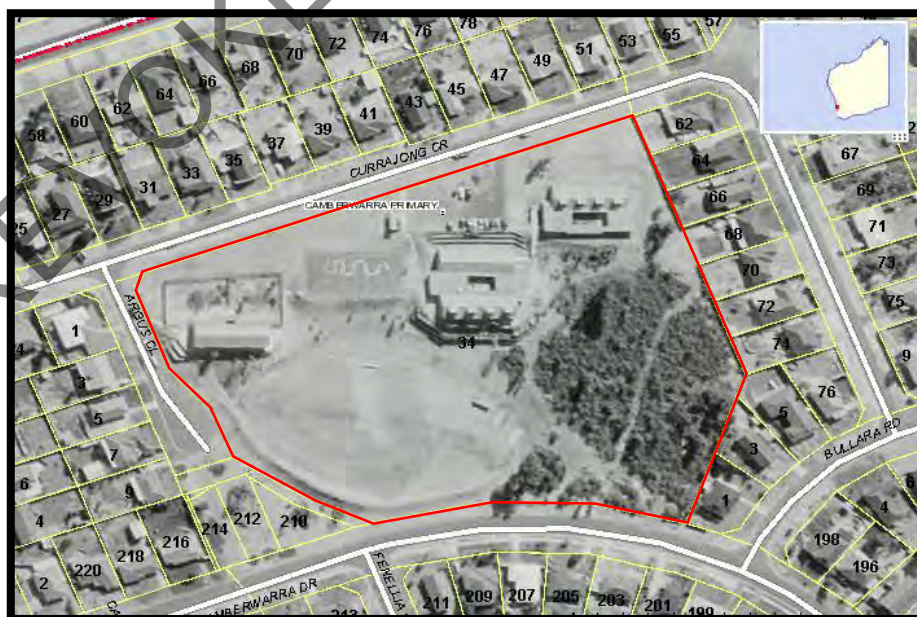
Photo 2: Historical Aerial Photography from 1979 (Landgate, 2013)

Aerial photography from 1979 shows that much of the vegetation in the south-east corner has been removed for an additional structure and hardstand sports court (Photo 2).

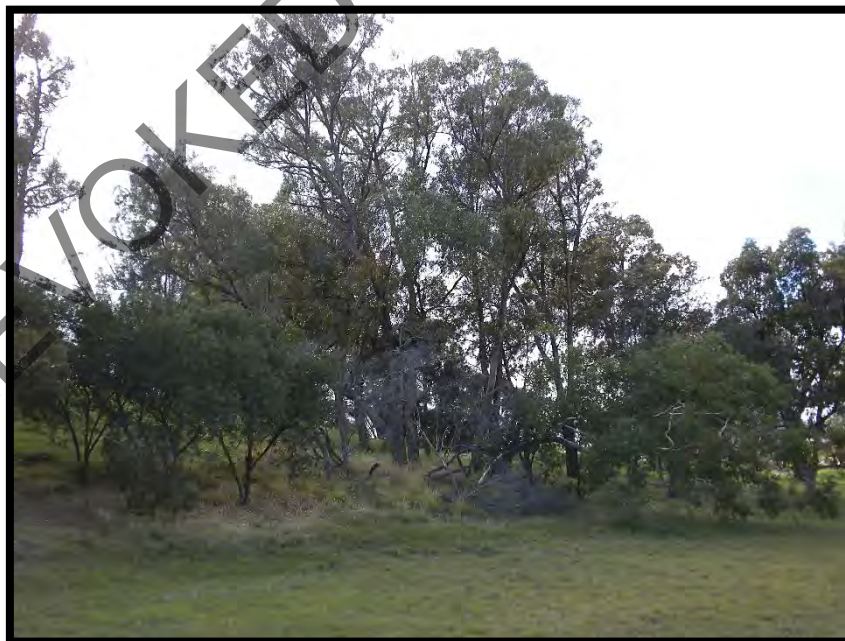
Photo 3: Vegetation on the site

As a result of past clearing there is very little remnant vegetation on the site and most of the trees present have been planted in the last 35 years. Currently the Camberwarra Primary School Site consists of largely planted exotic and native species of tree over a weedy understorey (Photo 3).
