R1668 Rev 1

May 2022

City of Joondalup

**Joondalup Coastal Monitoring
2021/22 Data Report**

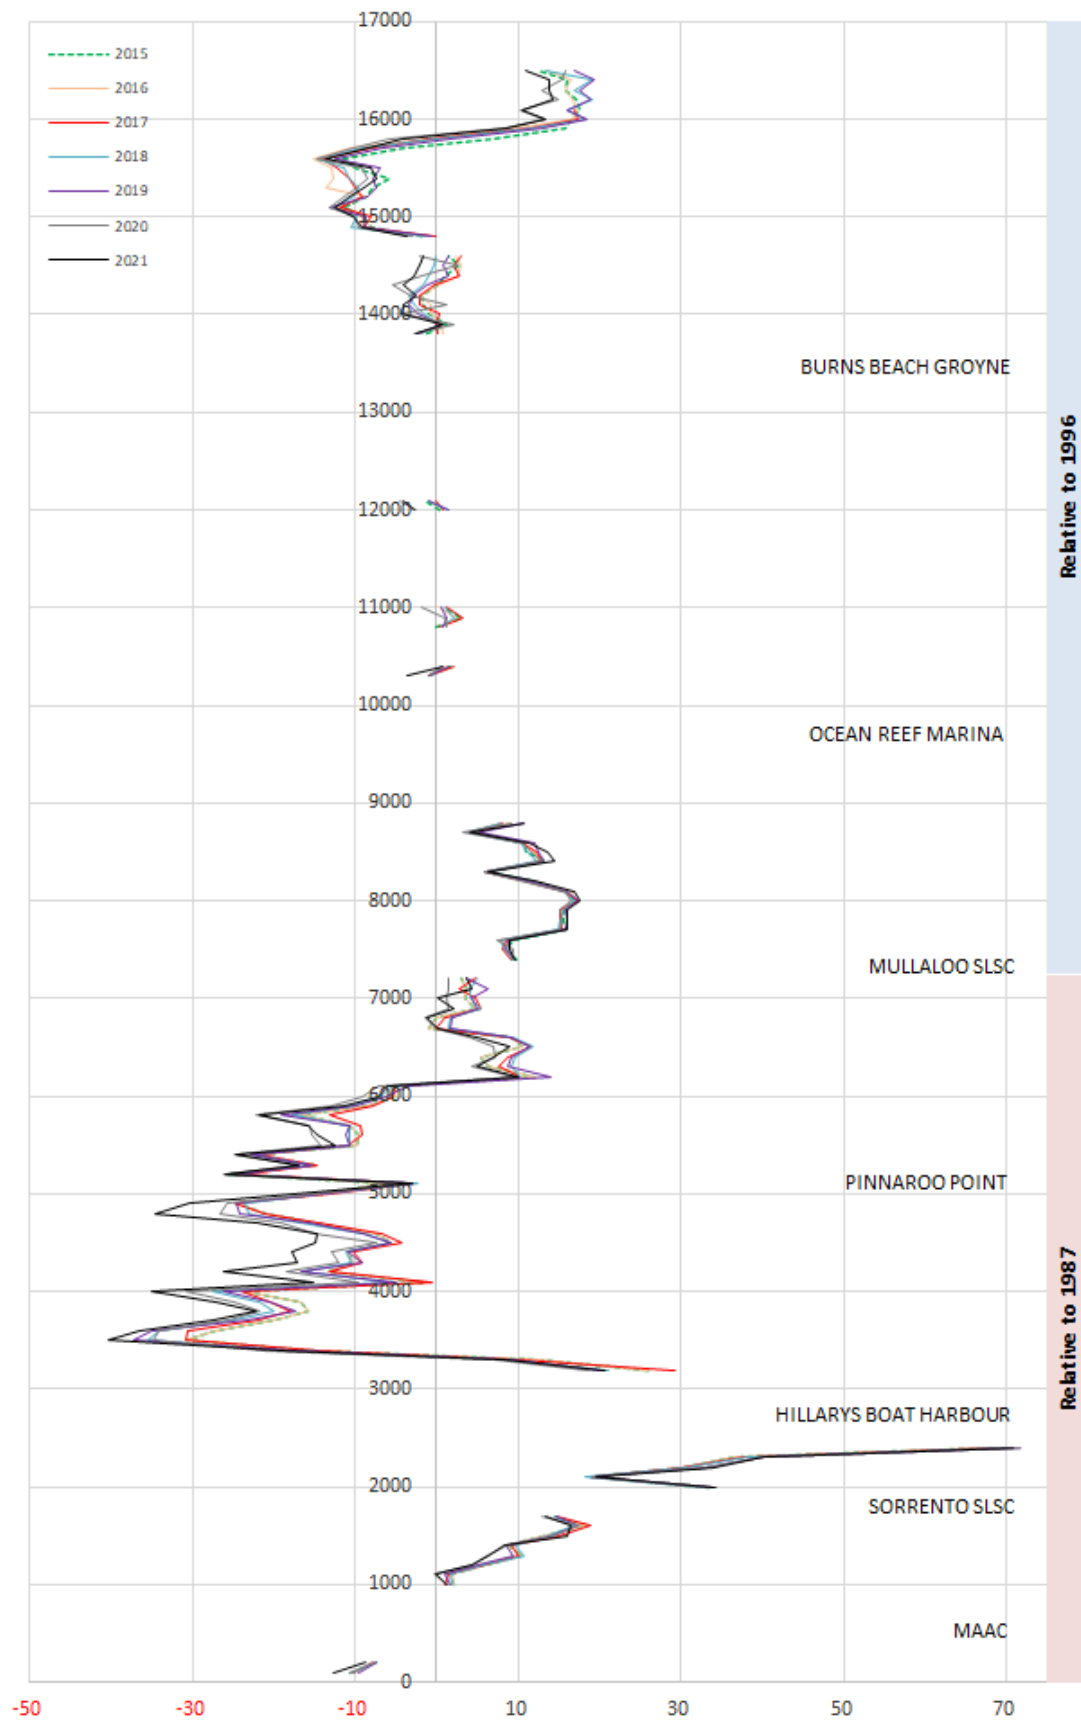
Figure 4.2 Shoreline Movement to 2021

- There were considerable amounts of erosion (up to 8 m) and areas of accretion along the City's coastline between August 2020 and October 2021.
- The overall change to shoreline position between 2015 and 2021 is generally less than 5 m. The only notable exceptions occurred at the following previously identified sites:
 - Hillarys Beach Park.
 - Pinnaroo Point.
 - The northern end of Burns Beach.

The movement in the shoreline position is presented in the following figure. While historical vegetation lines date back to 1942, significant changes to the sediment movement dynamics in the area were caused by the following developments:

The first available vegetation lines after these developments (1987 and 1996) are therefore used as the baseline for analysis in Figure 4.2. This has been discussed in detail in previous monitoring reports and assessments for the City (MRA 2016, MRA 2017, MRA 2018b and MRA 2019)). It should be noted that the gaps in the shoreline movement plot (Figure 4.2) represent sections of rocky shoreline or coastal structures where this method of coastal monitoring is not applicable.

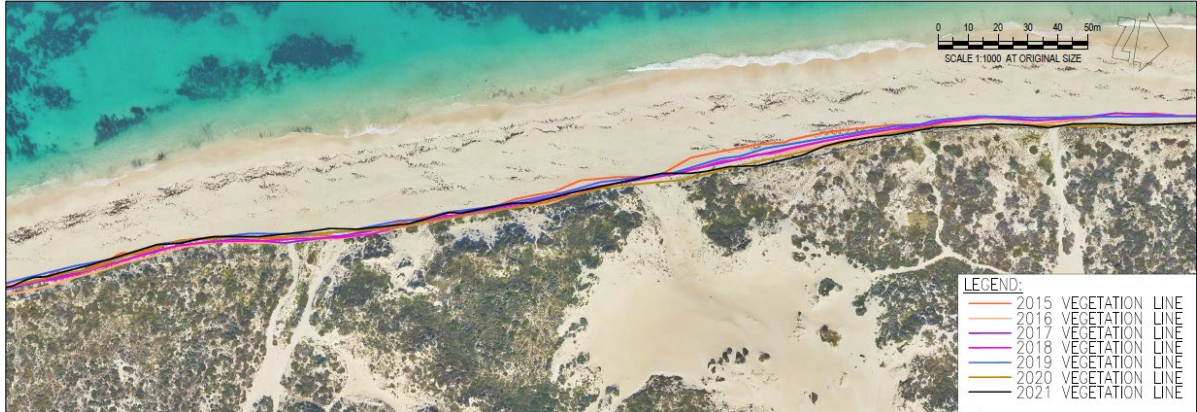
Figure 4.6 Recent Shoreline Movement at Northern End of Burns Beach

The shoreline along Burns Beach generally experienced mild accretion of up to 2m between August 2020 and October 2021. This is notably in contrast to the recession of up to 7 m between August 2019 and August 2020. The severe storm conditions and high-water levels experienced in 2020 are likely to have influenced the recession of the vegetation line. It is apparent from the periodic photographic monitoring at this site that the beach profile exhibits considerable seasonal variation. The severity of the seasonal metocean conditions and timing of the aerial imagery are likely to have an impact on the annual position of the vegetation line at this location. This observation is supported by the Photographic Monitoring discussed later in this report and included in Appendix D.

- Continue to monitor and actively manage (if required) erosion between and including Hillarys Beach Park and Pinnaroo Point.
- Continue to complete annual sand bypassing around Hillarys Boat Harbour (around 10,000 to 15,000 m³, depending on budget) to address the recession identified at Hillarys Beach Park and Pinnaroo Point. The bypassed amount should be increased from recent operations.
- Progress long term adaptation options for Hillarys Beach Park.
- Continue to monitor the shoreline movement at Burns Beach.

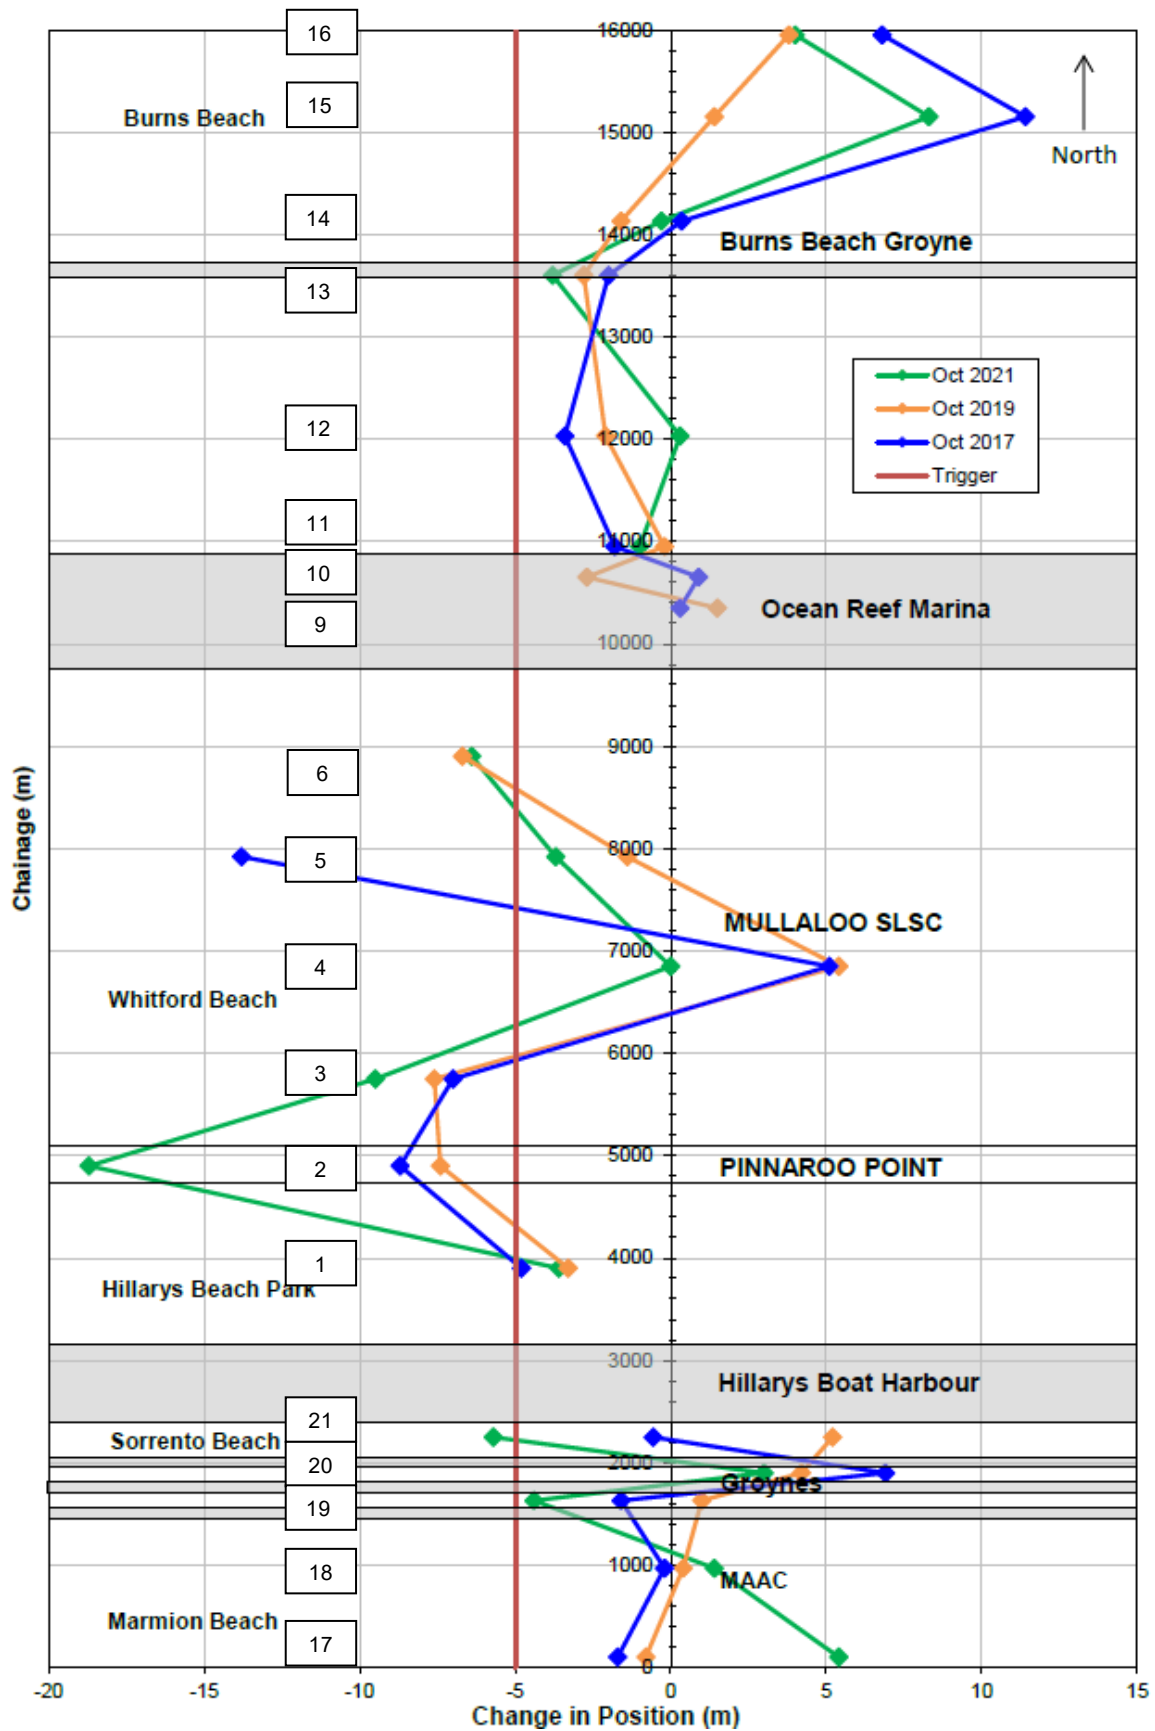
Figure 5.2 Position of 0 mAHD Relative to 2015 Baseline

- Profile 21 at Sorrento Beach has eroded over 10 m since 2019. The MSL has receded over 5 m since 2015, greater than the trigger. It should be noted that between the 2019 and 2021 surveys, two rounds of sand bypassing have removed approximately 8,700 and 8,000 m³ from Sorrento Beach. This removal of sand is a contributor to the change in the position of the MSL contour.

- All profiles north of Burns Beach groyne have accreted since 2019.
 - Profile 14 has accreted 1.3 m over 2 years, and has receded 0.3 m over 6 years.
 - Profile 15 has accreted 6.9 m over 2 years, and has accreted 8.3 m over 6 years.

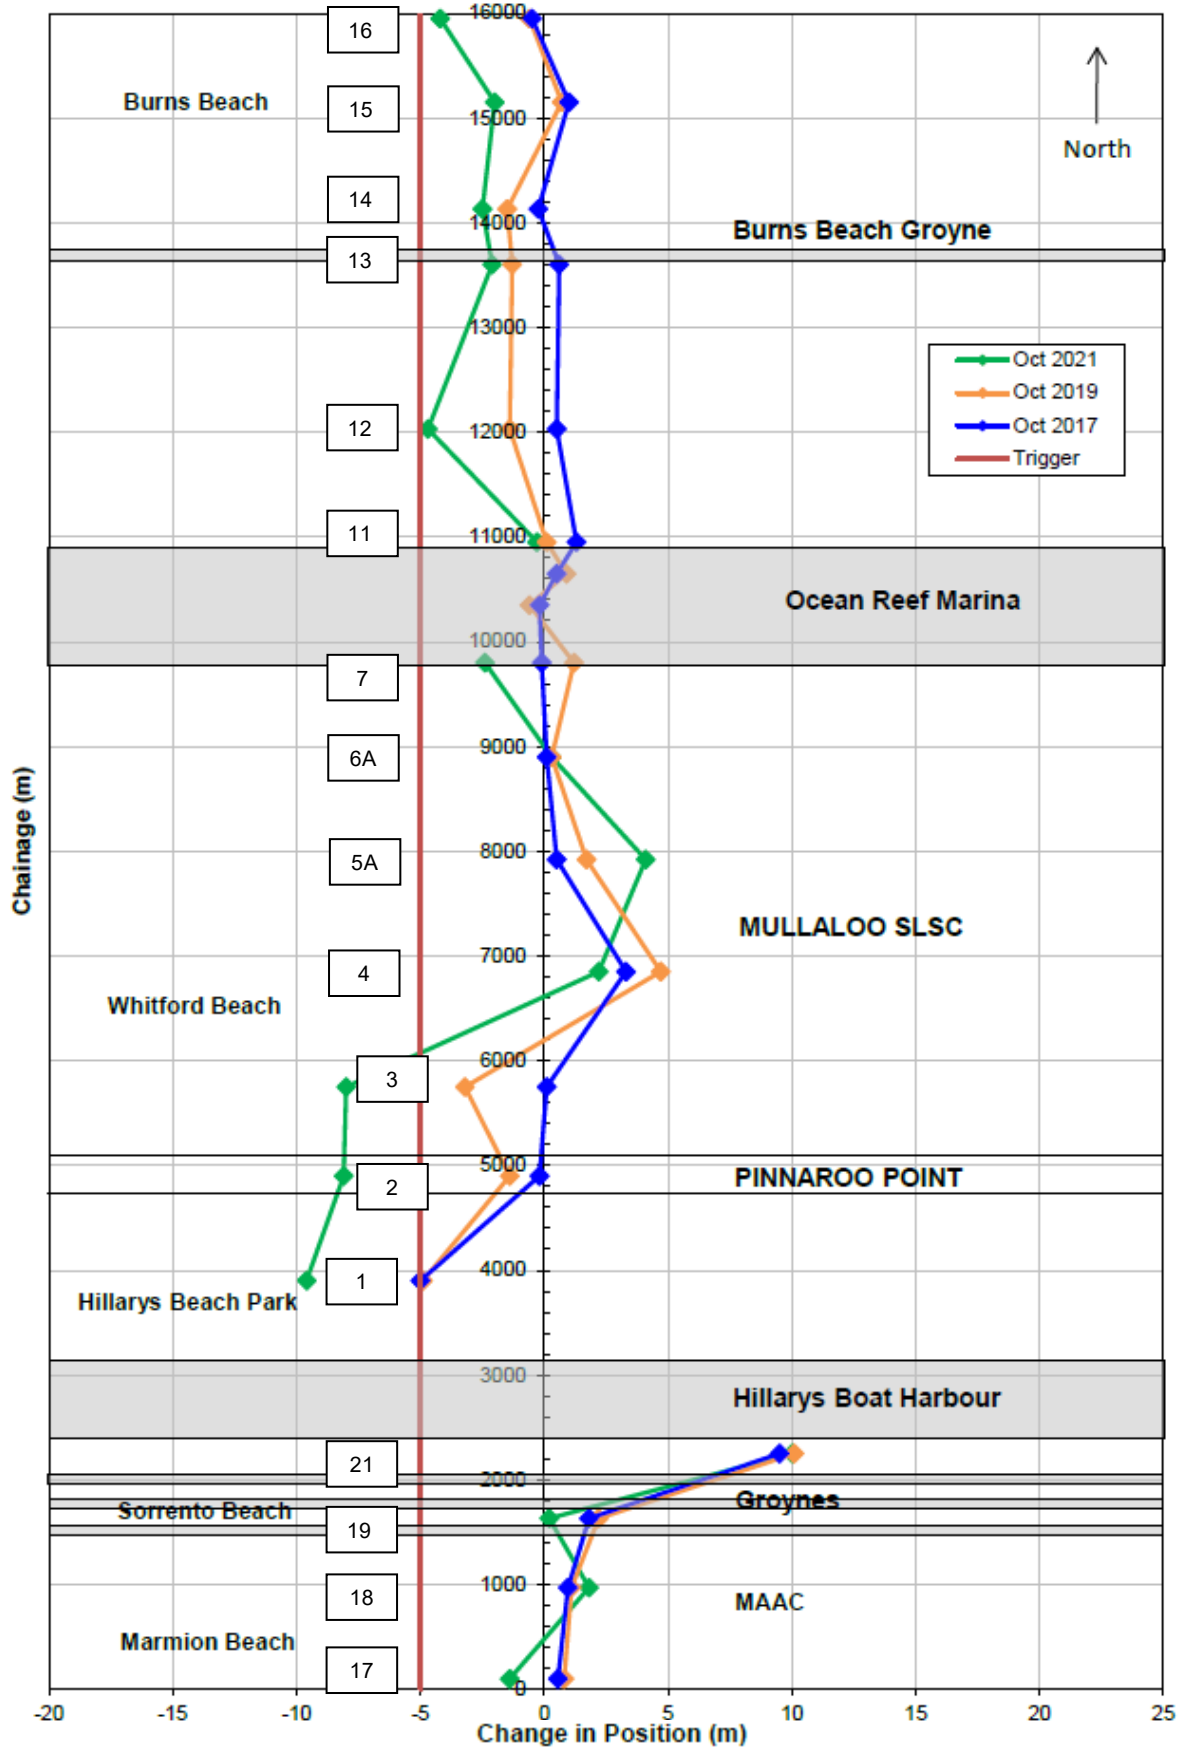
Figure 5.3 Position of Vegetation Line Relative to 2015 Baseline

As expected, changes to the +3.5 mAHD (approximate vegetation line) contour are not as large as the MSL, as it is a longer-term indicator of shoreline change and less susceptible to fluctuation and short-term changes. However, Profiles 1, 2 and 3 are above the trigger value for erosion. These profiles have all eroded more than 4.5 m since 2019.

At Sorrento Beach (profile 21) the survey data shows that the 0 mAHD contour (MSL) has receded by 5.7 metres since baseline monitoring began, this is in contrast to the accretion of the +3.5 mAHD contour (vegetation line) by 10 metres relative to baseline. While this initially appears contradictory, the sand by-passing supply area is close to the waterline of Sorrento Beach which is why a recession has been noted in the MSL. The recorded recession may be to do with timing and layout of the survey with respect to the sand removal works. The sand-passing volume is considered to be less than the sediment arriving onshore at Sorrento, the accretion of the vegetation line is considered to be a resultant of the anticipated surplus of material which is likely wind blown and is contributing to dune growth and vegetation line accretion.

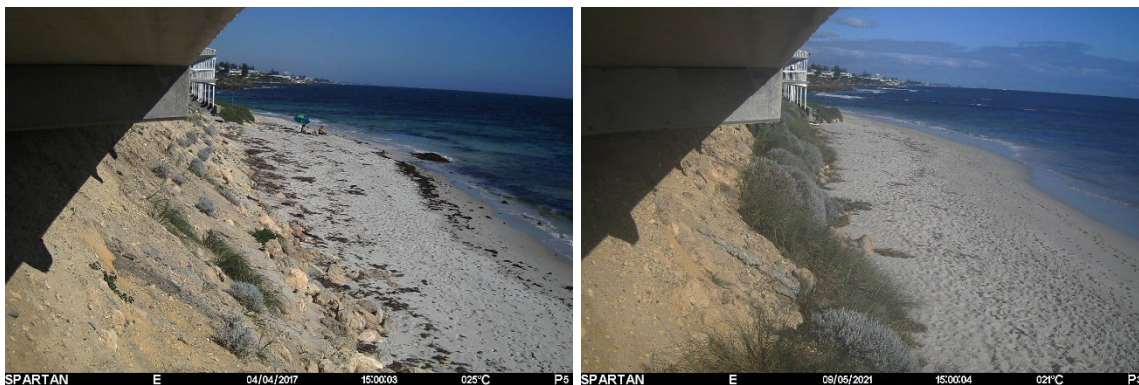
Figure 6.2 L) 2017 Commencement; R) 2021 Conclusion

Since the setup of the camera in 2017, the shoreline and dune in front of the carpark and MAAC has not experienced any significant long term erosion or accretion. The dune face that provides a foundation for the carpark has exhibited an increase in vegetation over the past 4 years which appears to be stabilising the dune as seen in Figure 6.2. There is also the presence of cobble-size rocks at the base of the slope which appear to be acting as scour protection during moderate to high water events. While there is still a risk to the carpark if the dune were to be eroded, particularly in extreme weather events, minimal net change in the beach profile and dune face was recorded throughout the duration of the fixed camera monitoring program. It was therefore decided to not install another fixed camera at this location. This location will continue to be monitored via surveying and periodic photo monitoring.

Instead, the utilisation of a temporary camera at a point of interest (Hillarys Beach Park, Pinnaroo Point, Burns Beach) to capture a severe storm event is being investigated. This will provide the City useful data in helping to manage coastal assets that are located in areas that have historically eroded or are at risk from erosion due to severe weather events.

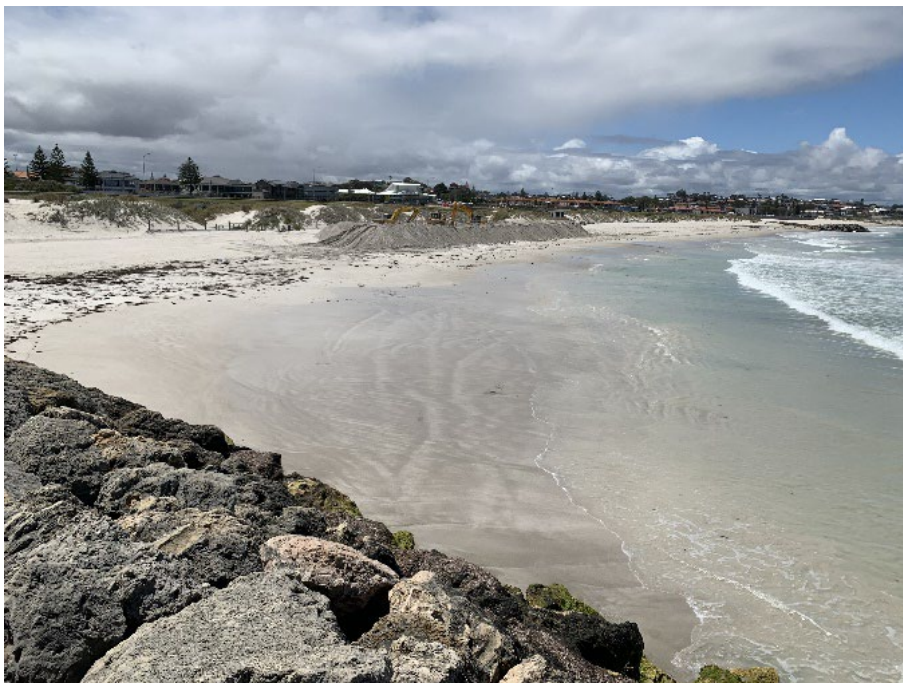
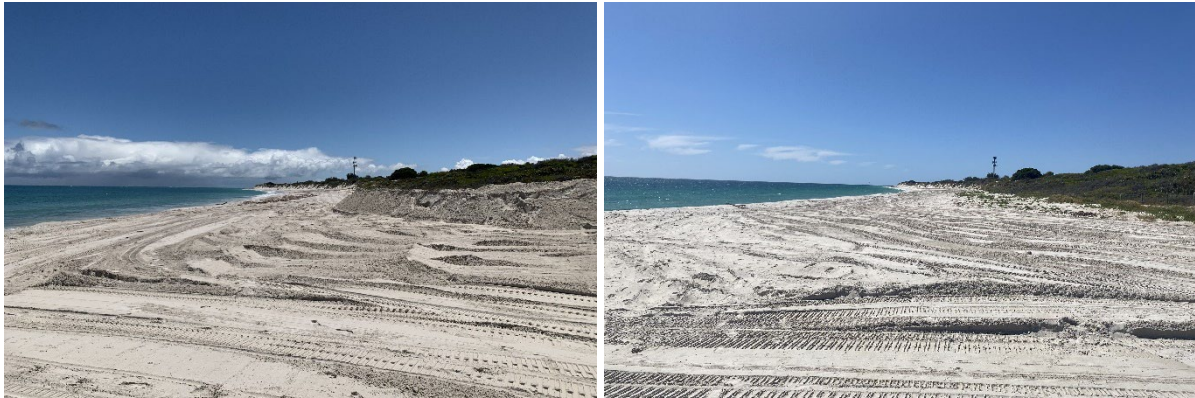
MRA (2021) recommended that the sand bypassing volume be increased (10,000 to 15,000 m³) to address the continued recession identified at Hillarys Beach Park and Pinnaroo Point. The 2021/22 bypassing was undertaken in October/November 2021 and is shown in the following figures.

- The 8,000 m³ bypassed is less than the 10,000 m³ target recommended for the works. This is significantly less than the amount of sediment movement out of these areas in recent years and some recession would still be expected.
- A significant amount of material was extracted from the waterline, which was intended as per the Drawings and Specification for the works (MRA 2020) and will assist the beach at Sorrento in naturally accreting.
- The grading in the disposal area appears to adhere to the requirements given in the Drawings.

It is evident that the sediment volumes that have been bypassed are not significant enough to completely offset the observed shoreline retreat at these locations. The City could look to increase future sand bypassing targets or look to progress the longer term adaptation options for this section of coastline. The City is currently preparing a Coastal Hazard and Risk Management Plan (CHRMAP) to inform future decision making about the management of coastal assets in areas experiencing erosion. The erosion experienced at Hillarys Beach Park and Pinnaroo Point will need to be considered in the City's future adaptation planning.
