Ern Halliday Centre

## Coastal Hazard Assessment Map 6

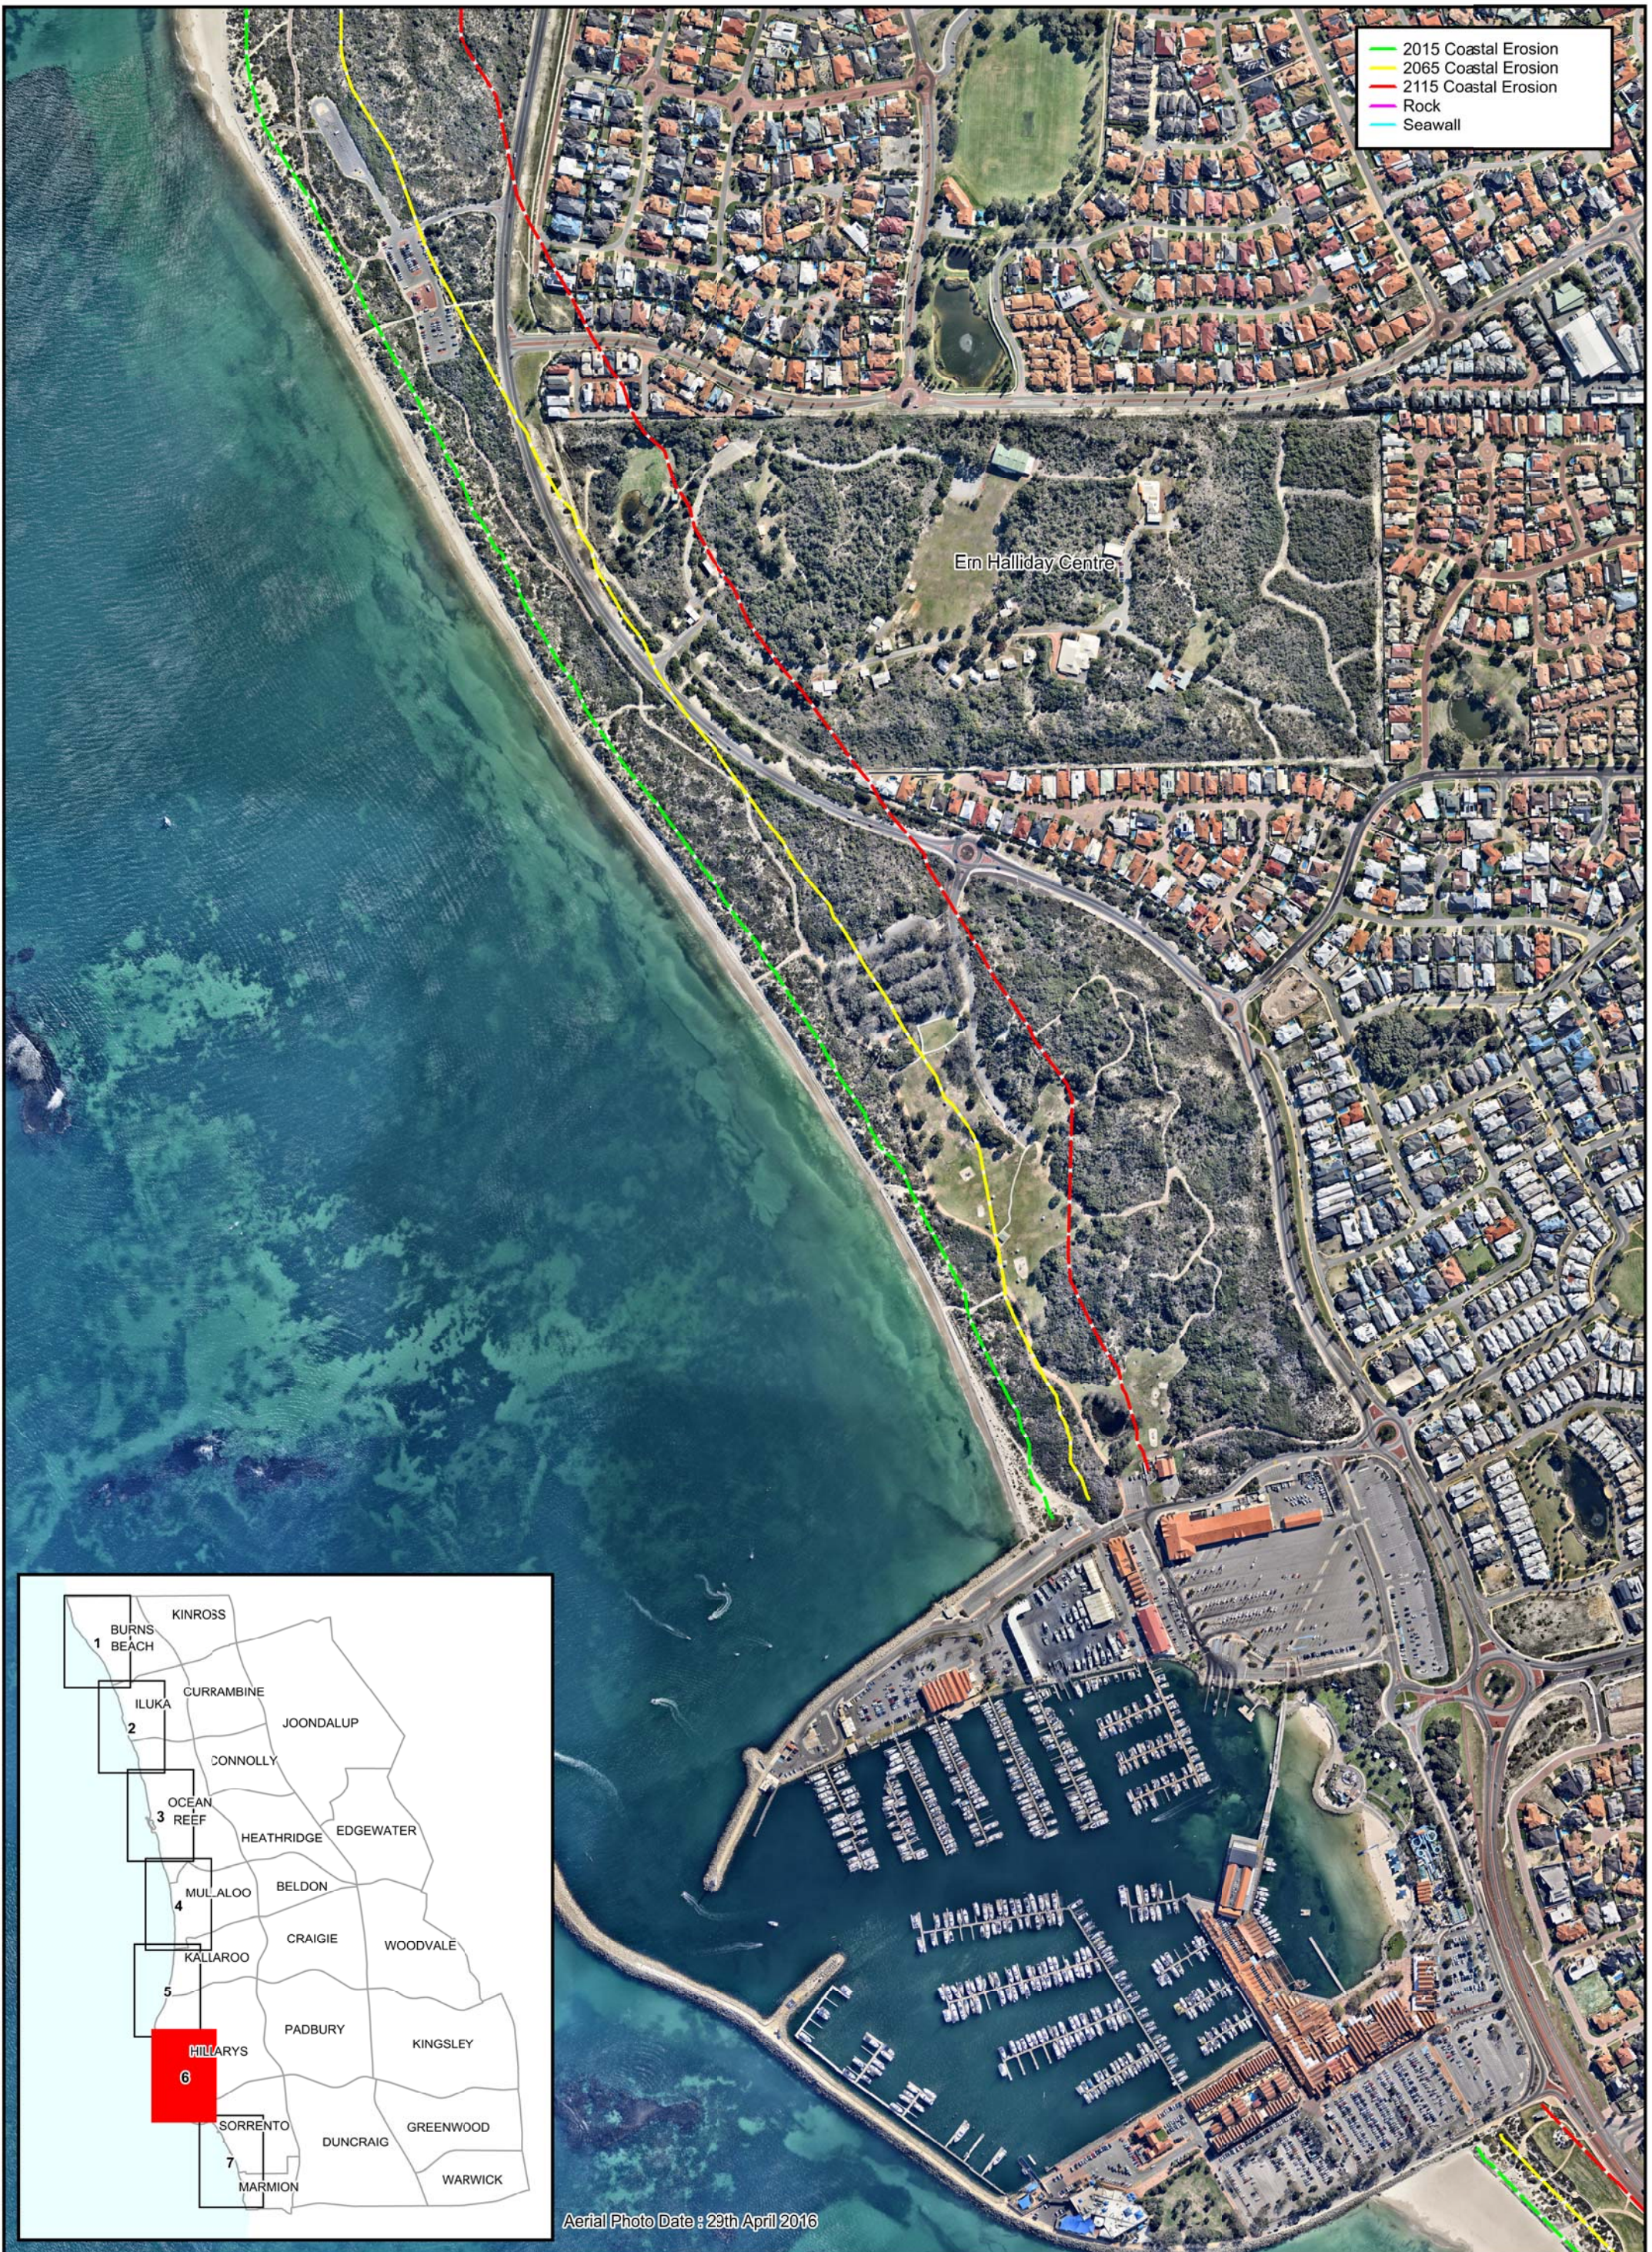
- 2015 Coastal Erosion
- 2065 Coastal Erosion
- 2115 Coastal Erosion
- Rock
- Seawall

Aerial Photo Date : 23th April 2016
